# EIFS Come and EIFS Go; A Case Study on EIFS Cladding Rehabilitation

**Project Title:** Exterior Facade Rehabilitation, Fisher Corporate Center

**Location:** 1707 North Randall Road, Elgin, Illinois

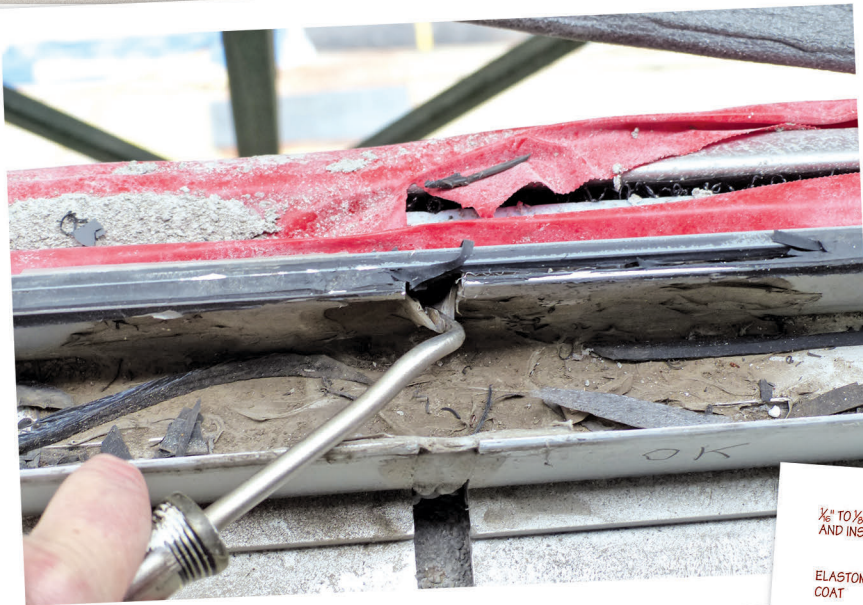
1. Lack of cover plates over splice joints between frame sections at window heads and sills (Figure 4)
2. Failure of retrofitted sealant at splices due to thermal expansion and contraction of the window frame sections (Figure 5)
3. Failure of sealant at window perimeters
4. Failure of sealant within glazing pocket

Figure 5 – Failure of retrofitted sealant at splices.

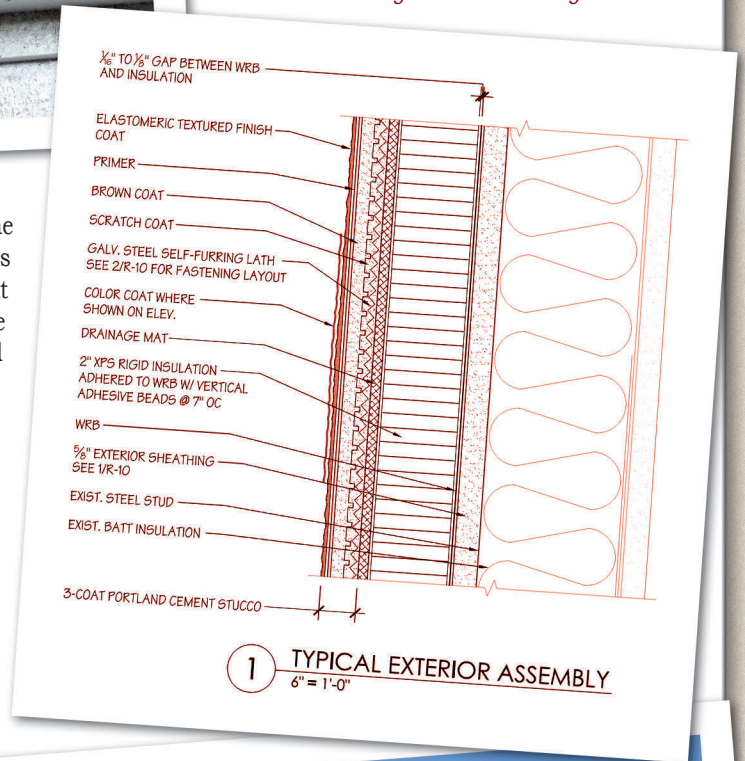
Figure 6 – Stucco system detail.

The three-coat stucco system was designed to appear nearly identical to the existing EIFS system, but to incorporate redundant resistance to water penetration (Figure 6). The scope of work included complete removal of the existing EIFS cladding system and installation of new sheathing, fully integrated water-resistive barrier, secondary drainage cavity, insulation, drainage composite, and three coats of Portland

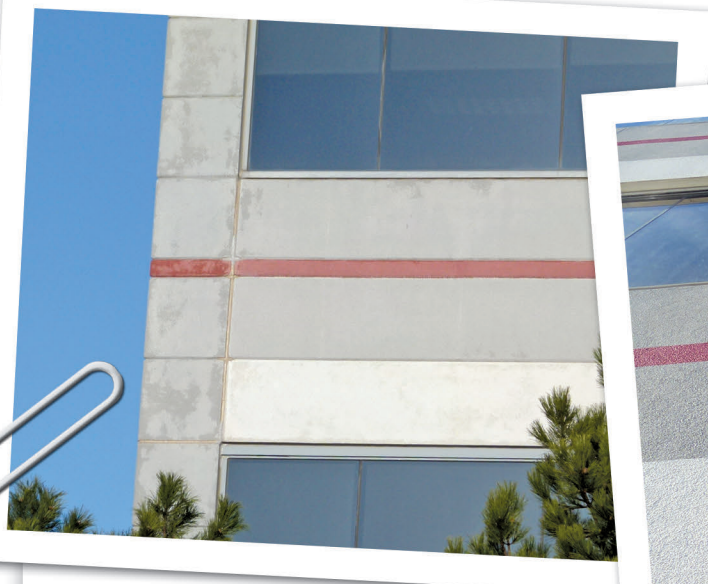
Figure 7 – Original EIFS cladding.

was tinted to replicate the light and dark gray colors of the original EIFS panels. An acrylic-based finish coating was then used to replicate the red stripe accent bands (Figures 7 and 8).

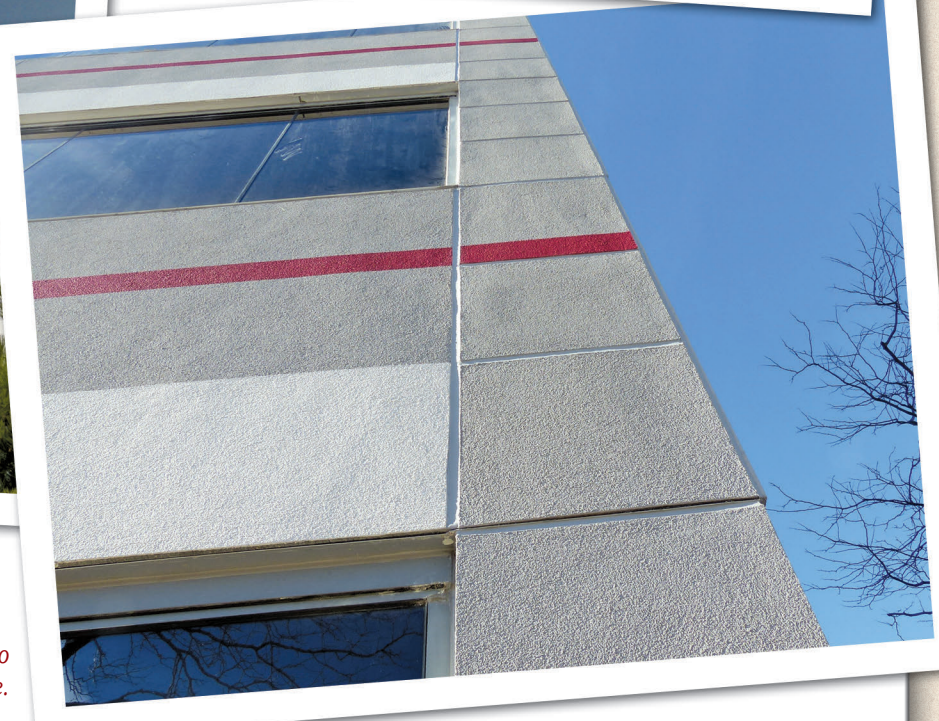
Figure 8 – Stucco system designed to replicate original appearance.

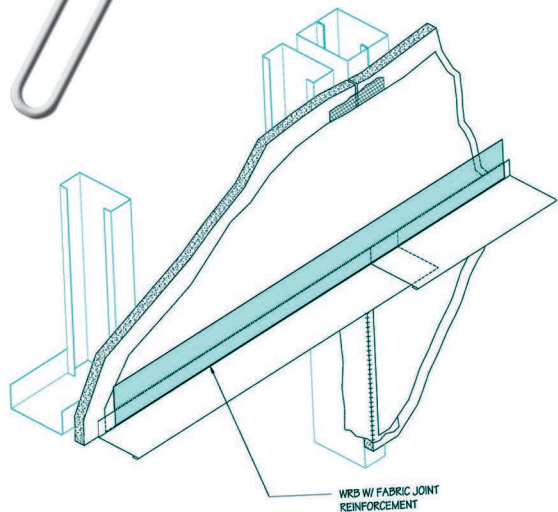
Figure 9 – Window head flashing detail.

Intricate flashing details were developed to redirect water that penetrates the stucco system back to the exterior (Figures 9 and 10). The integration of the new cladding system components made material selection a critical design consideration. The stucco system manufacturer was selected because of its capability to provide appropriate water-resistive barrier (WRB) and fluid-applied flashing materials, allowing the entire cladding system to be captured under a single warranty. Using a single manufacturer also helped minimize potential for compatibility issues among various materials.

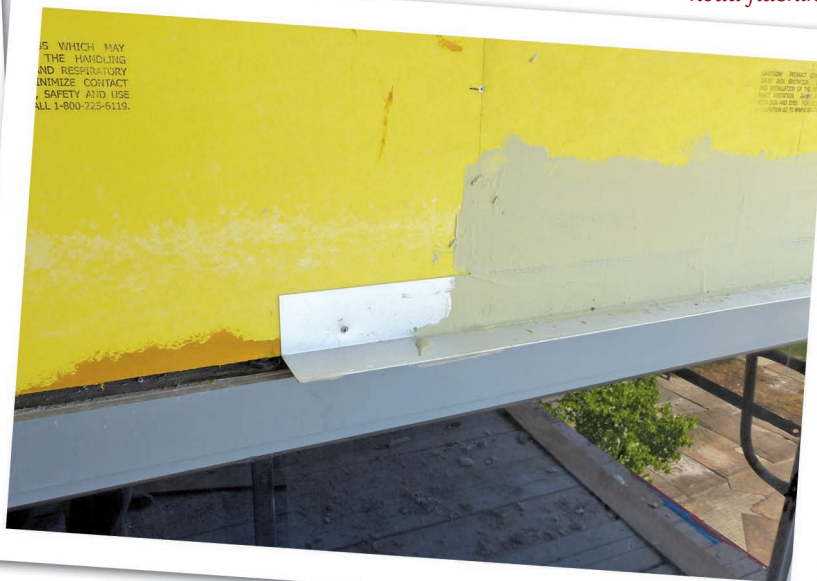
Figure 10 – Window head flashing.

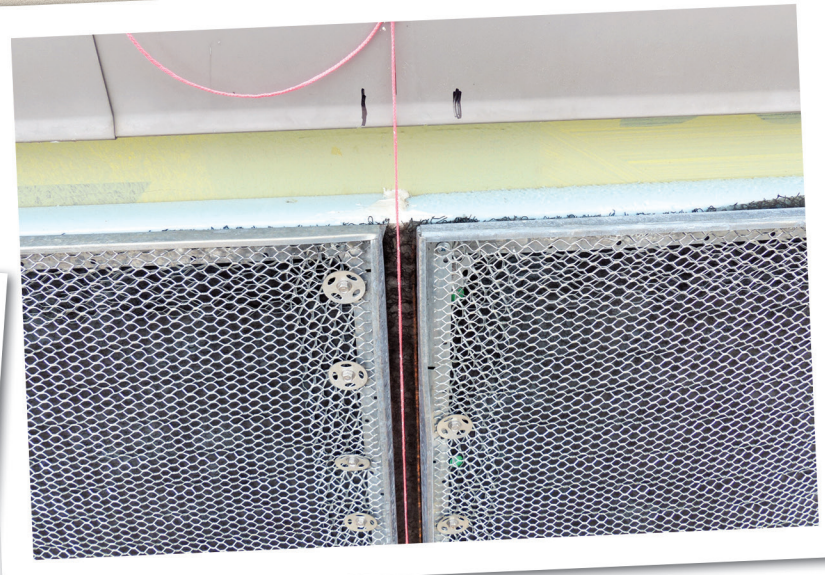
Figure 12 – Metal lath fasteners spanning across insulation and sheathing.

Prescriptive requirements for fastening metal lath to light-gauge framing were based on the most common stud spacing used in the industry (i.e., 12, 16, or 19.2 inches). However, the light-gauge steel studs at the building were spaced at 24 inches. As such, detailed calculations and fastener patterns were necessary to ensure adequate resistance to wind loads, given the atypical stud spacing. Additionally, the metal lath fasteners had to span across 2 inches of insulation and the exterior sheathing to anchor into the existing studs (Figures 11

and 12). As such, the anchors had to be designed to withstand bending stresses in addition to shear and pullout strength considerations.

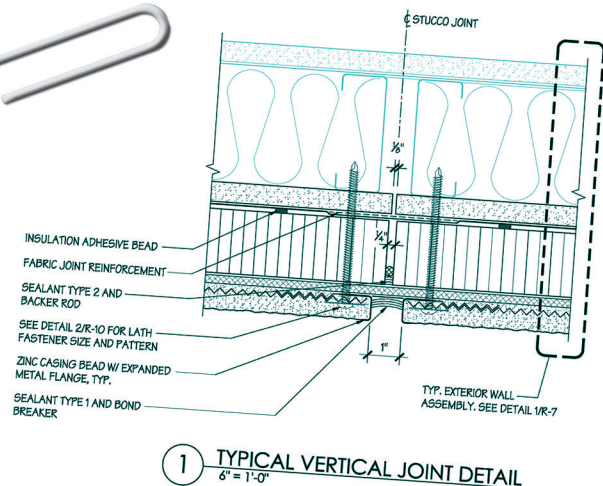
1 TYPICAL VERTICAL JOINT DETAIL  
6" = 1'-0"

Figure 11 – Joint detail for metal lath fasteners spanning across insulation and sheathing.

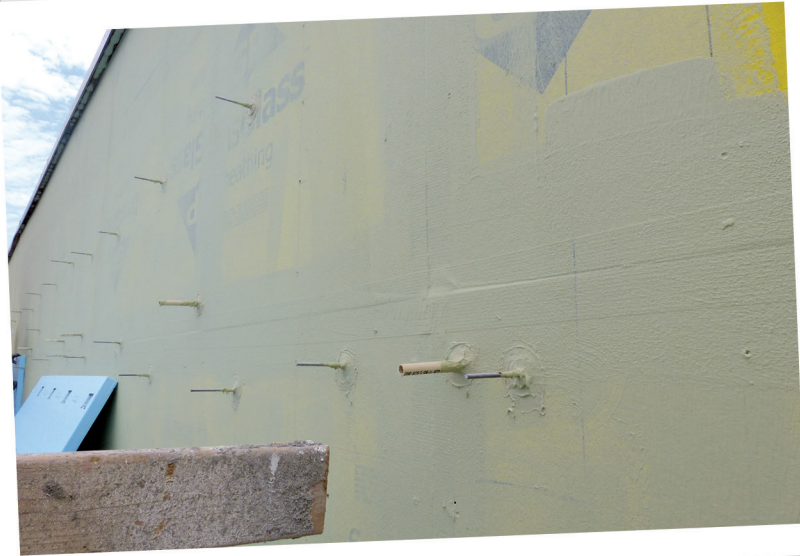
Figure 13 – WRB application around signage support anchors.

longer anchors and conduits to span across the thicker stucco system. Location of the anchors needed to be closely coordinated by the various trades prior to installation of the stucco system components so they could be properly flashed with the fluid-applied WRB (Figures 13 and 14).

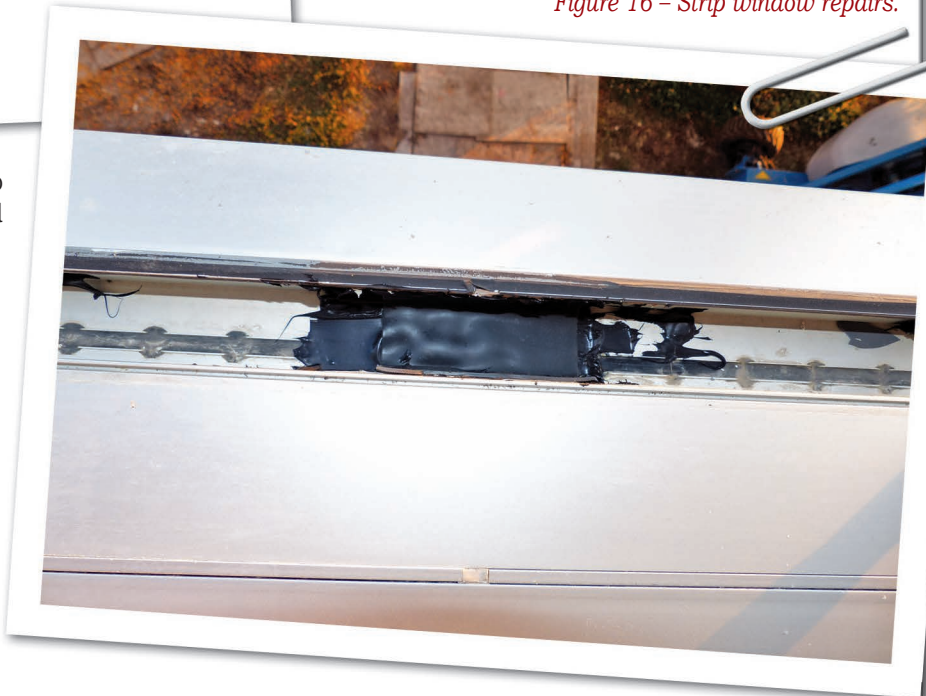
Figure 16 – Strip window repairs.

Strip window repairs included repairing internal seals and thermal breaks and adding splice cover plates at head receptor joints (Figures 15 and 16). Repairs to the internal seals and thermal breaks required temporary removal and reinstallation of glass panels at frame splice locations where leaks had been reported. The strip window repairs were uniquely designed to be performed independently. This gave the contractor flexibility to complete the strip window repairs before, during, or after installation of the stucco system. Frame splices were only repaired at known leak loca-

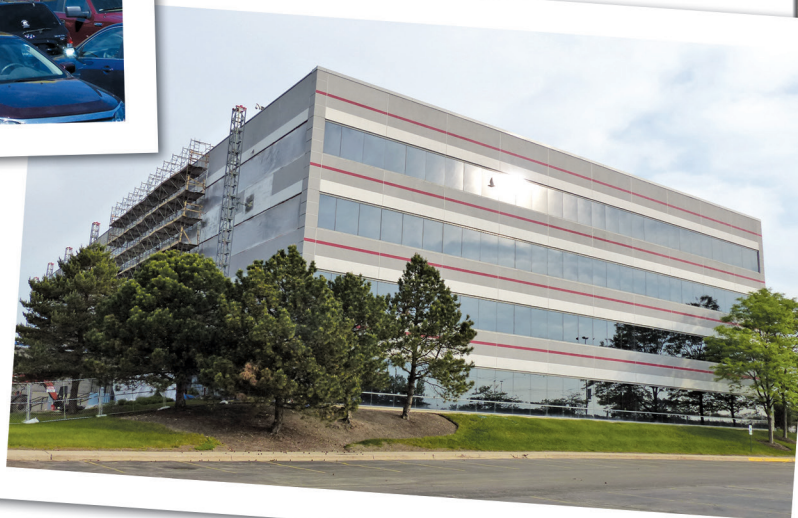
Figure 18 – Completed east elevation.

The first phase, which included the east elevation only (approximately 10% of the total façade area), was treated as a mock-up phase where the contractor worked through a learning curve in order to establish the most efficient sequencing (Figures 17 and 18). The first phase was completed in three months. The remainder of the building was completed over a five-month period the following year. Mast climbers were used for the

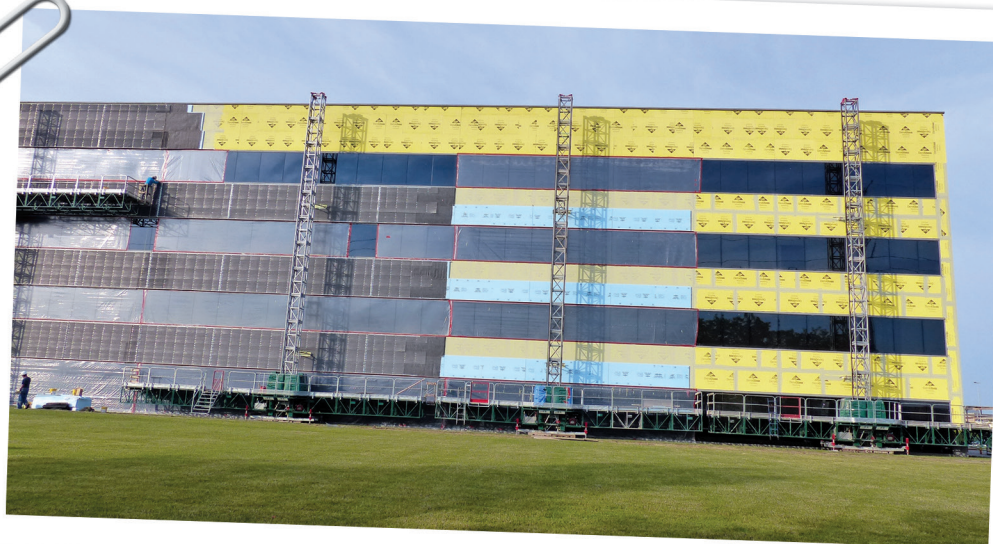
Figure 19 – Metal lath installation several days after sheathing and insulation.

During construction, EIFS panels were removed and new sheathing was fastened directly to the existing steel studs the same day. Metal lath, which also needed to be fastened directly to the steel studs, was typically installed several days after the sheathing fasteners had been covered by the subsequent layers of the stucco wall system (Figure 19). As such, the detailed fastener patterns previously discussed were critical to ensure adequate resistance to wind loads and to ensure proper staggering for the “blind” installation of the metal lath fasteners.

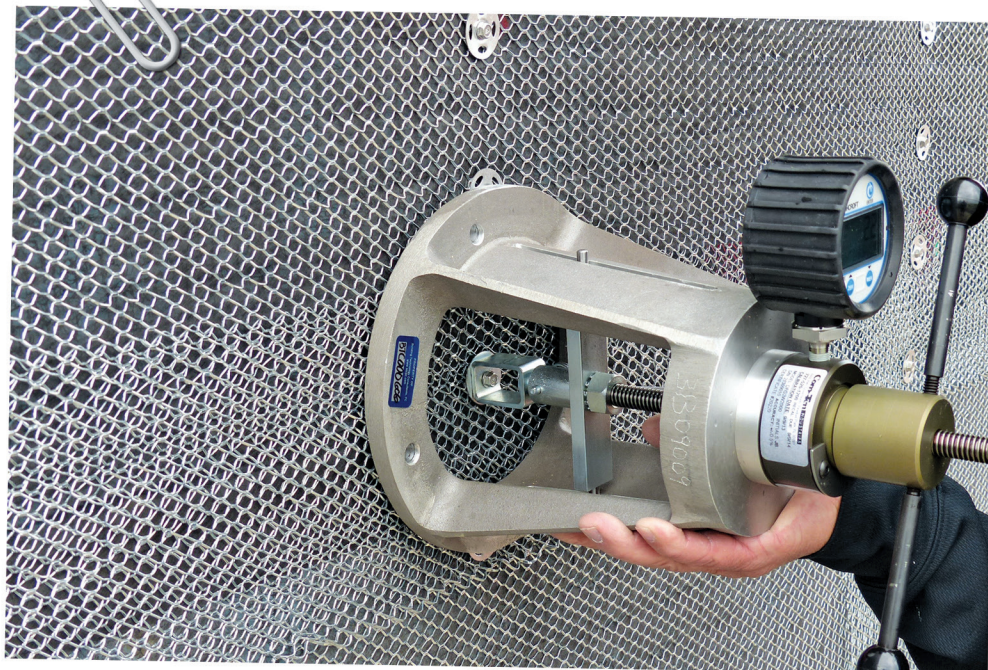
The fourth floor of the building was not occupied and was unfinished during the construction phase of the façade rehabilitation project. As such, fastener penetration into the studs could be verified from the interior on the fourth floor as a measure of quality control. Metal lath fasteners were also randomly tested for pullout resistance using a calibrated pull tester throughout the project to verify their attachment to the steel studs (Figure 20). Fasteners had engaged the steel studs at 100% of the tested locations.

Figure 20 – Fasteners tested for pullout resistance.

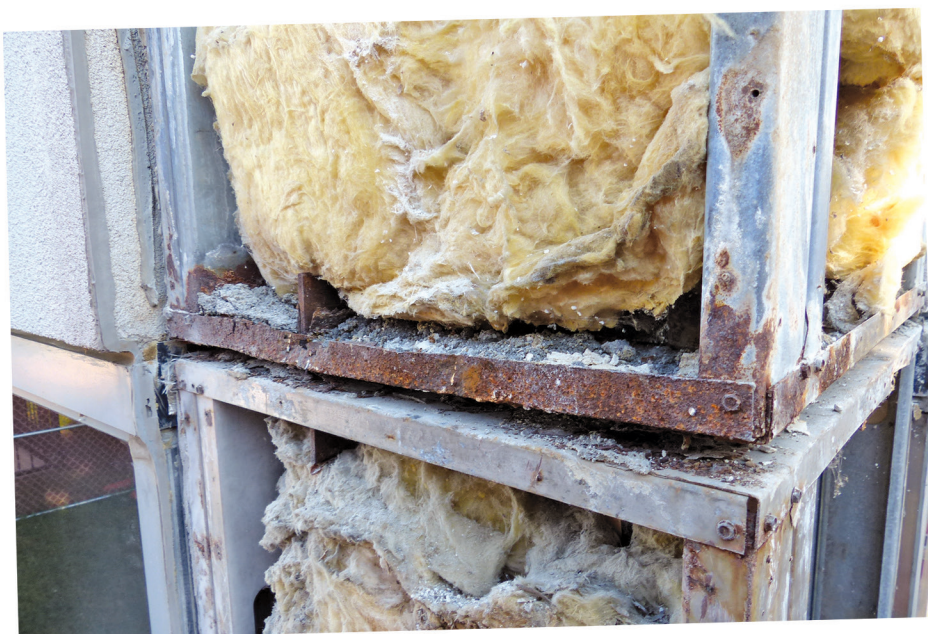
As removal of the existing EIFS panels progressed, some of the light-gauge steel-framing members were found to be severely corroded and needed to be reinforced (Figure 21). A detail was devel-

Figure 21 – Corroded light-gauge steel-framing members.

oped that allowed for a quick installation of reinforcement at corroded framing members to ensure openings could be closed the same day and still provide a sufficient substrate to which to fasten the stucco system components.
