AN UNCONDITIONAL APPROACH TO CURTAIN WALL REPAIR

BY KAMI FARAHMANDPOUR, PE, FRCI, FNAFE, RRC, RWC, REWC, CCS, CCCA

This is the second installment of this article. The first installment summarized the typical failure mechanisms in curtain wall systems, the conventional repair approaches and a discussion of advantages and disadvantages of each repair approach. This installment is a case history on using the repair approaches outlined in the first installment.

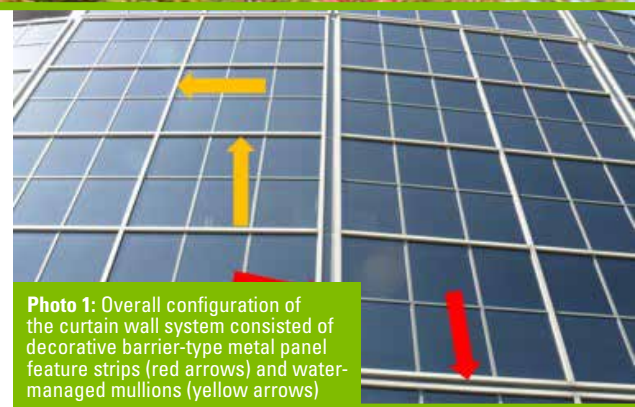
Photo 1: Overall configuration of the curtain wall system consisted of decorative barrier-type metal panel feature strips (red arrows) and water-managed mullions (yellow arrows)

metal cladding system separating the curtain wall panels (Photo 1). The joints in the barrier metal cladding are sealed with field-applied liquid sealant. On the

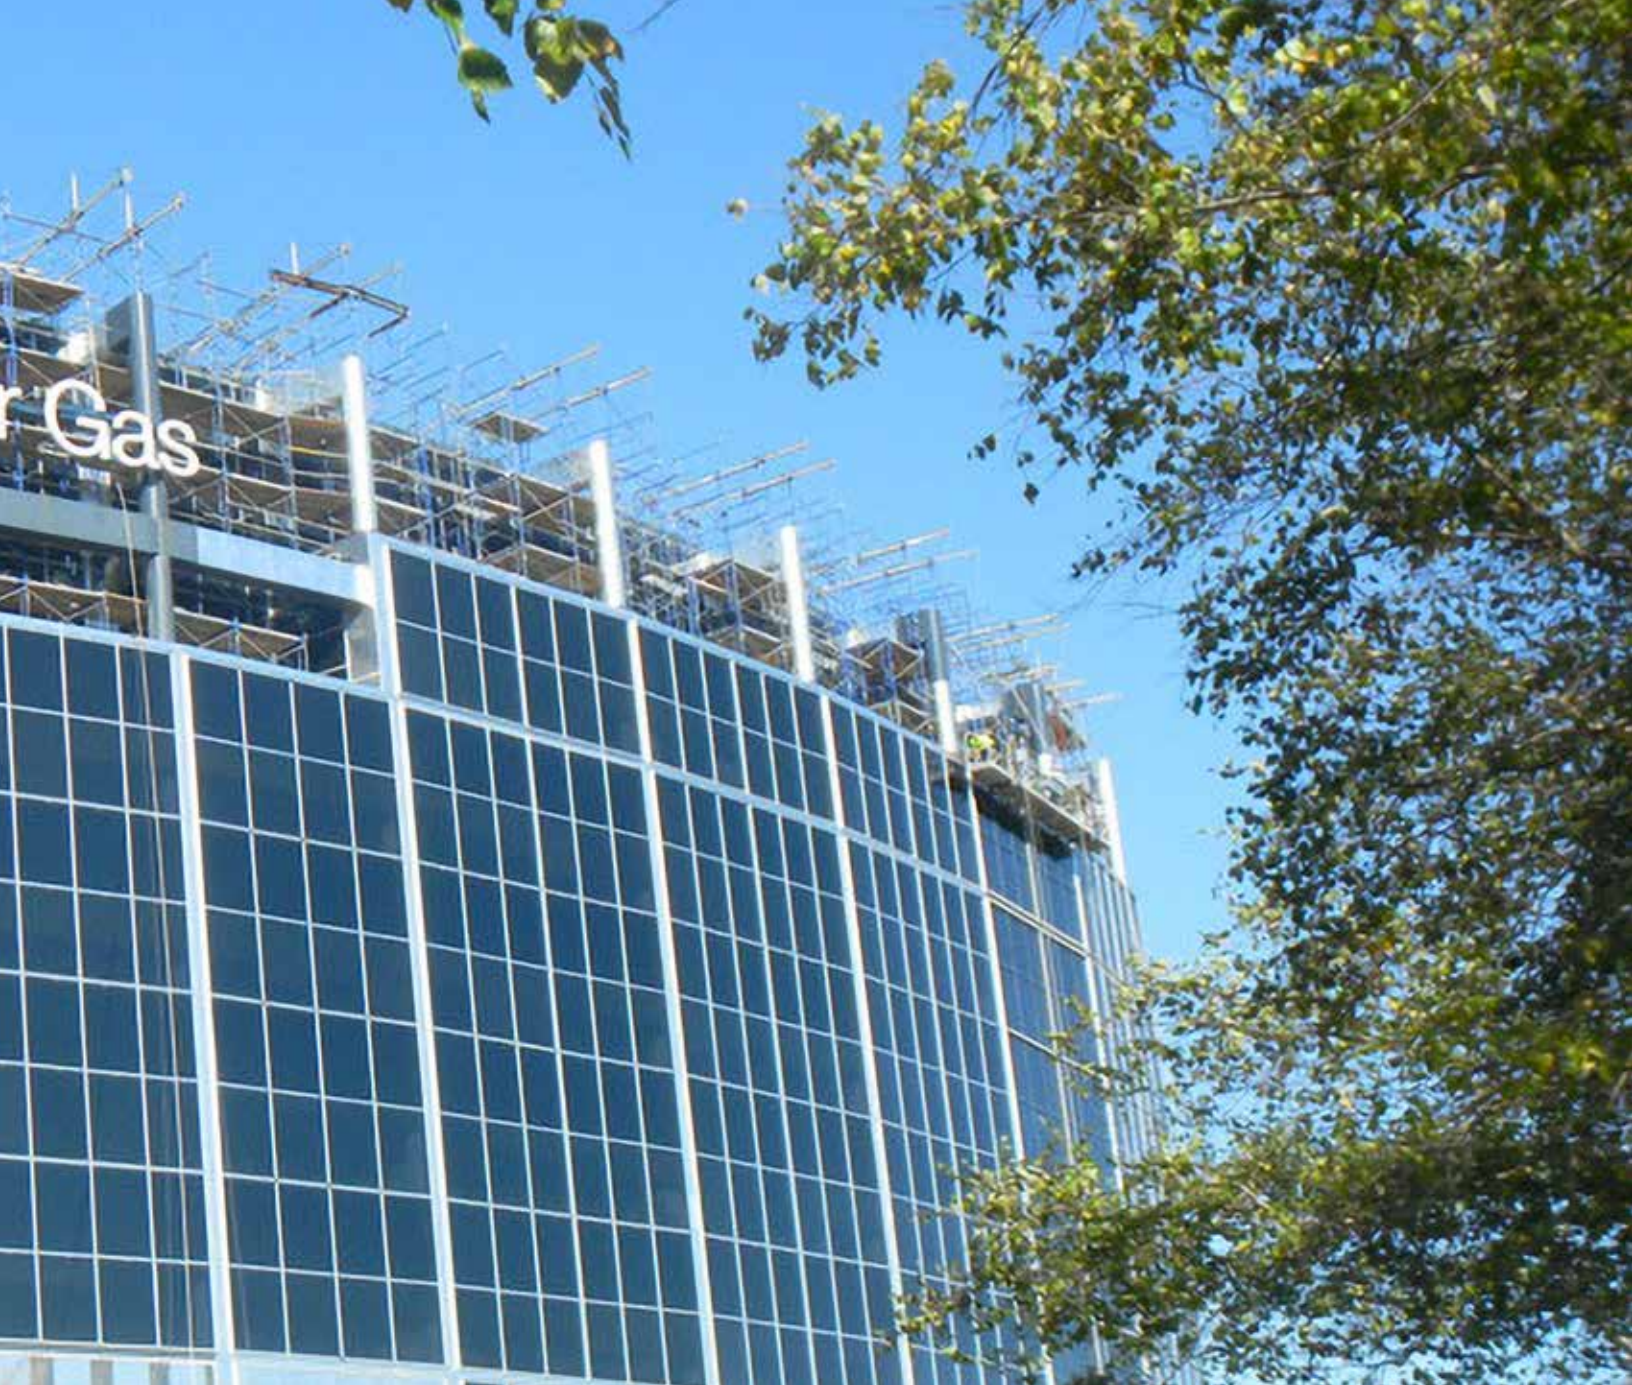
Photo 2: View of the building corner showing barrier-type metal panel cladding at corners (yellow arrow) and buttresses (red arrow). East and west elevations of the building also included HVAC

been integrated into the curtain wall system (Photo 2).

On the south elevation, the building columns extended above a setback terrace area forming decorative buttresses (Also Photo 2). These buttresses had been clad with a barrier type prefinished aluminum cladding system.

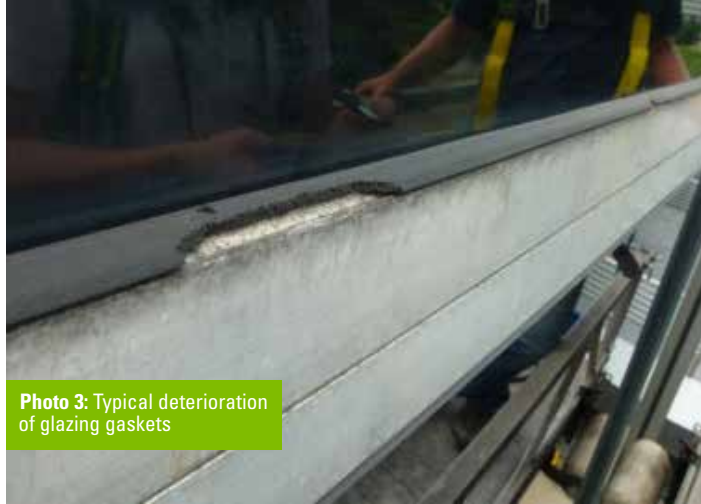
The investigation revealed several issues associated with the curtain wall system. These included faded aluminum finishes, deteriorated glazing gaskets (Photo 3), deteriorated or open sealant joints at barrier metal cladding (Photo 4), inadequate internal seals, open frame joinery (Photo 5), displaced or rotated mullions, and extensive water leakage issues below the louver assemblies. In addition, dislodged and loose mullion caps were also observed at several locations. Extensive water leakage below the louvers was also confirmed through water testing.

Photo 3: Typical deterioration of glazing gaskets

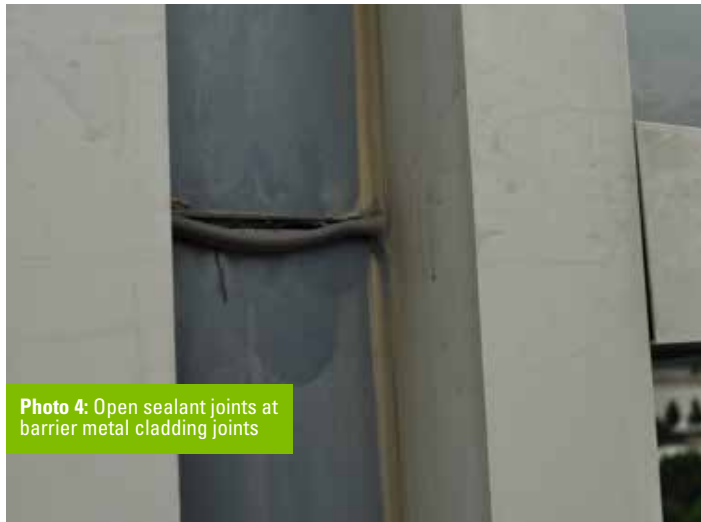
Photo 4: Open sealant joints at barrier metal cladding joints

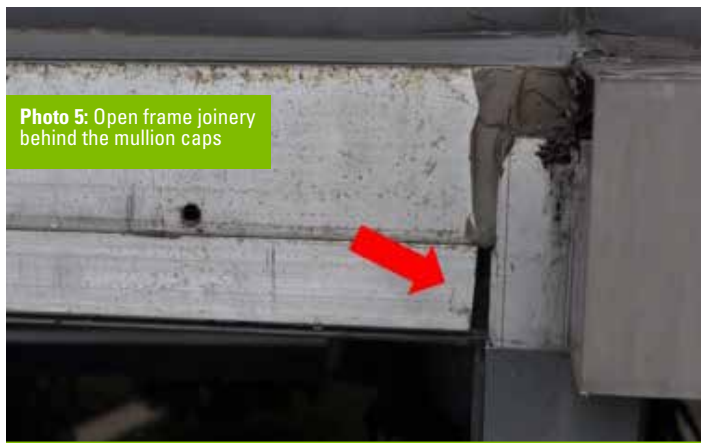
Photo 5: Open frame joinery behind the mullion caps

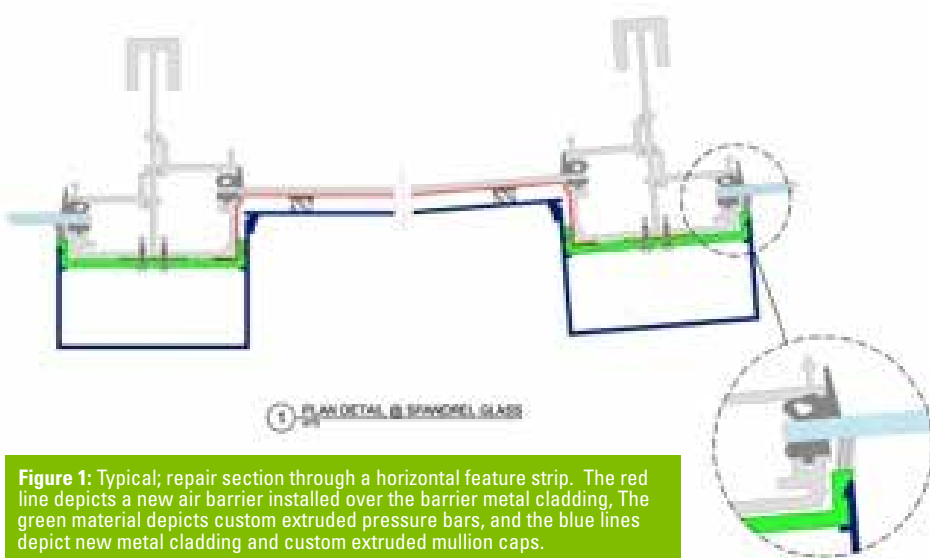
Figure 1: Typical repair section through a horizontal feature strip. The red line depicts a new air barrier installed over the barrier metal cladding. The green material depicts custom extruded pressure bars, and the blue lines depict new metal cladding and custom extruded mullion caps.

Figure 1 depicts the basic concept of Option 3 repairs at a typical horizontal mullion. The repairs would consist of trimming the exposed portions of the glazing gaskets, removing the existing snapped-on mullion caps, cleaning the frame surfaces, installing a custom-extruded aluminum pressure bar set in sealant, applying perimeter glazing sealant and installing a new custom-extruded pre-finished aluminum snapped-on cap. The new pressure bar would be 1/2

inch wider than the existing frame members allowing a glazing sealant depth of 1/4 inch. In addition, the new pressure bar sealant shoulder would be placed approximately 3/8 inch away from the exterior face of the IGU to allow for suitable sealant geometry. Such sealant geometry is far more reliable than a sealant cap bead typically used for wet seal repairs.

Once the new pressure bar was installed, weep holes would be drilled at the same locations as the existing weeps so that the internal water management of the system would function as originally intended.

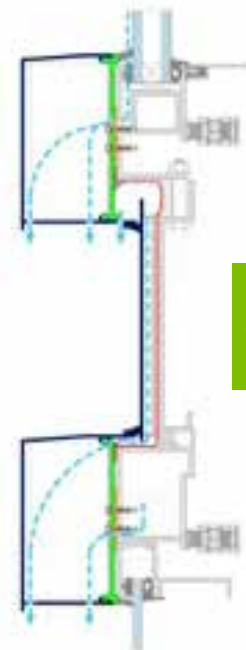
Figure 2: Light blue lines depict drainage path in the retrofitted system.

Figure 2 depicts the typical design detail at one of the horizontal decorative strips which originally consisted of a barrier type metal cladding system. At those locations, a self-adhesive air barrier would be installed over the existing metal cladding and terminated below the outer lips of the new curtain wall pressure bars. The new metal cladding panel would then be installed over a series of vertical aluminum

spacer bars. These bars were designed to provide a drainage cavity between the new air barrier and the back of the new metal cladding panels. That cavity was designed to weep to the exterior through the horizontal mullion cover below each strip. In order to avoid fastening the new metal spacers and cladding through the air barrier, the design team opted to use structural tape to adhere the spacer bars to the back of the new metal cladding in the shop and structural glazing to adhere the assembly to the air barrier in the field. The sequence of repairs for the typical curtain wall section is shown in Figures 3a through 3j.

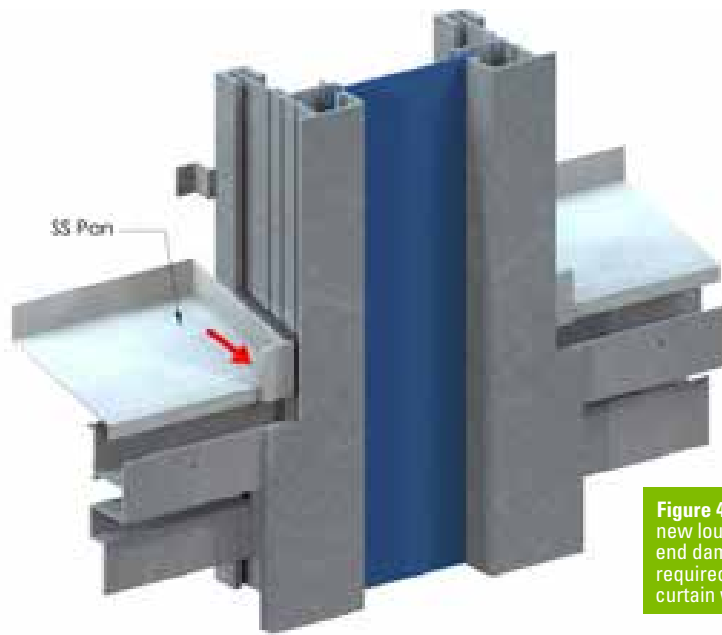
Another challenge was the configuration of the HVAC louvers. Field testing had indicated extensive water leakage below the louvers. The interior of the louvers were either blanked off or directly connected to large ductwork. In order to ensure water management below the louvers, the louvers would have to be removed so that a pan flashing could be installed below them. The louvers had originally been installed from the interior: however, removal of the louvers would require removal of the interior ductwork which was deemed impractical. As such, it was decided to trim the exterior flanges of the vertical mullions to allow removal of the louvers from the exterior of the building. Once the flanges were trimmed, the louvers could be disconnected from the interior ductwork and removed. The

Figure 4: Stainless steel pan flashing below new louvers with a specially configured end dam. Red arrow depicts a welded tab required to divert water to the exterior of the curtain wall system.

ing curtain wall framing were modeled using 3D solid modeling software. This modeling allowed the design team to evaluate the sequence of work during construction and develop an appropriate end dam configuration for the louver pan flashing (Figure 4).

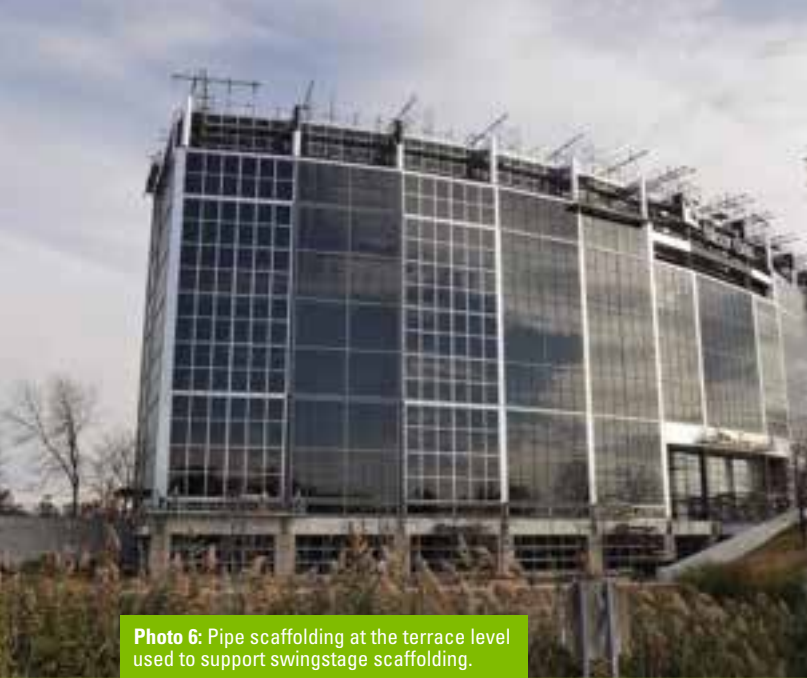
Photo 6: Pipe scaffolding at the terrace level used to support swingstage scaffolding.

This allowed the use of the building davit system to erect swing stage scaffolding over most of the facade. However, at the terrace areas, pipe scaffolding was installed to gain access to the building exterior (Photo 6). In addition, building entrances and entrance canopies were protected with temporary canopies.

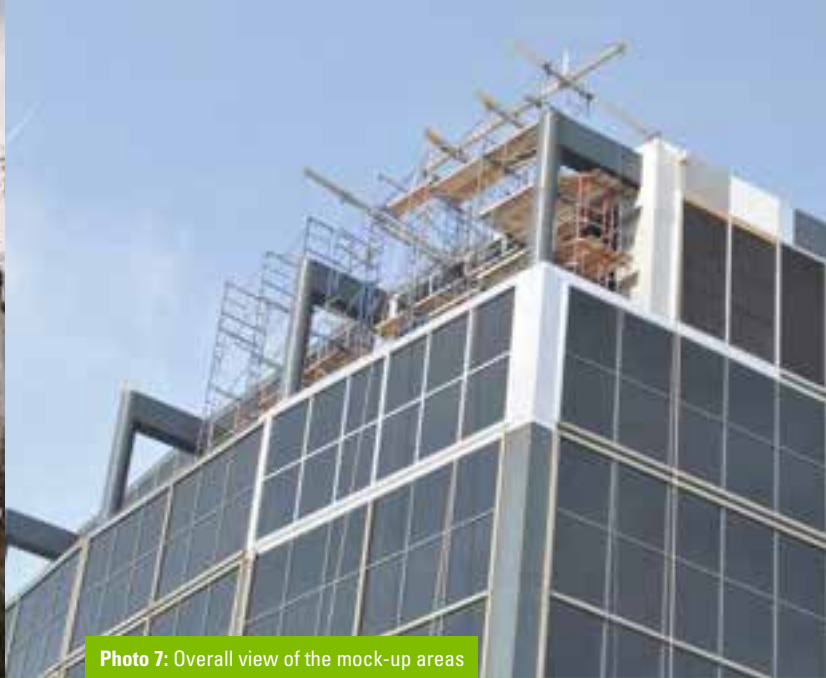
Photo 7: Overall view of the mock-up areas

curtain wall section including a decorative metal cladding strip, and one at a louver (Photo 7). Once the mock-ups were constructed, they were water tested by the design team to ensure they performed properly. The testing revealed no leaks through a section of the curtain wall which exhibited chronic leaks before the repairs.

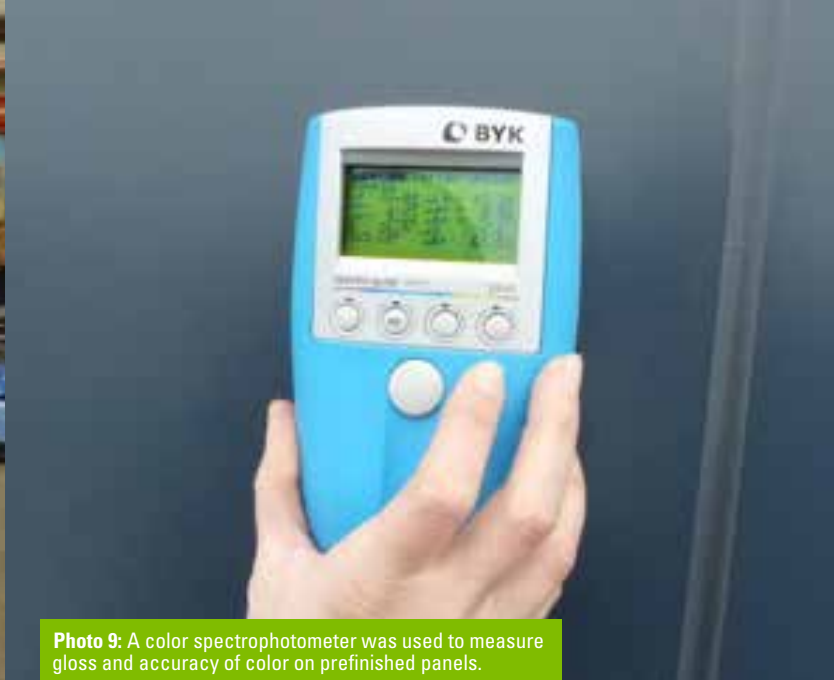
Photo 9: A color spectrophotometer was used to measure gloss and accuracy of color on prefinished panels.

A preliminary review of the pre-finished components revealed inconsistent finish texture and gloss. This triggered a series of inspections and tests by the design team. The design team utilized a color spectrophotometer to quantitatively measure gloss of the finished components (Photo 9). The measured values were then compared to limits set by the specified standard (AAMA 2605) and the manufacturer's stated gloss value. The evaluation of the finishing gloss revealed that several curved panels were significantly out of the acceptable range of gloss. As such, those components were sent back to the finisher for re-finishing. During the repairs, the existing sign on the building which was attached to the terrace buttresses had to be changed to reflect the name and logo of the
