Project Profile

Project Name:
20 East Cedar
Exterior Facade Repairs

Project Location:
Chicago, Illinois

Year Completed:
2006

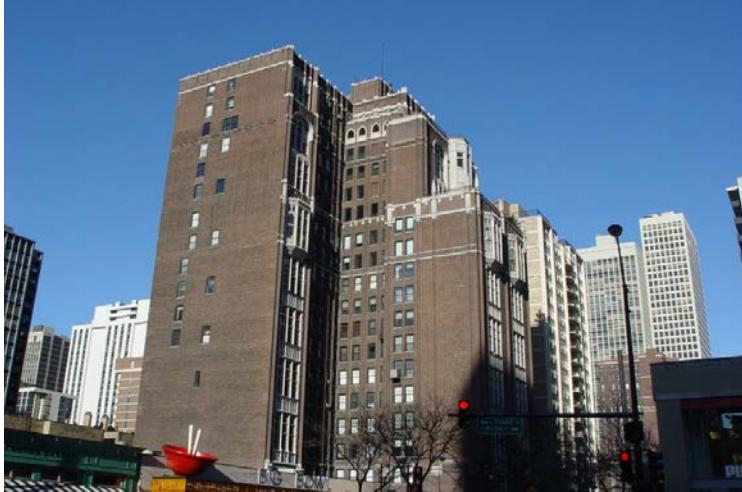
The 20 East Cedar Building is a 19-story gothic high rise completed in 1925. The center of the building steps back at the south elevation to form terraces at the 14th and 18th floors. The building is concrete framed and clad in brick and architectural terra cotta. The south elevation also includes four 2-story terra cotta clad Oriel windows, a projecting terra cotta clad spiral stairway enclosure, and 7 large finials at the 14th floor terrace.

BTC's evaluation of the exterior facade indicated significant corrosion of the 14th floor parapet wall steel support angle, cracking and displacement of the 18th floor parapet walls, significant cracking of terra cotta units, many loose terra cotta units, failed crack repairs from previous repair projects, and deteriorated brick mortar joints.

Repair of the exterior walls required removal and replacement of the corroded parapet wall support steel, rebuilding portions of the 18th floor parapet walls, removal and replacement of 130 terra cotta units, removal and resetting of 115 loose terra cotta units, removal and replacement of failed sealant at previous crack repairs, installation of retrofit facade stabilization pins, epoxy repair of selected cracked terra cotta units, and repointing of deteriorated mortar joints.
