Project Profile

No leaks into the lower level of the garage have been reported since completion of the repair project. Furthermore, repairs to the joints between the precast double-tee beam flanges have withstood impact and abrasion from snowplows with very little deterioration. Project Name: Parking Garage Repairs Naperville Financial Center

Project Location: Naperville, Illinois

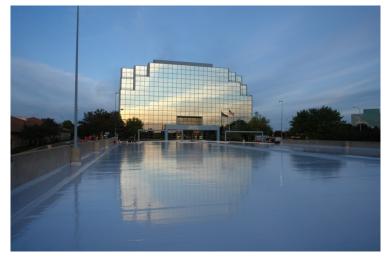
The Naperville Financial Center parking garage is a 2-level structure. The elevated deck consists of untopped precast double-tee beams supported on perimeter foundation walls and a precast inverted tee beam at the center of the garage. Ongoing water leakage through the joints between double-tee beams had been an ongoing problem for many years.

Evaluation of the parking garage indicated significant deterioration of the double-tee beam flanges due to corrosion of embedded reinforcing steel and connection hardware. Deterioration of sealant at the joints between the double-tee beam flanges was the cause of water leakage into the lower level of the garage. Chloride testing indicated chloride contents within the top flanges of the double-tee beams were significantly higher than the threshold value required for corrosion.

Repairs to address overall deterioration and water leakage included concrete patch repairs, grinding shoulders of doubletee beam flanges to minimize impact from snowplows, replacement of sealant at the joints between double-tee beam flanges, pre-striping joints between double-tee beam flanges with a fabric-reinforced traffic bearing membrane, and completely coating the upper level of the garage with a traffic bearing membrane. Other repairs included replacement of miscellaneous deteriorated sealant, concrete foundation wall repairs, replacement of entrance ramps and expansion joints, and painting parapet walls around the upper level of the garage.
