**Project Name:**  
*Fire Damage Investigation  
Busse Building*

**Project Location:**  
*Mount Prospect, Illinois*

**Nature of Services:**  
*Forensic Investigation*

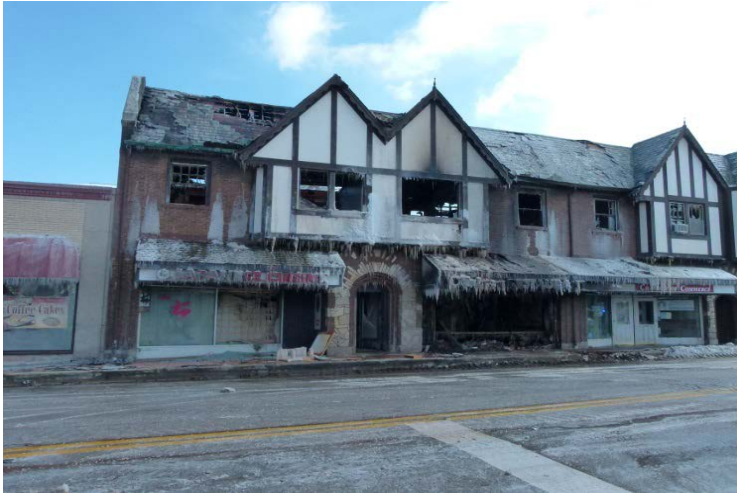
The evaluation indicated that the northernmost portion of the building that contained the restaurant was a complete loss. The timber floor and roof framing had been almost completely consumed in the fire. Steel floor support beams had significantly warped in the heat of the fire. In addition, portions of the masonry walls had collapsed. As such, the cost to repair this portion of the building would have been greater than demolishing and rebuilding it.

Although the remaining portion of the building exhibited only minor damage, it was judged to be more costly to salvage this portion of the building than to rebuild it with the northern portion. Therefore, this portion of the building was also demolished.
