Project Name:
*Roof Collapse Investigation
Wildbrook Commercial Building*

Project Location:
Prospect Heights, Illinois

Nature of Services:
Forensic Investigation

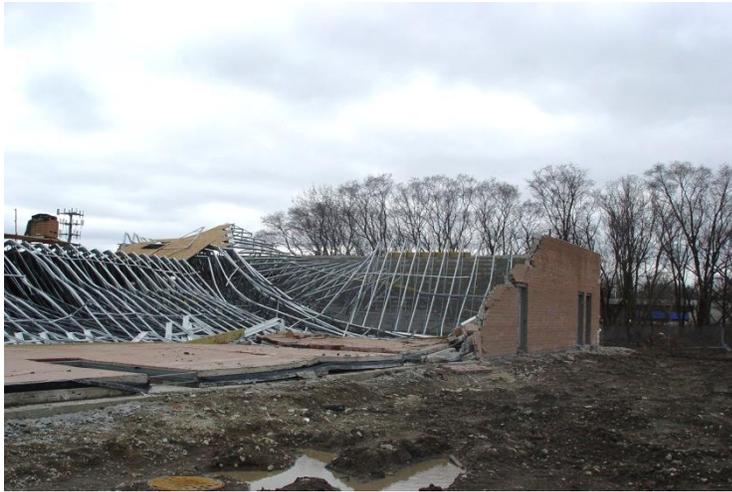
While the south building was under construction, the roof structure collapsed during a high wind event. This also resulted in collapse and/or damage to most of the masonry walls. Wind gusts on the day of the collapse varied from 30 to 35 miles per hour.

At the time of the collapse, all of the roof trusses were in place and only the east half of the roof had been sheathed. In addition, no temporary masonry wall braces had been installed. As such, the unbraced masonry walls were inadequate to support the wind loads imposed on them from the incomplete roof diaphragm.

BTC reviewed the remaining masonry walls and provided recommendations for repair and replacement based on the extent of the damage.
