CONVENTIONAL AND NONCONVENTIONAL REPAIR OF CURTAIN WALL SYSTEMS

KAMRAN FARAHMANDPOUR,
FCI, RRC, RWC, REWC, RBEC, PE, CCS, CCCA, FNAFE

BUILDING TECHNOLOGY CONSULTANTS, PC

Building
Envelope
Technology
Symposium

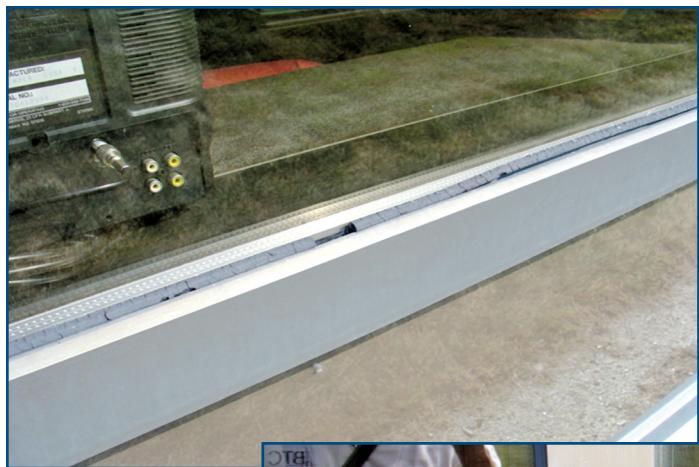
Photo 1 – Crazing of glazing gaskets in a curtain wall system.

Depending on gasket type, prolonged exposure to UV can result in hardening, shrinkage, and crazing (cracking) of the gasket material (*Photos 1 and 2*). In some cases, gasket shrinkage is significant enough that the gaskets shrink away from glass corners, resulting in loss of watertightness. Molded gaskets can pull out of their retaining grooves due to shrinkage, and extruded gaskets can simply shrink away from the corners, leaving the corners with no waterproofing protection (*Photo 3*). Although most curtain wall systems

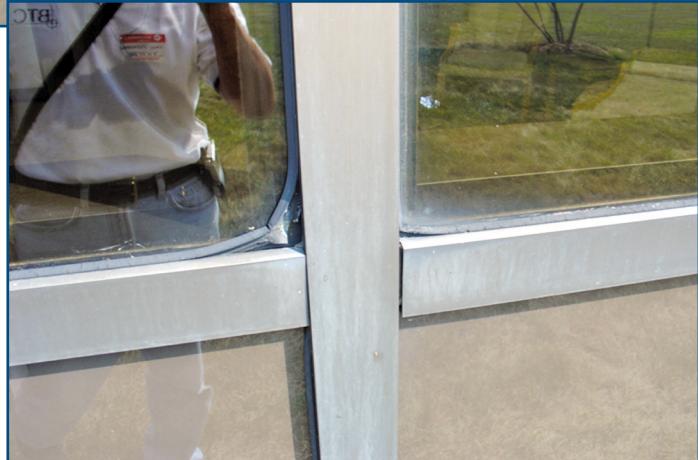
Photo 2 – Shrinkage of glazing gaskets.

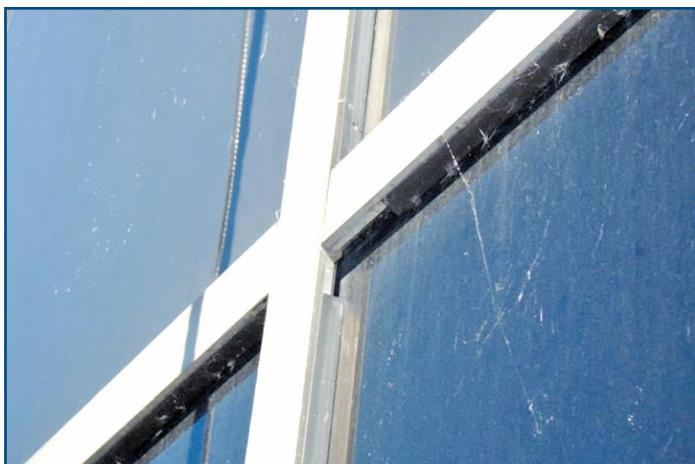
Photo 3 – Extruded glazing gasket shrinkage.

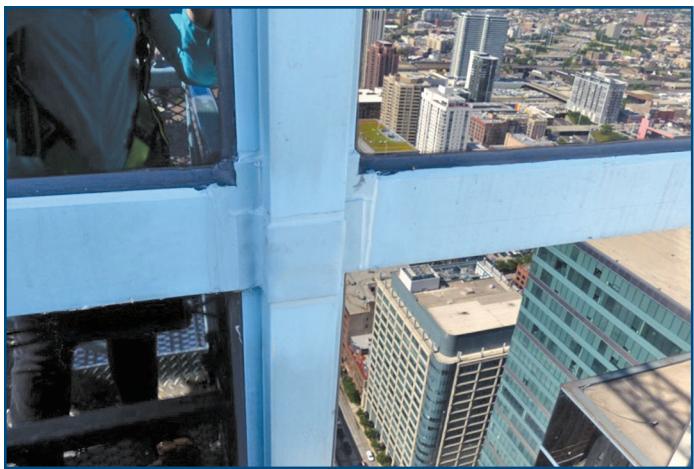
Photo 4 – Premolded silicone boots used to seal framing joints.

One of the most common and least expensive repair approaches to address curtain wall water infiltration issues is to seal all exposed glazing and frame joinery with sealant. This approach is typically referred to as "wet-sealing." Wet-sealing involves application of sealant over glazing gaskets and at all other locations where water infiltration into the system can occur. Although sealing of exposed frame joinery need not necessarily be included in a wet-sealing project, it often is. Wet-sealing of glazing typically consists of cutting and removing the exterior portion of the glazing gaskets and applying a cap bead of sealant around the glazing. In addition, frame joinery can be sealed. However, in most cases, decorative mullion caps are not removed to seal frame joinery. Instead, sealant is applied at all mullion cap interfaces. Some wet-sealing projects involve the use of silicone strips or premolded silicone shapes to seal mullion and frame joinery (Photo 5).

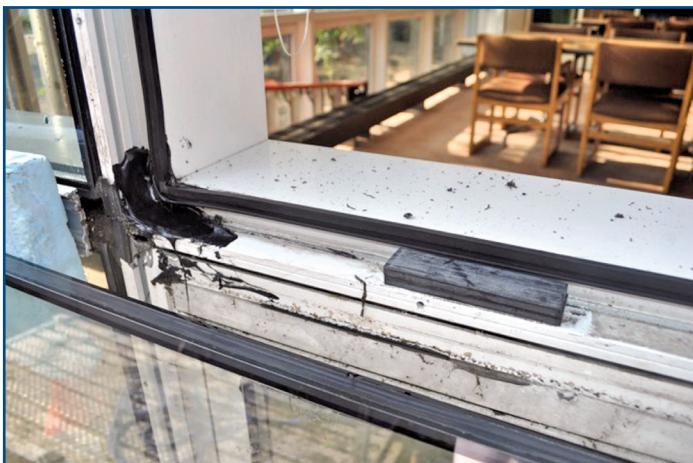
Photo 5 – Repair of internal seals by deglazing.

Repair of internal seals is not performed on a routine basis. Such replacement will necessarily require deglazing to expose the internal seals (Photo 5). In some cases, repair of internal seals may be possible by removing exterior pressure bars to expose glazing pockets. However, such repairs are difficult and not as reliable as those made where glazing is removed from the system.

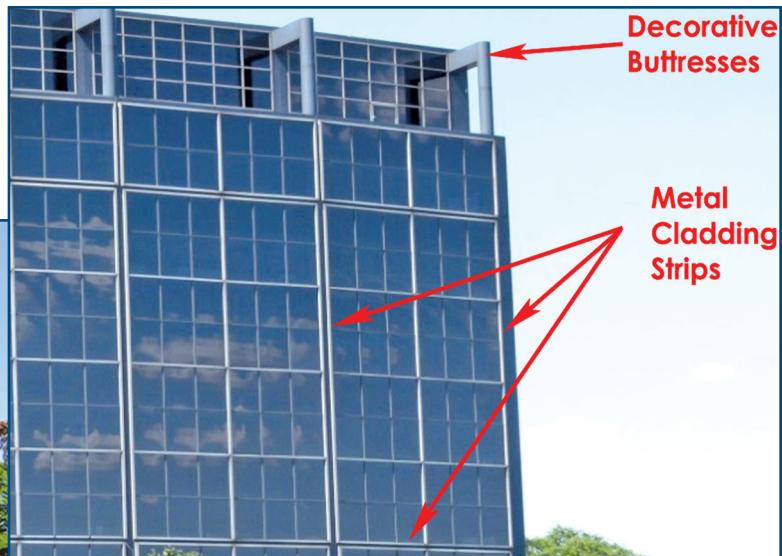
Photo 7 – Barrier-type metal cladding strips between curtain wall sections.

decorative metal cladding system separating the curtain wall panels (*Photo 7*). The joints in the barrier metal cladding are sealed with field-applied liquid sealant. On the east and west elevations of the penthouse level, large aluminum louvers serving the HVAC equipment have been integrated into the curtain wall system (*Photo 8*).

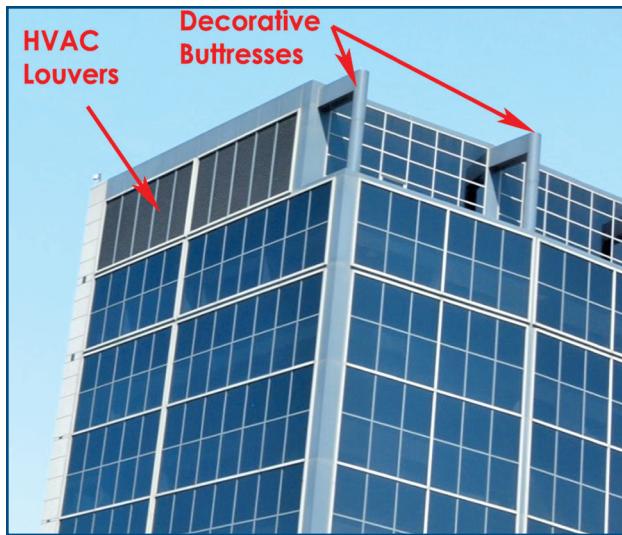
Photo 8 – Large HVAC louvers installed within the curtain wall framing.

deteriorated glazing gaskets, deteriorated or open sealant joints at barrier metal cladding (*Photo 9*), inadequate internal seals, open-frame joinery, displaced or rotated mullions, and extensive water leakage issues below the louver assemblies. In addition, dislodged and loose mullion caps were observed at several locations. Extensive water leakage below the louvers was also confirmed through water testing.

Another challenge for the design team was the configuration of the HVAC louvers. Field-testing has indicated extensive water leakage below the louvers. The interiors of the louvers were either blanked off or directly connected to large ductwork. In order to

ensure water management below the louvers, the louvers would have to be removed so that a pan flashing could be installed below them. The louvers had originally been installed from the interior. However, removal of the louvers would require removal of the interior ductwork that was deemed

impractical. As such, the design team opted to trim the exterior flanges of the vertical mullions to allow removal of the louvers from the exterior of the building. Once the flanges were trimmed, the louvers could be disconnected from the interior duct-work and removed. The design documents included an alternate to replace the louvers with new high-performance louvers.

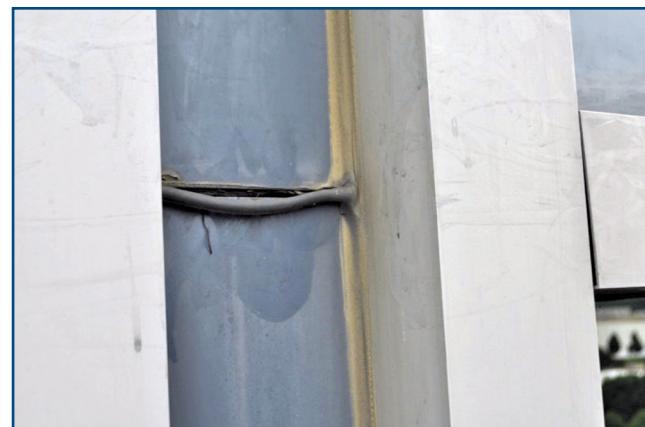
Photo 9 – Failed sealant joint at decorative metal cladding joint.
