Building Material Problems Caused by Condensation at an Enclosed Swimming Pool and an Enclosed Ice Rink

Martha G. VanGeem, P.E.
Member ASHRAE

Kami Farahmandpour, P.E.

John Gajda, P.E.

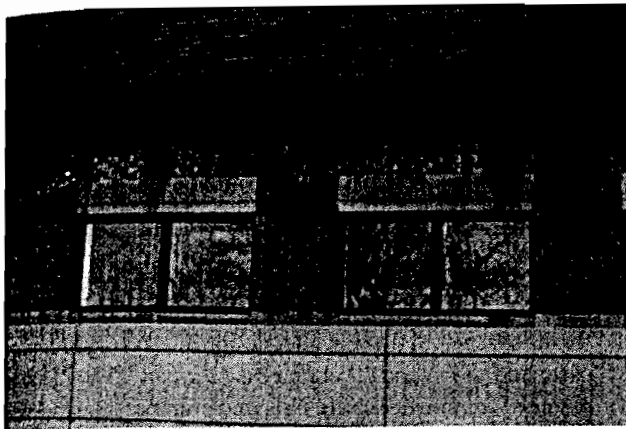
Laboratory testing of the brown-stained water samples taken at pool area roof eaves indicated that the source of the brown-colored material was the OSB of the ventilated deck boards.

Figure 1 Stains on brick masonry below pool area roof eaves.

Visual review of the building exterior confirmed the presence of several brown stains on the brick masonry immediately below the pool area roof eaves (Figure 1). These stains were not limited to the areas below the skylights and appeared uniformly distributed. It appears that the staining was caused by condensed water that formed on the outside surfaces of the ventilated deck boards. This condensed water would dissolve brown, water-soluble compounds within the OSB and would flow down the roof deck, discharging at the eaves.

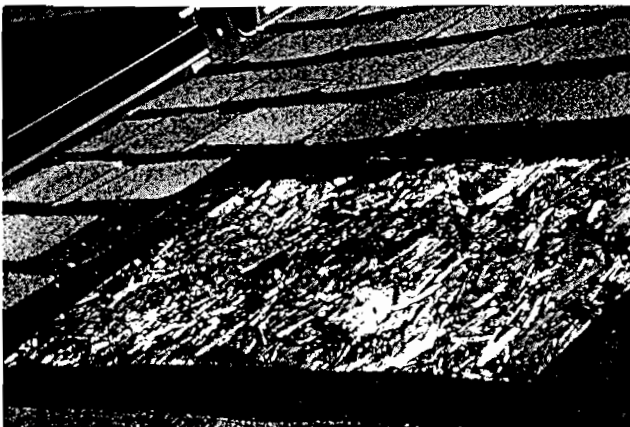
Observations within exploratory openings into the exterior roof surface revealed water damage to the OSB boards in all cases. The water damage was accompanied with mildew in areas adjacent to the skylight (Figure 2). This condition was attributed to the presence of the ice and water protection membrane placed over the outer OSB board in those areas. The presence of this relatively impermeable layer slowed the

Figure 2 Mildew on OSB board in roof areas adjacent to the skylight.

evaporation of the condensate from the OSB boards and promoted mildew growth. In all exposed areas, the damage caused by the condensation was severe enough to adversely affect the physical characteristics of the OSB boards.

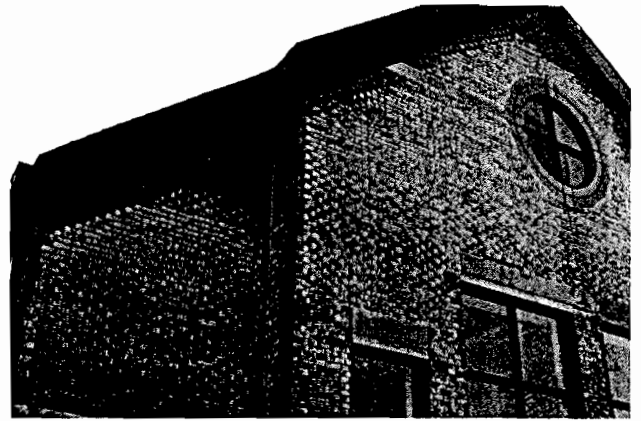
Figure 3 Efflorescence on exterior masonry surface.

Severe efflorescence was observed on exterior masonry surfaces at the north wall (Figure 3). Efflorescence was also observed on the east and west walls of the pool area, as well as the fireplace chimney on the east elevation. The fireplace was located in a lounge area adjacent to the pool area.

The efflorescence observed on the exterior masonry was also attributed to lack of a vapor retarder. In the absence of an effective vapor retarder, warm, humid air from the pool area penetrated the porous plaster finishes, CMU, and rigid insulation. As it reached the colder surfaces of the exterior brick, it condensed. This condensed moisture was continuously driven toward the outside by higher water vapor pressure on the inside. As it passed through the porous mortar, it dissolved water-soluble salts such as calcium carbonate and brought these salts to the outside surfaces of the brick. Eventual evaporation of the moisture left these salts on the masonry surface in the form of the observed efflorescence.
