# **Failure Mechanisms in Liquid-Applied Waterproofing Systems**

Kami Farahmandpour, PE, RRC, CCA, CCCA

### **Case History: Cincinnati Museum Center Plaza Fountain**

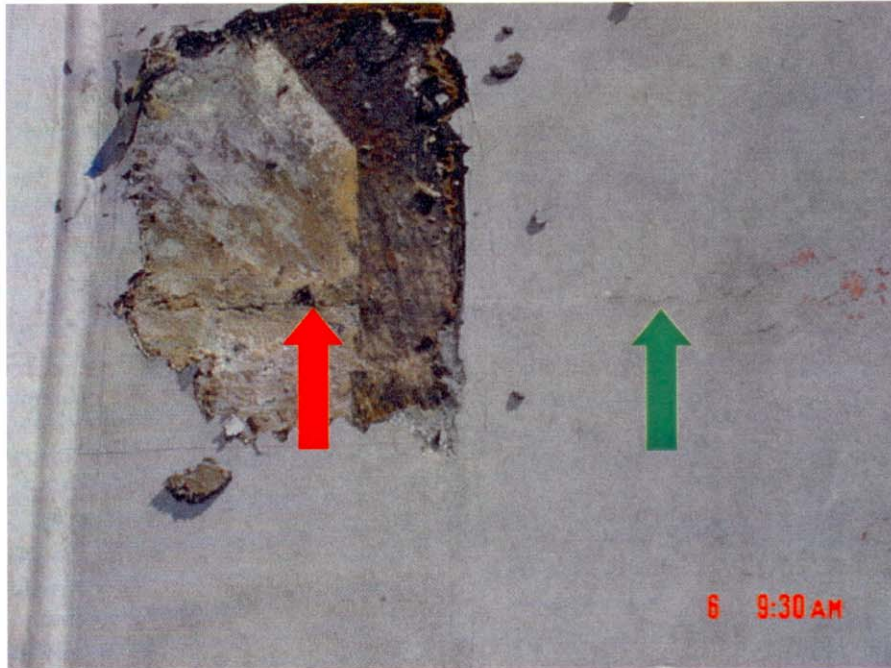
LAMs depend on substrate integrity to perform properly. Although in some cases the membranes are reinforced with some type of fabric/scrim reinforcement, most LAMs are applied directly over a substrate without the use of reinforcing fabric/skrims. Reinforcing fabric/skrims can help distribute crack movements over a wider area. This will help reduce stresses on the membrane over the crack region. However, when reinforcing fabrics/skrims are not present, crack movements will typically cause high stress concentrations on the membrane over the crack, resulting in localized tearing of the membrane (Figure 1). This phenomenon is called crack reflection.

Figure 1 – Crack (tear) in a reinforced liquid-applied membrane (left arrow) coincides with substrate crack (right arrow).

In the author's opinion, better guidelines for application of LAMs over substrate cracks should also be developed. At a minimum, routing and sealing of cracks that are greater than 0.05 inches (1.27 mm) wide should be required. Narrower cracks may also have to be repaired in a similar manner. Regardless of the width of a crack, all moving cracks should be treated carefully to provide for distribution of stresses over the crack.

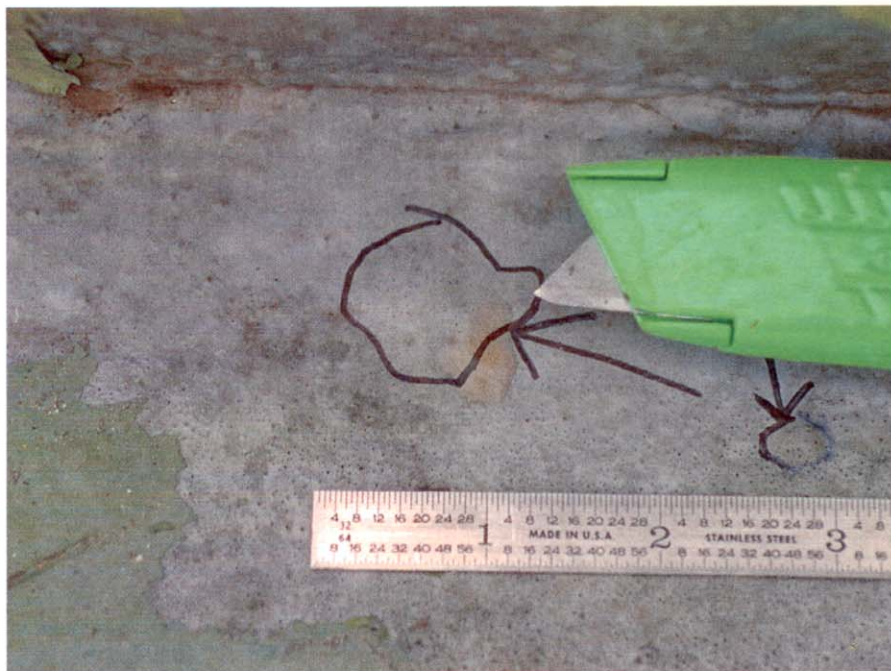
When a LAM is applied to the surface of concrete, it acts as a vapor retarder at the concrete surface, preventing evaporation or moisture emission. Water vapor moving to the surface of the membrane cannot escape, thus causing a buildup of water vapor pressure between the membrane and concrete surface. This phenomenon can occur within minutes of applying a LAM to a concrete surface. Because most LAMs are chemically cured and require several hours to cure and establish bond to substrates, buildup of water vapor pressure shortly after application can inhibit development of a proper bond between the membrane and concrete substrate. Zones of weakened bond can manifest quickly as blisters filled with water and can ultimately cause failure of the membrane (Figures 2 and 3).

Figure 2 – Water-filled blister in a liquid-applied membrane.

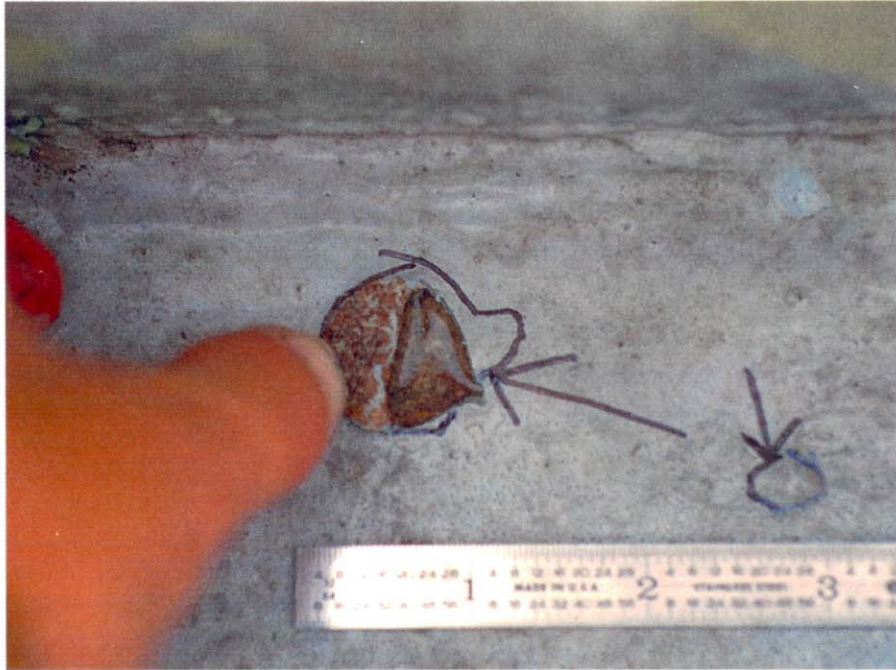
Figure 3 – Water entrapped in the blister shown in Figure 2.

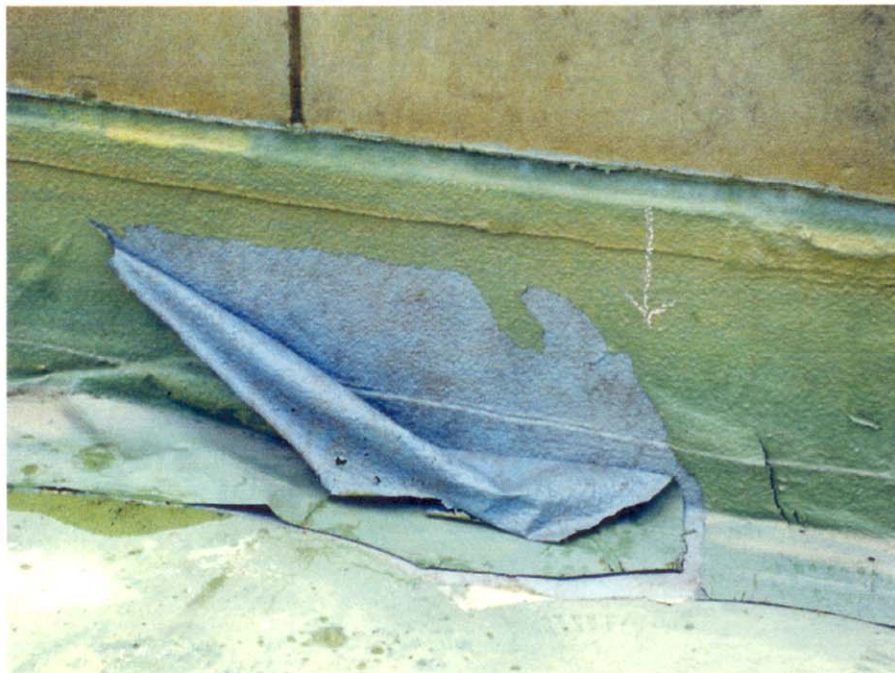
The waterproofing membrane had debonded (separated from the substrate) and delaminated (separated from its underlying layers) in many areas of the fountain (Figures 6 and 7). Large sheets of membrane and color coat peeled away easily in some areas. In general, second and third applications of the membrane (previous repairs) were poorly bonded and could be separated readily. In a few cases, individual layers of the first application of membrane and color coat exhibited interlayer delamination. In most cases, the primer (identified by its red color) appeared to be well-adhered to the concrete.

Figure 6 – Large interlayer delaminations of the membrane.

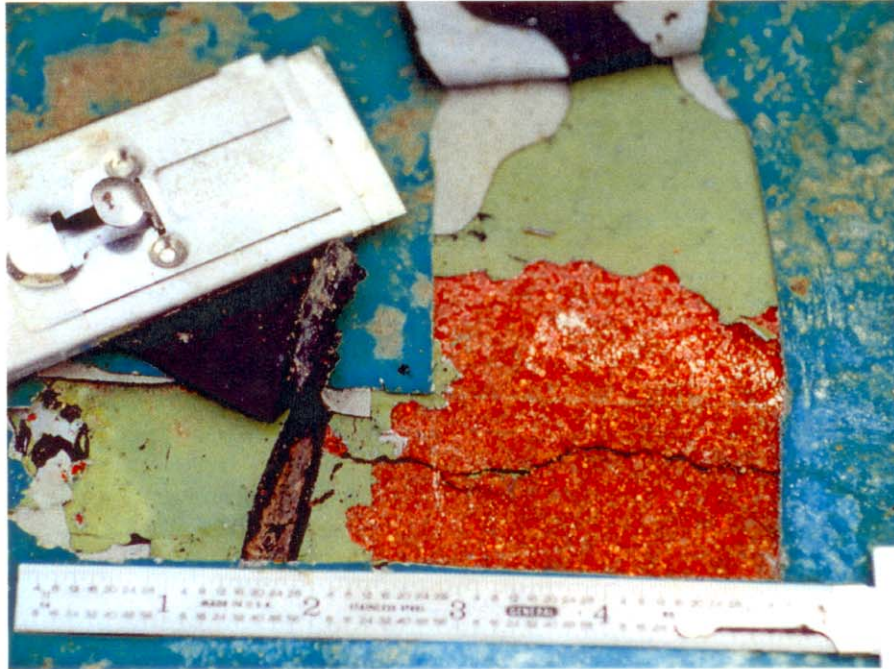
Figure 7 – Interlayer membrane delaminations at various interfaces. Note the substrate crack reflecting through the first light green application of the membrane.

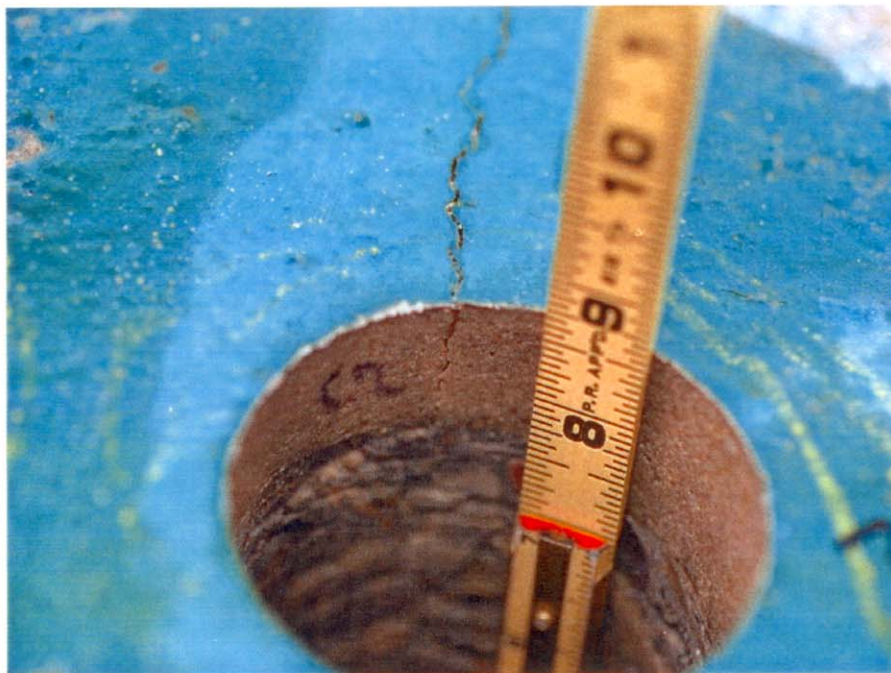
In several areas, cracking of the substrate concrete had reflected through the membrane directly over the crack (Figure 8).

Cracks observed within the membrane lined up with cracks in the substrate. These cracks were attributed to deterioration of repair patches, as well as cracking and deterioration of the original concrete within the fountain. Because the original fountain concrete was not air-entrained and did not have a topside waterproofing membrane for many years, it was susceptible to freeze-thaw deterioration. Also, a drainage layer was not provided at the level of the lead pan. Therefore, water penetrated and saturated the concrete above the lead pan. During winter months, the trapped water froze and cracked the saturated concrete. This deterioration likely began shortly after construction and has continued through the life of the fountain.

Figure 8 – Substrate crack reflecting through the membrane.

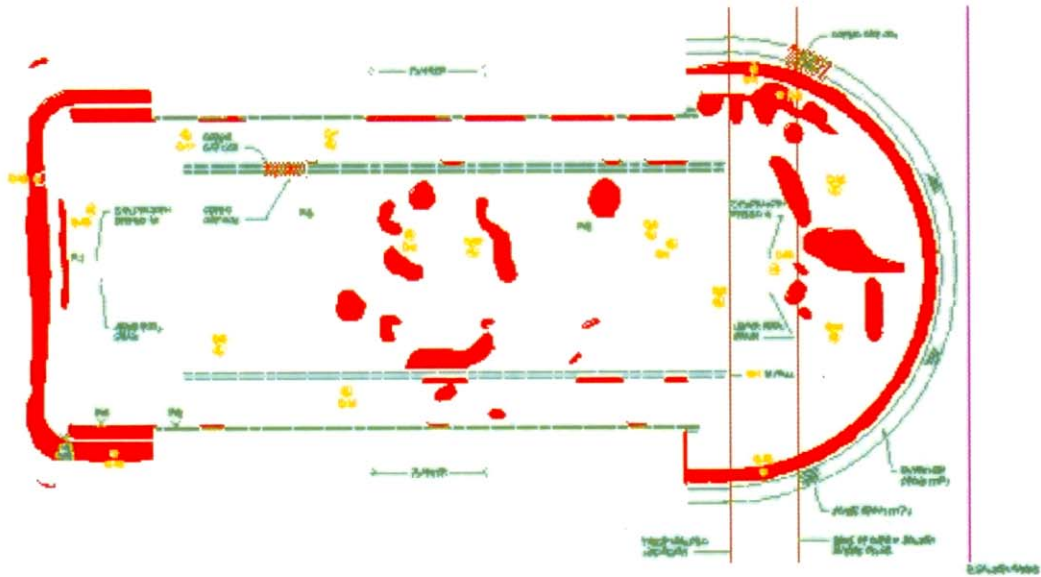
Approximately 10 percent of the fountain surfaces exhibited sub-surface delaminations when sounded with a hammer (Figure 9). The delaminations were primarily in areas where previous repairs were performed using an epoxy repair mortar. Core sampling at these locations showed that the epoxy repair material had debonded from the substrate concrete.

Figure 9 – Delamination survey results. Red areas indicate delaminations detected by sounding.

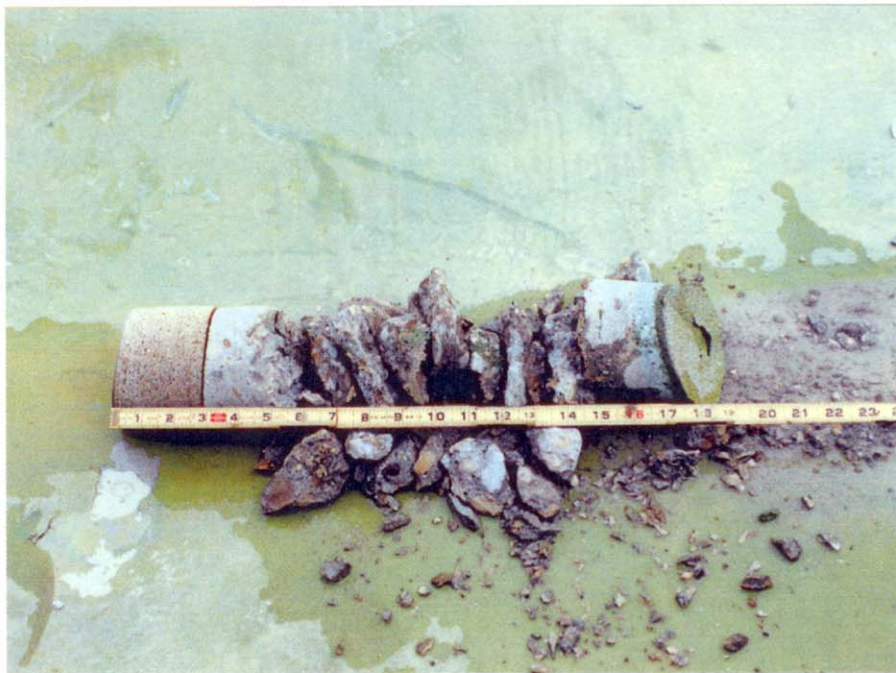
Examination of cores during sampling indicated widespread delaminations deep within the fountain concrete. Most of these areas containing deep delaminations were not detectable by hammer sounding (Figure 10).

In addition to the surface delaminations, many cores exhibited extensive cracking and delaminations deep within the fountain concrete. Core samples removed from areas where hammer sounding did not detect surface delaminations indicated that deep delaminations and cracking were widespread throughout the fountain.

In general, the epoxy repair mortar had delaminated from the cementitious substrate. The majority of the deterioration and cracking was found in the original concrete layer. The original concrete was not air-entrained. Therefore, it is susceptible to freeze-thaw damage when saturated with water. Extensive sub-parallel cracking, typical of freeze-thaw damage, was present in the original concrete

Figure 10 – Core retrieved from a wall section revealed extensive delaminations in the center portion of the wall. The outer layers do not exhibit delamination.

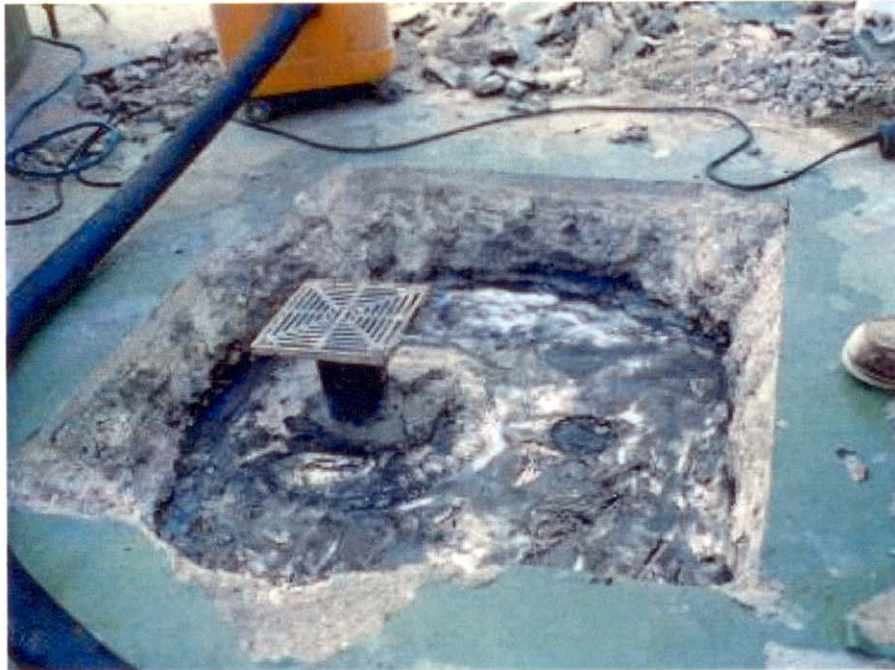
At the lower exploratory opening (Figure 11), water was observed running into the opening at the level of the lead pan, indicating water had migrated to and was ponding on the lead pan. Water continued to enter the exploratory opening for the duration of the field investigation. The drain within the exploratory opening did not appear to be original. The existing 3-inch (75-mm) drain line was placed in an 8-inch (400 mm) diameter hole in the structural slab, presumably from the previous drain line. Backer rod was placed in the annular space between the 3-inch (75 mm) drain line and the concrete, and approximately 1 inch (25 mm) of grout was poured on top of the backer rod. The lead pan overlapped the original drain flange (still in place) but was not attached to the new drain. Therefore, the waterproofing system was not continuous and did not protect the structural slab around the drain.

A portion of the lead pan and bituminous waterproofing membrane was removed. The surface of the underlying structural deck was damp. A partial-depth concrete core (taken from Exploratory Opening No. 1 to evaluate the condition of the structural slab) indicated severe cracking and delamination.

Figure 11 – Overall view of Opening 1 showing the original lead pan and a retrofit drain.

Based on the findings of this investigation, it was concluded that the only viable, long-term solution for rehabilitation of the fountain was a complete reconstruction of the fountain above the lead pan. It was recommended that the lead pan be left in place and repaired as a redundant waterproofing membrane.

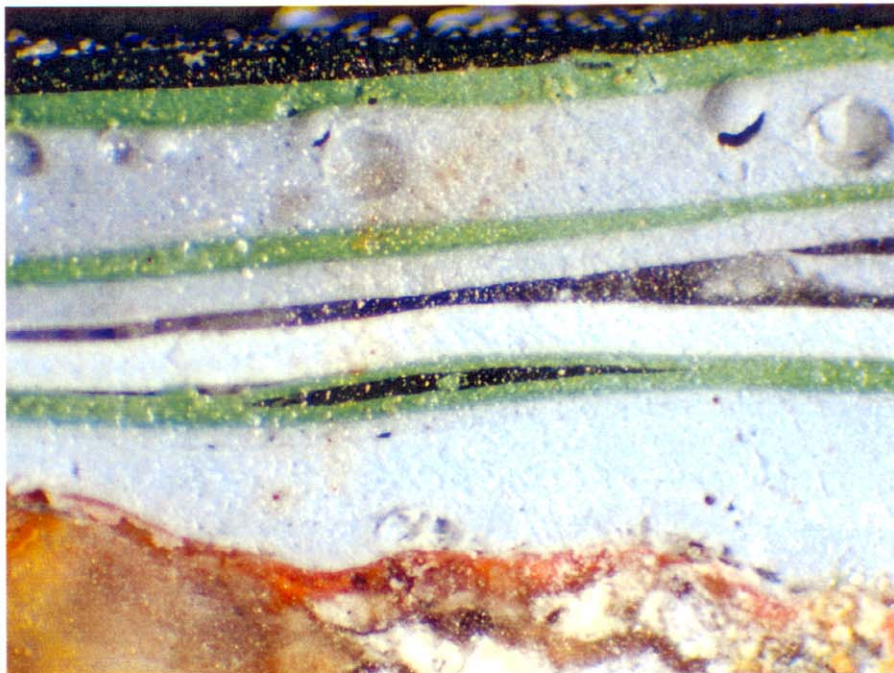
Microscopic examination of samples obtained in the field indicated the first application of the waterproofing membrane consisted of a red primer applied directly to the concrete/repair mortar substrate, followed by multiple coats of a light gray membrane and topped with multiple coats of a green color coat. In some areas, the membrane contained embedded aggregate up to 52 mils (1.321 mm) in diameter while the membrane did not contain any aggregate in other areas. The first application of the waterproofing membrane thickness was highly variable. Primer thickness ranged from 1 mil to 5 mils (0.025 mm to 0.127 mm). Membrane thickness ranged from 1 mil to 57 mils (0.025 mm to 1.448 mm), and color coat thickness ranged from 1 mil to 20 mils (0.025 mm to 0.508 mm). The coating system on sidewalls and sloped surfaces typically was thinner. Figures 12 through 14 depict various membrane configurations that were observed.

Reapplication of the membrane had failed in numerous areas, primarily because of lack of proper bond between the first membrane application and subsequent applications. Bond failure was typically caused by inadequate surface preparation techniques. The lack of interlayer bond provided voids that collected water and created blisters. The water collecting in these voids penetrated through pinholes and other deficiencies in the membrane.

Figure 12 – Photomicrograph of the membrane in an area with three membrane applications. Note interlayer delaminations at various layers.
