“L”-evating Concrete Façade Restoration to a New Level: A Case Study with Access Challenges

by Christopher Kottra

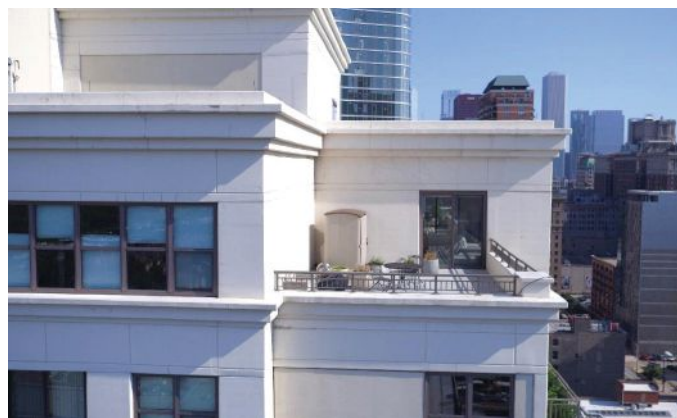
Fig. 4: Drone photo

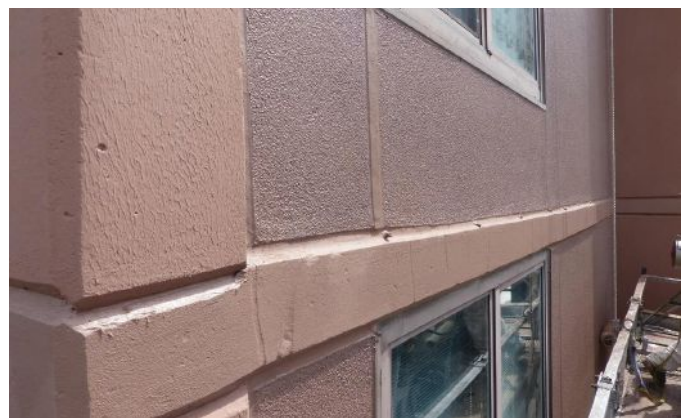
Fig. 5: DEFS crack repair and elastomeric coating; Concrete coating

1. Localized partial depth concrete repairs;
2. Acrylic protective coating application on vertical concrete surfaces and undersides of balcony slabs;
3. Elastomeric membrane system application on skyward facing concrete surfaces;
4. Crack repairs in DEFS panels with pre-formed silicone strips;
5. Elastomeric coating application on DEFS panels (Fig. 5);
6. Traffic-bearing membrane system application on balconies; and
7. Localized replacement of window perimeter sealant, glazing sealant, and sealant at joints between dissimilar materials (i.e., between concrete and DEFS panels).

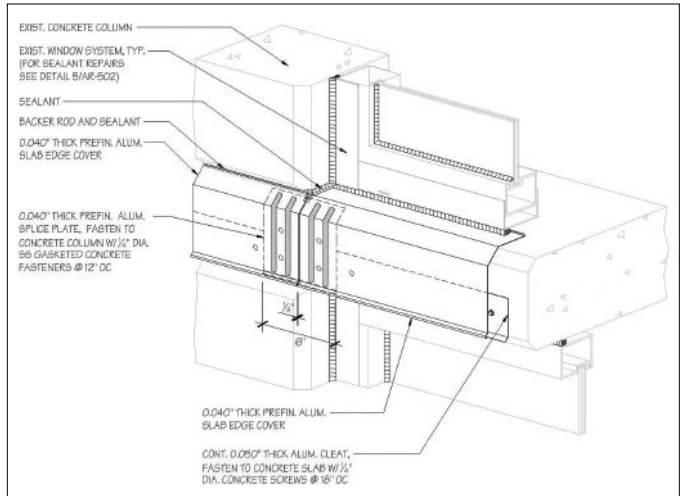
Fig. 6.: Slab edge cover detail

To evaluate good, better, and best repair options, alternatives for applying an elastomeric coating or installing sheet metal slab edge covers over exposed slab edges were included in the scope of work for each elevation. Considering aesthetics, durability, anticipated future maintenance, life cycle costs, and other factors, the association’s Board of Directors selected an upgrade to an elastomeric coating at exposed slab edges on the north, south, and west elevations. Sheet metal slab edge covers were selected for the east elevation (Fig. 6 and 7). Although the initial cost of the slab edge covers was significantly higher than the other options, limiting future access costs over the “L” tracks made the investment worthwhile. The Board also elected to replace 100 percent of the window perimeter sealant on the east elevation to proactively lower future access costs.

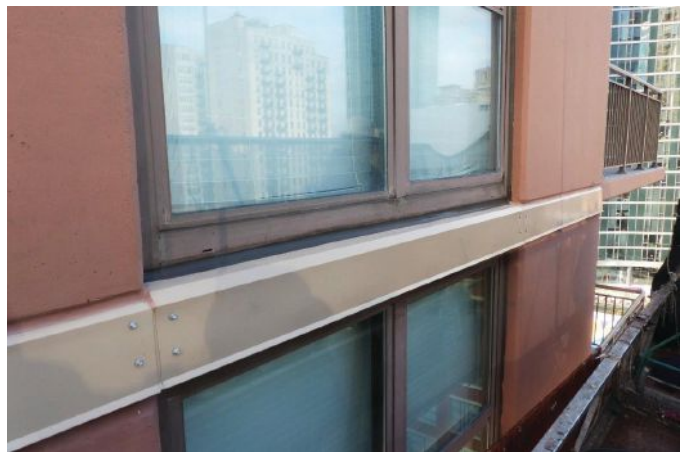
Fig. 7: Slab edge cover at east elevation

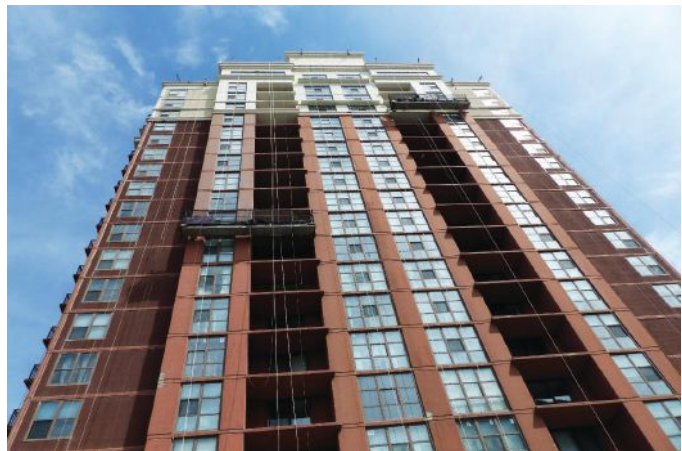
Fig. 8: Swing-stage work on south elevation

Construction began in spring 2018. The contractor started with the south elevation to meet the association’s requirements to reopen an adjacent common pool area for the summer months (Fig. 8). Work progressed to the west and parts of the north elevation after completion of the south. The contractor saved the east elevation until after the west elevation and west side of the north elevation were complete. This was done intentionally to help ensure efficient completion of the work, and to give more notice to CTA in the hope of getting their full cooperation when needed. The contractor also created a built-in back-up plan by starting the east elevation prior to completing the north elevation or starting work on the penthouse walls. The contractor worked on other drops and penthouse walls during early mornings and late afternoons when work was not permitted on the east elevation to maximize efficiency. This flexibility proved invaluable for the contractor due to the daily uncertainty of working on the east elevation. The consulting engineer also had to be flexible and available
