Project Name:
East Elevation Louver Repairs

Project Location:
*474 North Lake Shore Drive
Chicago, Illinois*

Nature of Services:
*Precast Concrete Louver Repair Design,
Bidding Assistance, and Construction
Phase Services*

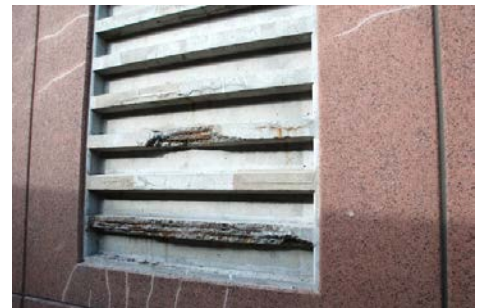
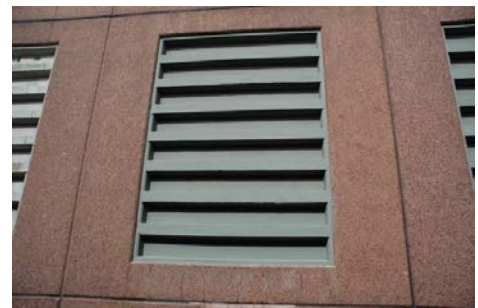
Significant deterioration of the east elevation concrete louvers was noted during a critical examination performed by BTC in 2008. Much of the observed deterioration was attributed to direct exposure to salt spray from heavily traveled Lake Shore Drive within 20 feet from the east elevation of the building. BTC was retained to design repairs for the deteriorated concrete.

A typical louver repair included removal of loose material down to sound concrete, cleaning and painting existing reinforcing steel, installing supplemental reinforcing steel where needed, installation of a new concrete patch material, and application of an acrylic waterproofing sealer. Other repairs included routing and sealing cracks, patch repairs of the exposed aggregate precast panels, and application of a clear water repellent at the first 15 floors of precast panels.
