Project Name:
*Balcony and Facade Repairs
One East 15th Place Condominiums*

Project Location:
*One East 15th Place
Chicago, Illinois*

Nature of Services:
*Forensic Investigation of Concrete
Balcony Failure, Repair Design, Bidding
Assistance, Construction Phase Services*

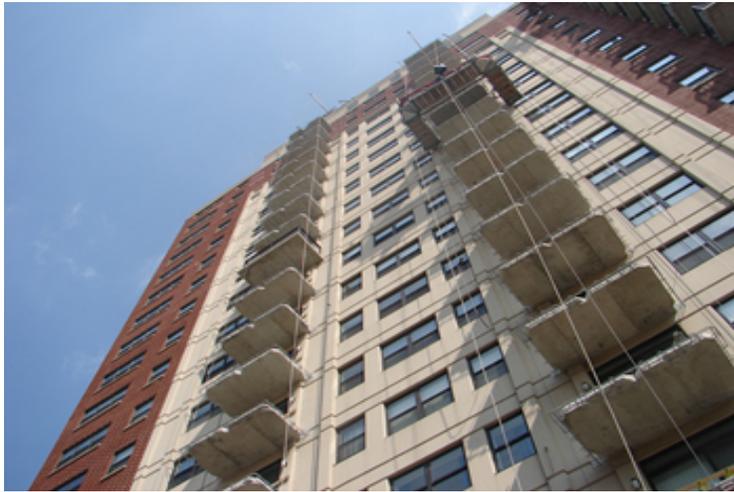
A few years after its original construction, a corner section of a balcony slab spalled prompting concerns regarding the structural integrity of the balcony slabs. BTC was retained to investigate the cause of the premature failure, and sporadic water leakage issues. The investigation indicated that the balcony guardrail post pocket filler had expanded in many locations due to exposure to moisture, and caused cracking and spalling of the surrounding concrete. The investigation also revealed several other deficiencies including early indications of freeze-thaw deterioration in balcony slab edges due to lack of proper air entrainment in the concrete, widespread cracking of masonry adjacent to balconies, deficiencies in the EIFS, splitting of balcony guardrail posts due to water infiltration, and cracking of concrete shear walls that allowed water infiltration.

BTC designed repairs to address the deficiencies. As part of the repairs, all balcony guardrail posts and slab edges were repaired. BTC's repair details allowed the retrofit of the existing guardrails. Replacement of the guardrails was only needed where the posts had split.
