Project Name:
*Facade Glazing Repairs
The Moorings of Arlington Heights*

Project Location:
Arlington Heights, Illinois

Client:
*Presbyterian Homes
Evanston, Illinois*

Nature of Services:
*Evaluation, Repair Design, and
Construction Phase Services*

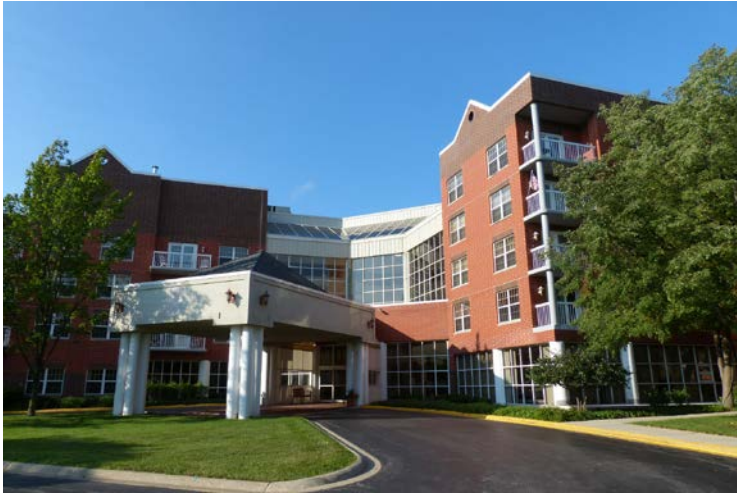
The Moorings of Arlington Heights is a retirement community that includes a 5-story concrete-framed building, clad in brick masonry. The 5-story lobby atrium is enclosed by vertical and sloped glazing systems. Water leakage through the vertical glazing system had been an ongoing problem for many years, despite several attempts to address the leaks.

Evaluation of the water leakage included a visual review, water testing, and partial dismantling of the glazing systems. This evaluation indicated that the cause of water leakage was due to the lack of a suitable water management system within the vertical glazing system; primarily lack of end dams, weep holes, and water diverters within the glazing pockets, and lack of through-wall flashing at the base of the glazing system. Long-term deterioration of exterior gaskets exacerbated the water leakage problems by allowing significant water penetration into the glazing pockets.

A comprehensive long-term rehabilitation option was selected to address the water leakage. This option included installation of end dams and weep holes within the glazing pocket of each lite within the system, replacing insulated glass units, replacing interior and exterior gaskets, and installing a back dam and liquid-applied through-wall flashing at the base of the glazing system.
