**Project Name:**  
*Exterior Wall Collapse Investigation  
Willow Glen Manor Condominiums*

**Project Location:**  
*Wheeling, Illinois*

**Nature of Services:**  
*Forensic Investigation*

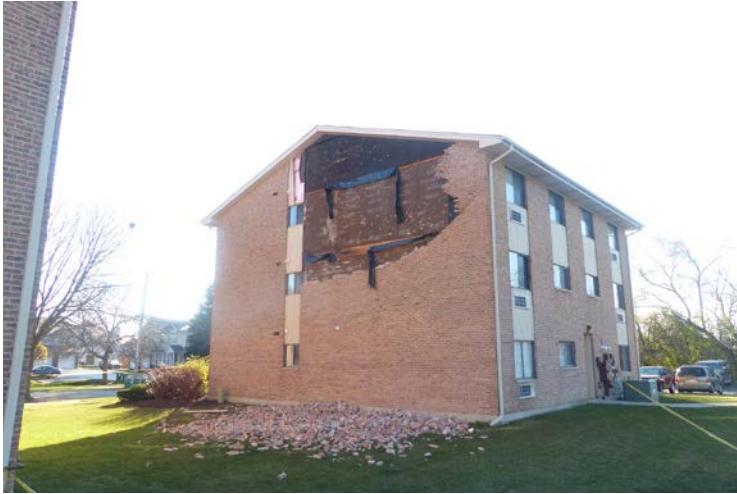
During a high wind event, a portion of the exterior wall on one of the buildings collapsed. The maximum wind gust reported in the area on the day of the collapse was approximately 48 miles per hour.

BTC's field investigation indicated that the collapse likely started at the peak of the gable wall immediately adjacent to the vertical strip of windows and siding panels, due to the discontinuity in the masonry at this location. However, the cause of the collapse was corrosion of the corrugated metal wall ties. Significant corrosion of the embedded portions of the ties was observed. Ties observable within the remaining portions of the wall were corroded through their entire thickness. It is likely the ties within the collapsed portion of the wall also had corroded to this extent prior to the collapse. As such, these ties would have provided no resistance to wall movement.

A borescope review indicated that the corrugated metal ties on the remaining buildings also were significantly corroded. Based on the findings, BTC recommended that the walls be stabilized in place or rebuilt to address the potential for future wall collapses.
