*Evaluation of Plaza, Elevated Walkways and, Parking Garage
Gatlinburg Town Square*

*414 Historic Nature Trail
Gatlinburg, Tennessee*

*Condition Evaluation of Plaza, Elevated Walkways, and Parking Garage,
Assessment of Leakage Sources,
Conceptual Repair Recommendations*

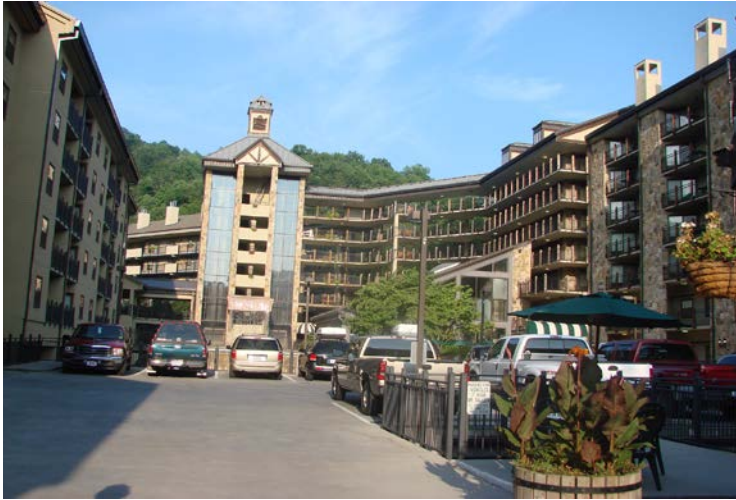
Our evaluation revealed significant deterioration in the concrete components of the garage and elevated walkways. The deterioration of garage components were primarily due to water leakage through the plaza waterproofing system. Lack of concrete protection had resulted in localized deterioration of the elevated walkways.
