The Reroofing of an Iconic Structure in Memphis

Employing Technology to Develop a Suitable Solution

By Charles Sietmann, RRO, REWO, CCCA, CIT, and Kami Farahmandpour, F-IIBEC, REWC, RRC, RWC, RBEC, PE, CCS, CCCA

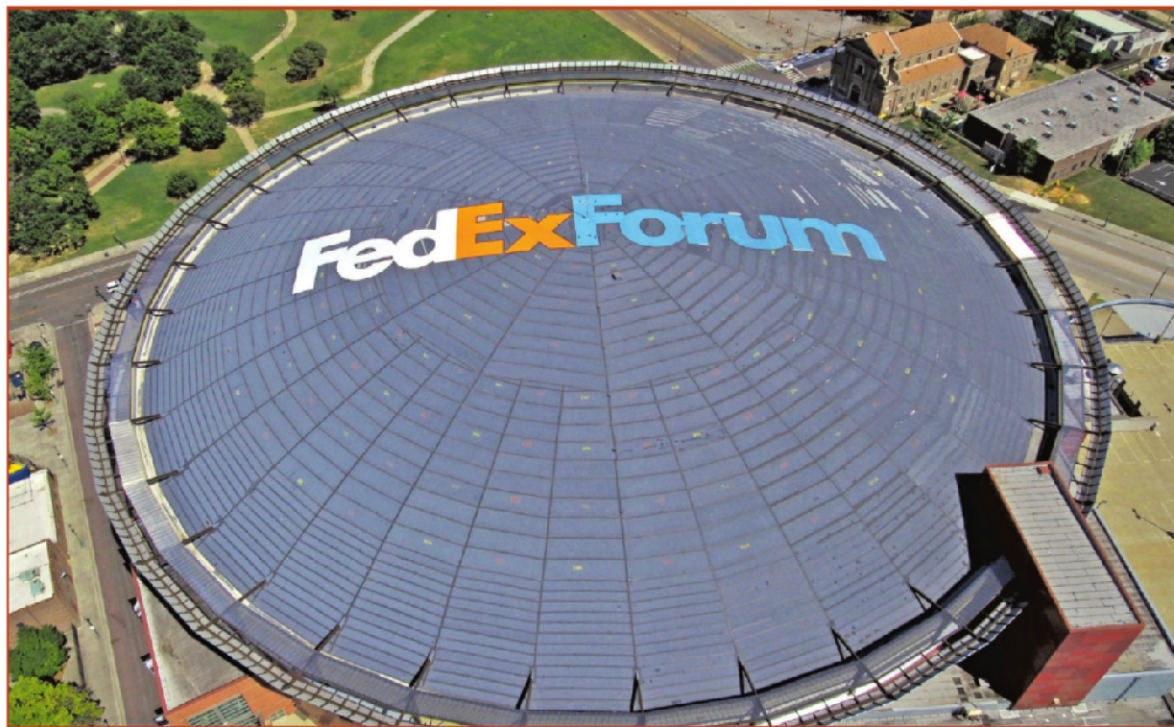
The dome structure consists of a steel frame with 36 perimeter columns and trusses, each forming a 10-degree sector of the dome (Fig. 2). The original roofing assembly of the dome consisted of a 20-gauge steel deck supported by the steel framing, two layers of rigid insulation panels, and a single-ply 45-mil-thick TPO roof membrane. A building wrap, apparently serving as an air barrier, had also been incorporated into the roofing system between the upper and lower layers of rigid insulation.

Figure 2. Overall aerial image of existing dome roof showing the roof sections.

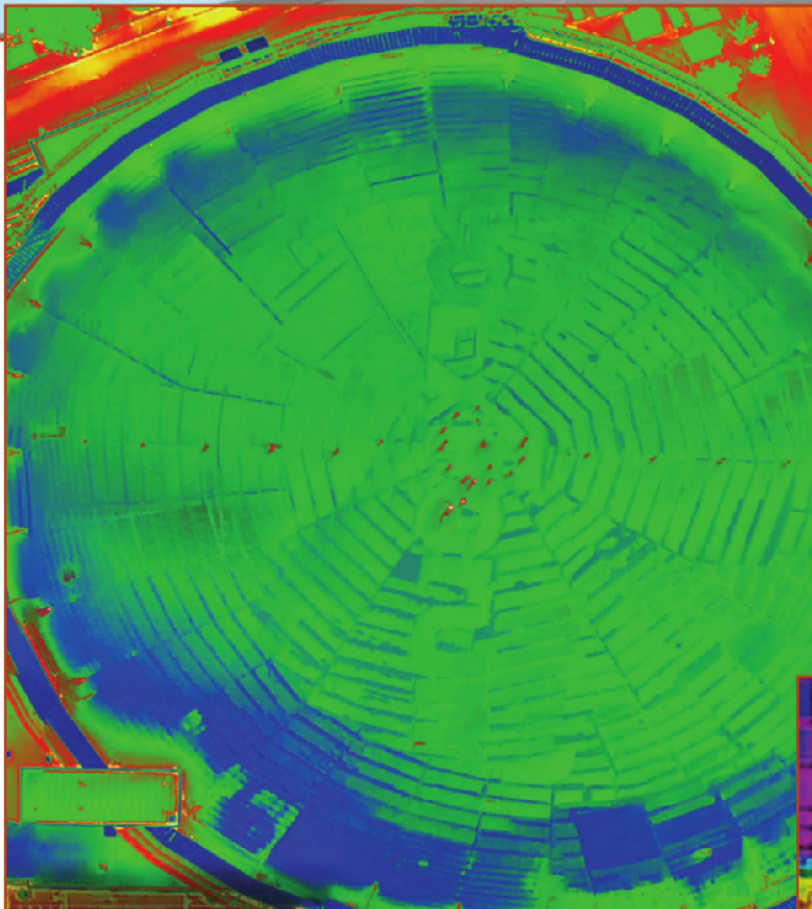
The visual review was supplemented with an aerial review and infrared thermographic survey performed using a UAS equipped with a gimbal-mounted remote thermal imager (Fig. 3). Several areas of the dome roof along the perimeter exhibited thermal anomalies (Fig. 4 and 5). Some of the thermal anomaly locations coincided with areas that had been previously repaired. Other thermographic anomalies correlated with the extent of craze cracking of the roof membrane. These observations of thermal anomalies indicated that moisture intrusion through craze cracking, and through the resulting tears, had saturated the lower areas of the roof. Similar craze

Figure 4. Stitched overall thermal image. Colors between blue and red typically indicate varying degrees of moisture within the substrate, with blue being colder areas, and red being warmer areas. Note the brighter green areas along the lower perimeter of the dome; these represent lower surface temperatures and were primarily areas of suspected saturated insulation.

cracking was also observed at the upper areas of the dome. However, our infrared thermographic survey did not indicate presence of moisture accumulation on the upper dome areas. This finding was attributed to two factors: (1) as water runs down the dome, the lower areas are exposed to more water, causing more water penetration through the roof membrane deficiencies; and (2) water that penetrated through the roof membrane also runs down the dome through the insulation joints, accumulating in the lower areas. Based on these observations, it was concluded that areas where water penetrated the roof membrane on the upper dome evaporated through the moisture-permeable air barrier. However, the rate of wetting and moisture accumulation at the lower dome areas exceeded the evaporation rate.

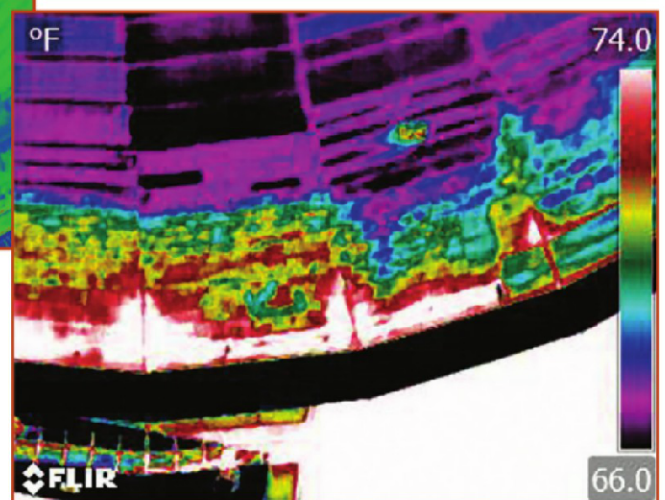
Figure 5. Close-up thermal image at the lower roof. Note thermal anomalies along the lower perimeter of the dome.

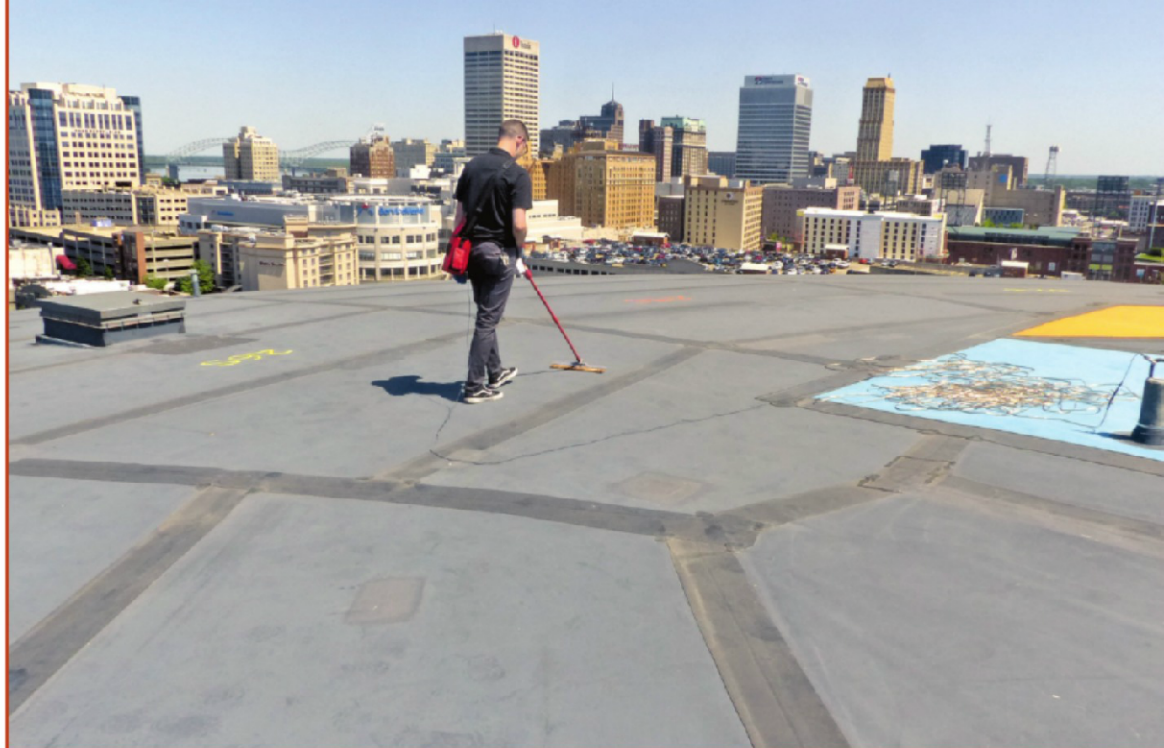
Nondestructive electronic leak detection was performed over most of the dome roof (Fig. 6). The testing was performed in gener-

Figure 6. High-voltage electronic leak detection testing being performed.

age leak detection testing identified numerous membrane breaches in the test areas. The breaches were recorded and roughly correlated with the extent of thermal anomalies detected through the infrared thermographic survey.

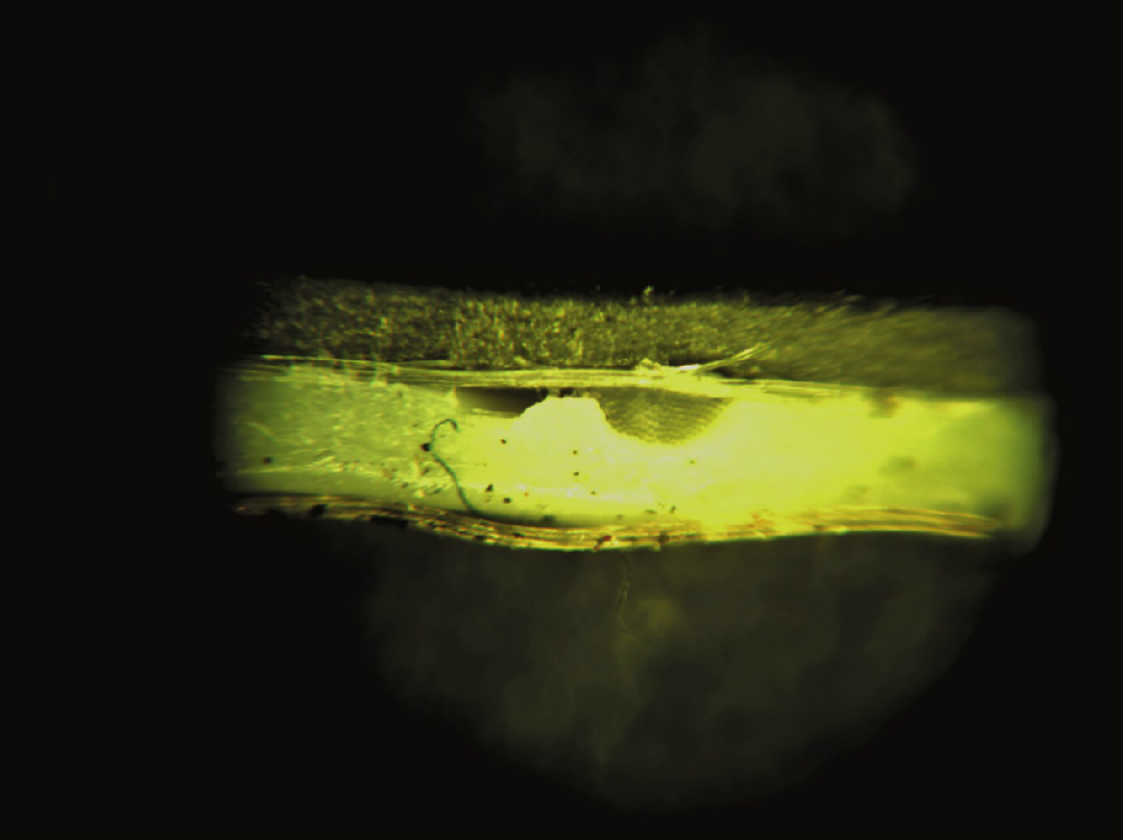
Figure 7. Microscopic examination of existing membrane. Note the void adjacent to reinforcement.

sample, three cross sections of the roof membrane were cut and examined under a variable magnification digital microscope. The investigators used their in-house equipment to evaluate the depth and potential cause(s) of the observed membrane crazing. Sections cut away from the apparent tears and crazing in the membrane indicated that the craze cracking had extended to the reinforcing scrim, and that there was a thinner TPO top coating than TPO bottom coating (Fig. 7). In one section, nearly the entire top TPO coating had been diminished. This condition was likely due to exposure to elements over the years that reduced the top coating thickness. In addition, in several examined sections, voids were observed near the reinforcing scrim; these were likely due to the original manufacturing process.

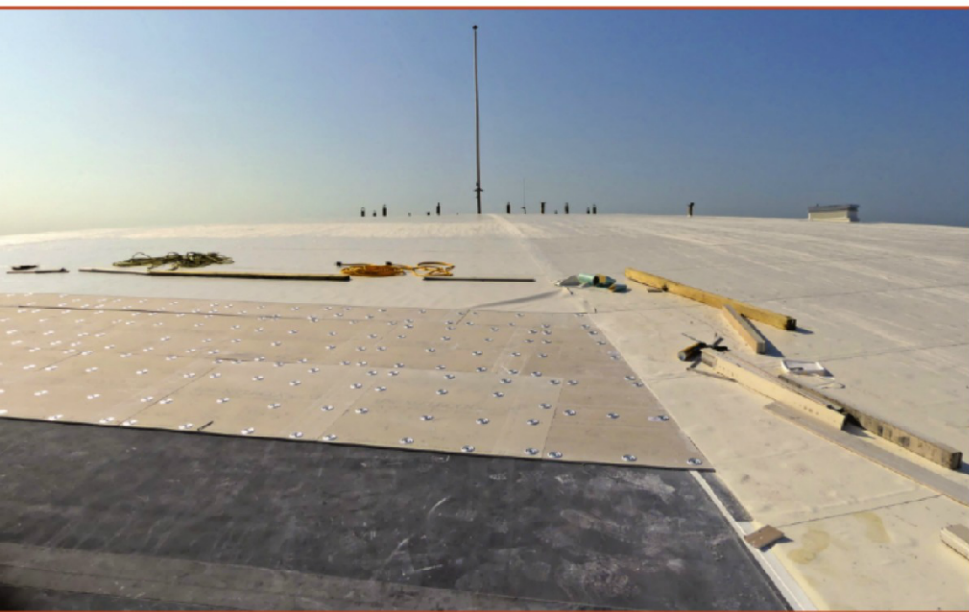
Figure 9. Roof re-cover in progress at the upper dome.

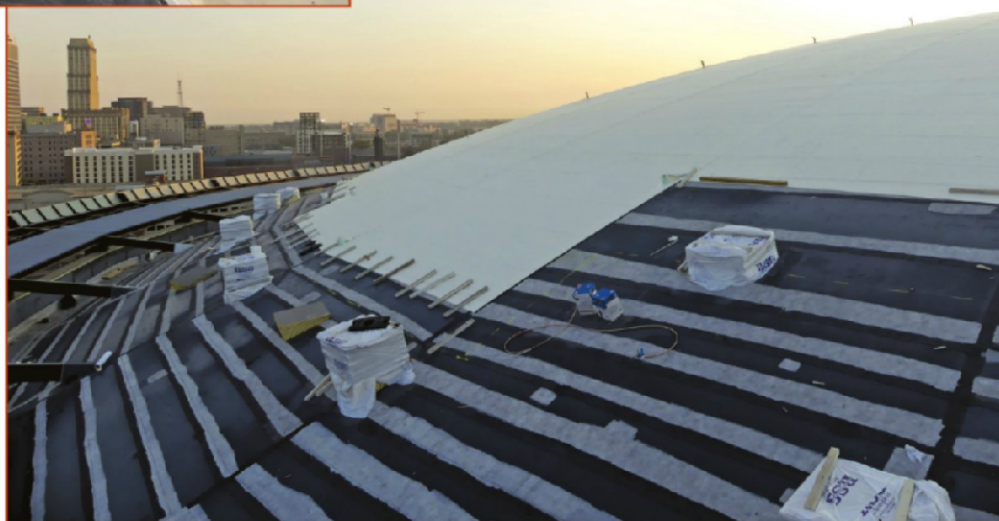
Figure 10. Roof re-cover in progress at the upper dome.

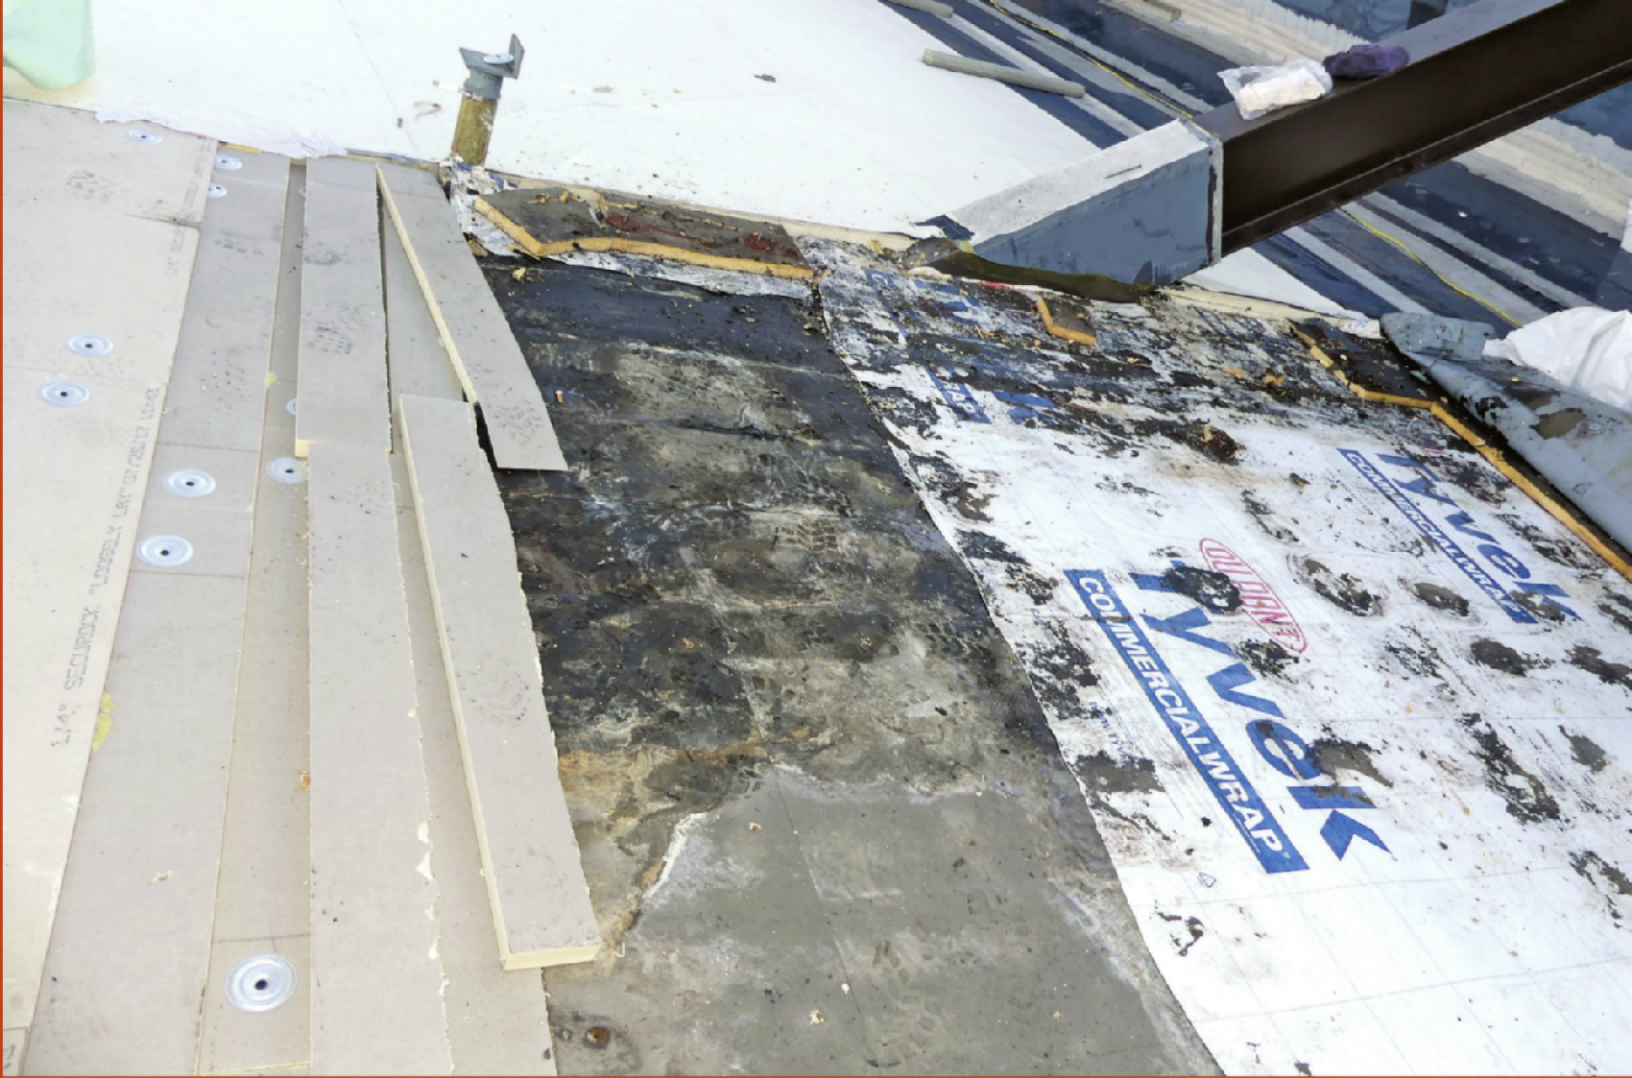
Figure 11. Tear-off in progress at lower dome. Note the signs of moisture on the existing insulation.

The areas designated for full replacement were reviewed during tear-off and appeared to correlate with the extents of the thermal anomalies observed during the evaluation phase's infrared survey (Fig. 11). No changes in the
