EVALUATION TECHNIQUES FOR

CONCRETE BUILDING ENVELOPE COMPONENTS

By Kami Farahmandpour, Victoria A. Jennings, Terry J. Willems, and Allen G. Davis

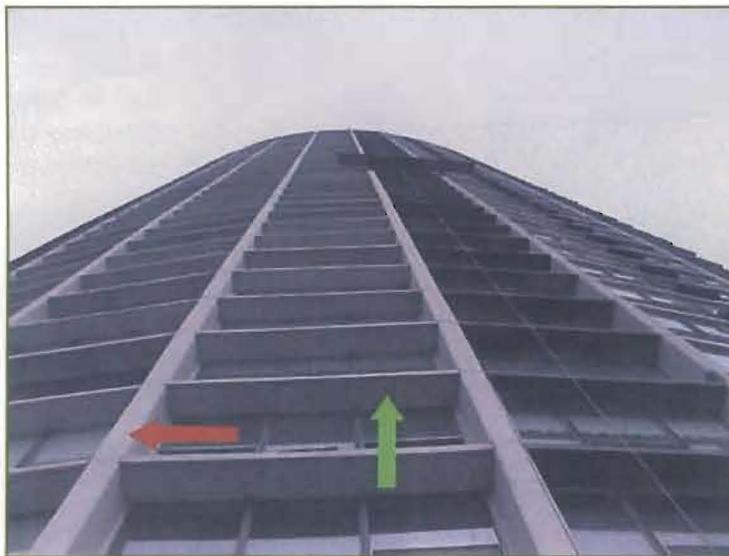
Photo 1 – High-rise building with exposed cast-in-place concrete columns (red arrow) and slab extensions (green arrow).

Building facades constructed of exposed concrete framing elements and infill windows are common for many high-rise residential, hotel, and institutional buildings (*Photo 1*). This results in economical construction and allows for free expression of the building structure.

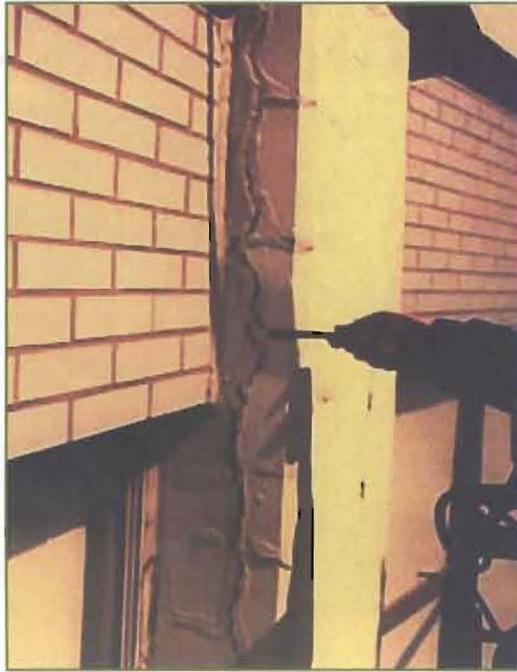
Photo 3 – Indications of extensive reinforcing-steel corrosion on a high-rise building exterior column.

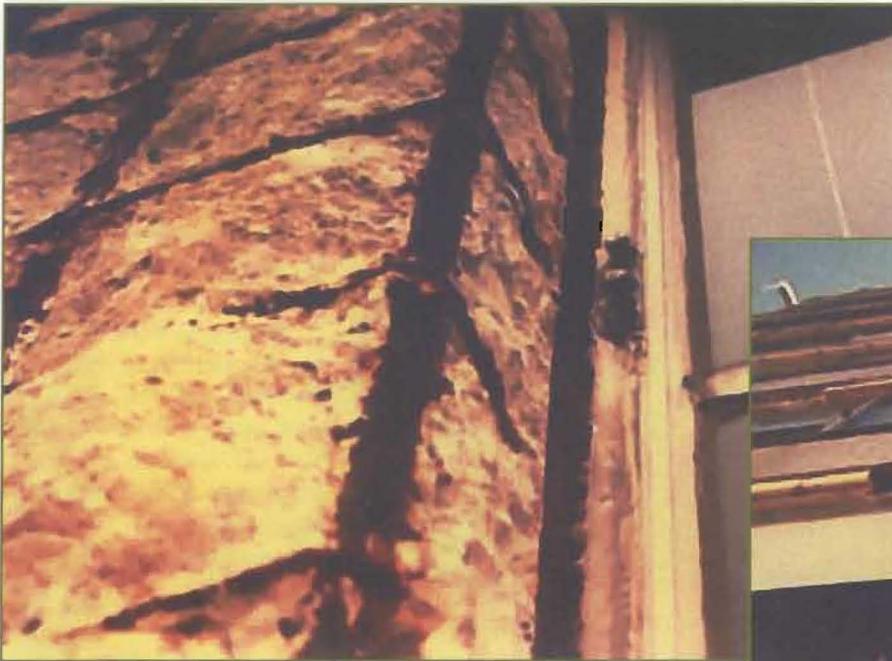
Photo 4 – Same column shown in Photo 3 after removal of the delaminated concrete.

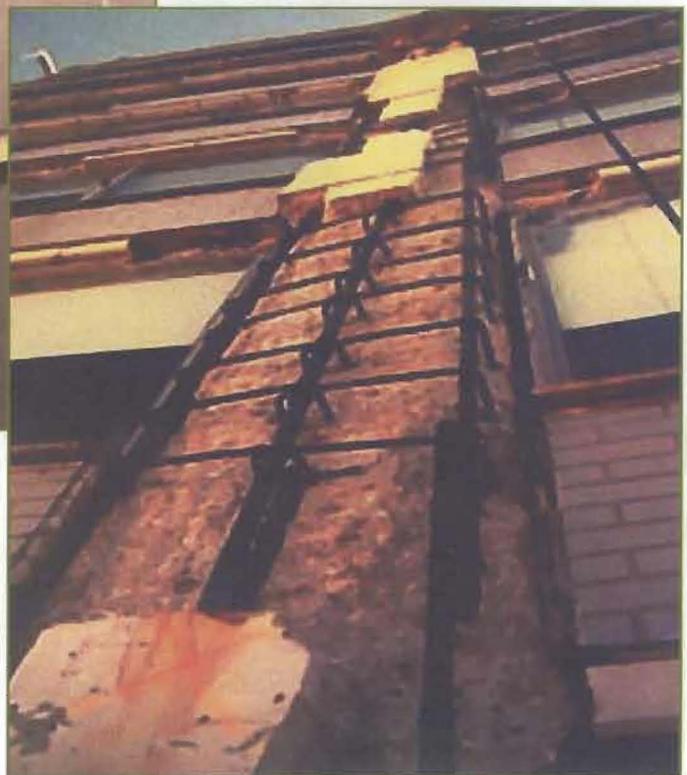
Photo 5 – Same column shown in Photo 3 during repairs.

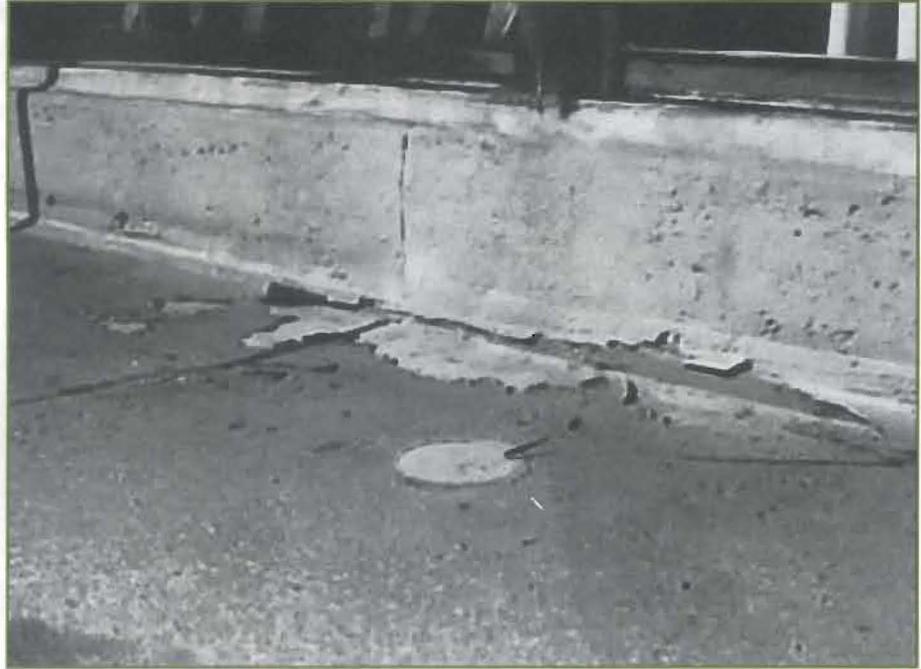
Photo 7— Failure of protective coating on a slab extension.

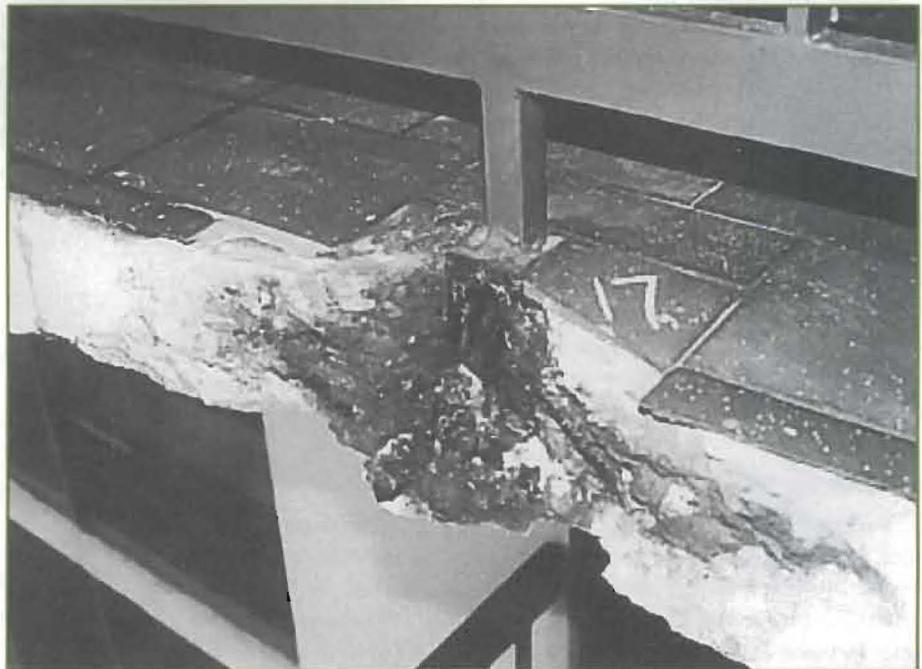
Photo 8 – Typical deterioration of balcony railing pockets.

Rust stains and cracking adjacent to embedded balcony railing posts should also be noted. Corrosion of embedded balcony railing posts typically results in radial cracking emanating from the railing post pocket (*Photo 8*). In some cases, deterioration of the filler in railing post pockets can also contribute to cracking of adjacent concrete. It is a good idea to expose the reinforcing steel arrangement around the railing posts to evaluate the presence of dissimilar metals and adequate reinforcement.

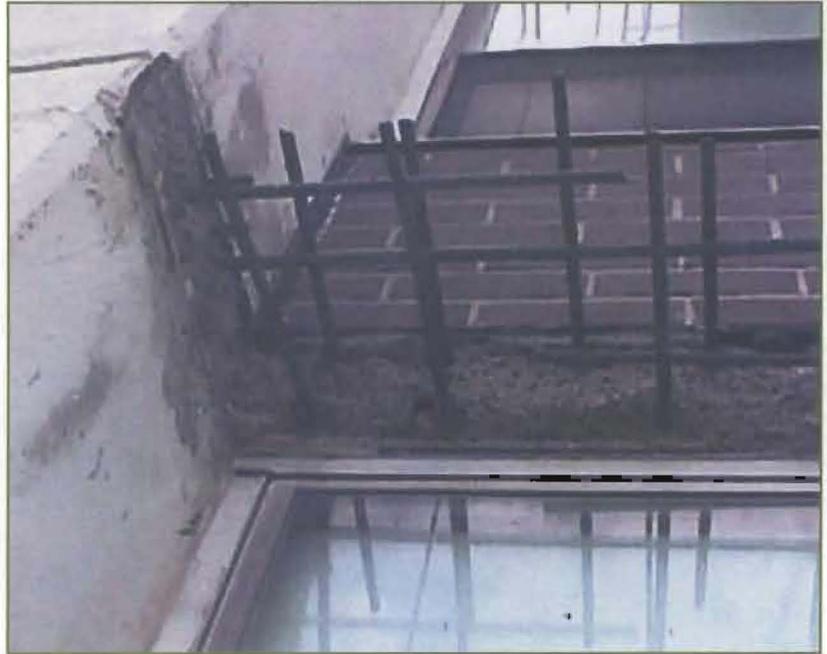
Photo 9 – Removal of slab extensions adjacent to columns during repairs can lead to a significant reduction in shear transfer capacity at the column-slab connection.

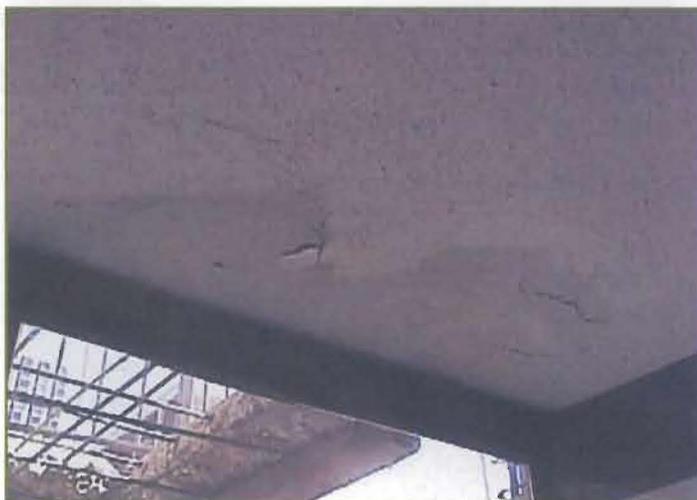
Photo 10 – Early indications of reinforcing steel corrosion inside a building adjacent to an exterior window.

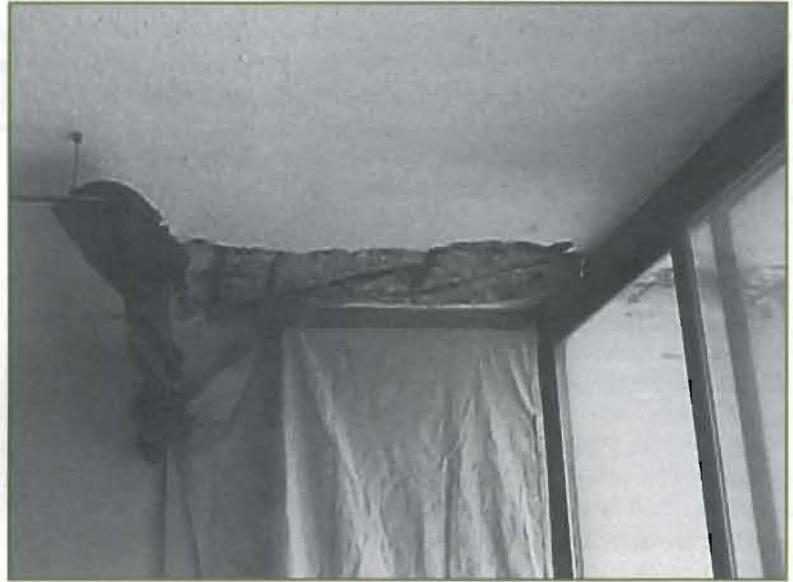
Photo 11 – Corrosion of reinforcing steel that has extended inside a building.

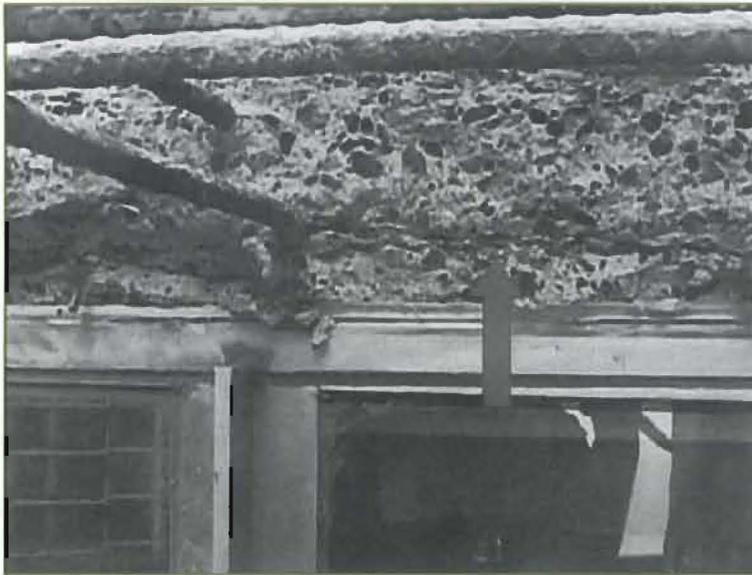
Photo 12 – Corrosion-related delamination that has extended inside the building.
