# Forensic Investigation of Water Leakage Issues into Buildings, Recreating the Leaks Vs. Determining the Cause

By Kami Farahmandpour, P.E., FRCI, REWC, RRC, RWC, RBEC, CCS, CCCA (NAFE 854F)

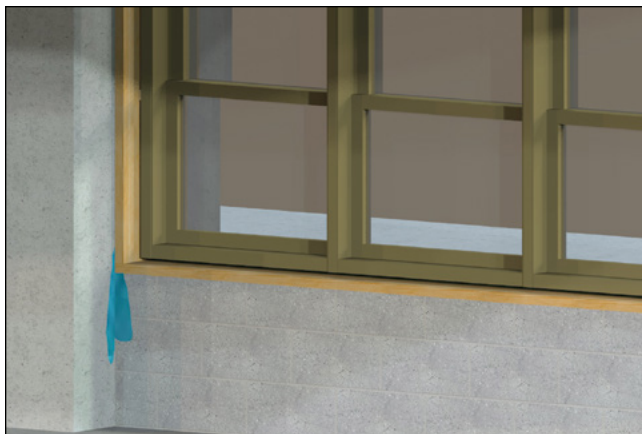
**Figure 3**

3-dimensional model used to demonstrate where leaks could be due to a gap between the window frames and the window rough opening. That gap was left open by design.
