Project Name:
*Emergency Roof and Wall Stabilization
Tri-State Electronics Building*

Project Location:
Mount Prospect, Illinois

Nature of Services:
Emergency Stabilization Consulting

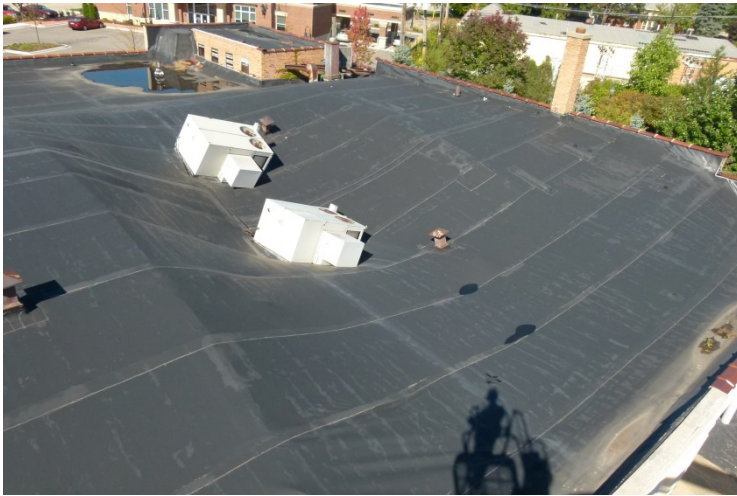
The Tri-State Electronics building is a single-story structure with bowstring wood roof trusses supported on load-bearing masonry walls. The building was located immediately adjacent to a primary 4-lane highway through the village.

On one October day with no precipitation or wind, 2 of the bowstring trusses failed. One of the trusses was located beneath 2 rooftop HVAC units. However, those units had been installed many years prior to the roof collapse. Collapse of the 2 failed bowstring trusses progressed slowly over a 5-hour period. Collapse of the trusses also caused significant outward movement of one of the masonry bearing walls. Village officials closed 2 of the 4 lanes of the adjacent highway due to concerns that the building could progressively collapse onto it.

Upon confirmation that roof and exterior wall movement had generally ceased, BTC evaluated the condition and stability of the exterior walls and portions of the roof that had not collapsed. Based on this evaluation, BTC prepared a temporary stabilization plan to minimize the possibility of further collapse. BTC also coordinated installation of the stabilization components for the building.

Stabilization work was completed within 2 days of the collapse and all lanes of the adjacent highway were reopened.
