## Project Profile

Evaluation of Exterior Wall Cracking at Village on the Lake Condominiums

Project Location: 720 Wellington Avenue Elk Grove Village, Illinois

Nature of Services: Evaluation of Exterior Wall Cracking, and Building Foundation Settlement, Structural Monitoring

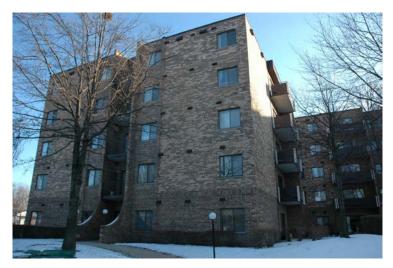
Village on the Lake Condominiums consists of several large 5story buildings which form a residential community. Each building is constructed on perimeter concrete footings and foundation walls. The exterior walls are primarily constructed of load-bearing masonry. The floors consist of concrete on metal deck, supported by steel joints and beams.

BTC's services were requested to evaluate ongoing cracking and distress on the exterior walls of one of the buildings. At that building, a tier of corner units had been affected along the entire height of the building. Attempts at addressing the cracking issues previously had not been successful.

BTC's investigation consisted of a visual review of the existing conditions, a review of prior repair records, and review of the original design drawings. The investigation revealed that many window sills along the affected tier were not level. Significantly wide cracks at the corners of these windows were observed on the exterior and interior faces of the exterior walls. BTC's review also indicated the presence of a large tree adjacent to the affected corner of the building.

Based on the investigation, BTC concluded that the building foundation had undergone significant settlement at the corner of the building that exhibited distress. The settlement was attributed to soil desiccation resulting from the presence of the large tree near the building footprint, and dry conditions during prior summers. BTC recommended that the tree be removed and the building be monitored for a period of time to ensure additional settlement did not occur. BTC installed crack monitors and performed periodic precision level measurements to evaluate if additional settlement had occurred. The monitoring revealed no further settlement after removal of the tree. At that time, BTC recommended repairing the cracks. No further structural repairs were deemed necessary.
