Key Design Considerations for Concrete Topping Slabs in Split-Slab Construction

By Michael F. Wiscons, SE, PE;
Kami Farahmandpour, RBEC, F-IIBEC, PE, FNAFE, CCS, CCA;
and George W. Seegebrecht, PE, FCI

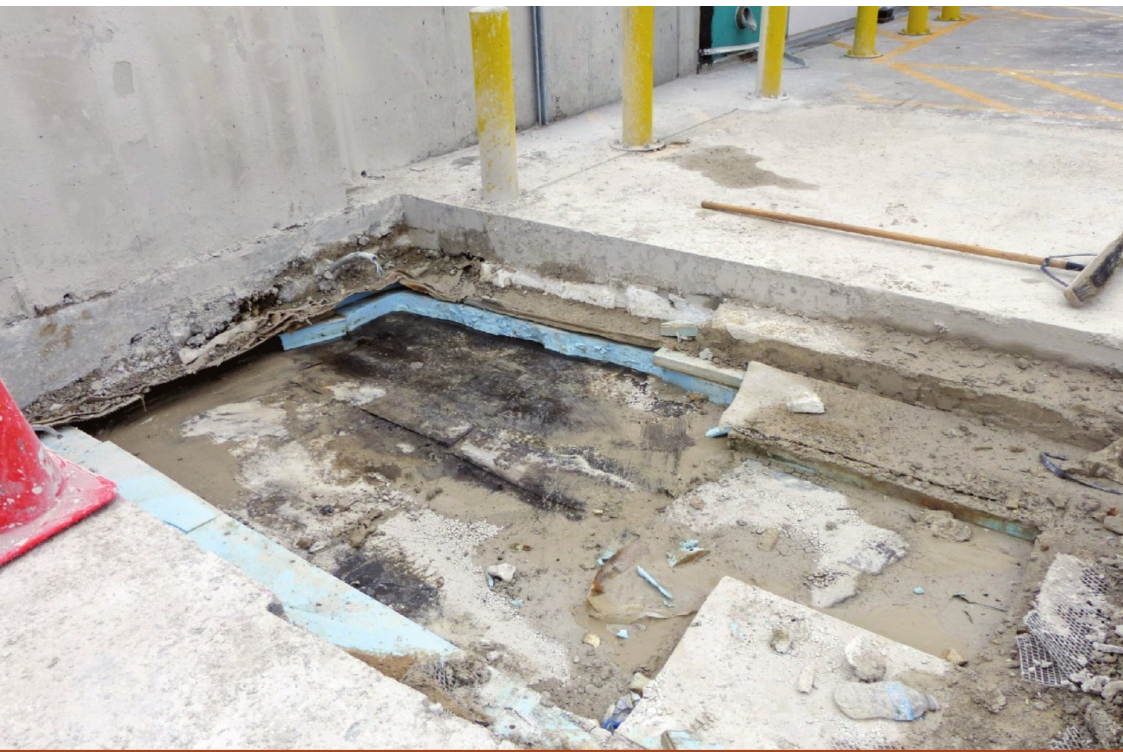
Figure 1. Example of split-slab construction.

assemblies incorporate a concrete topping slab over a structural concrete deck, which is separated by a waterproofing system (**Fig. 1**).

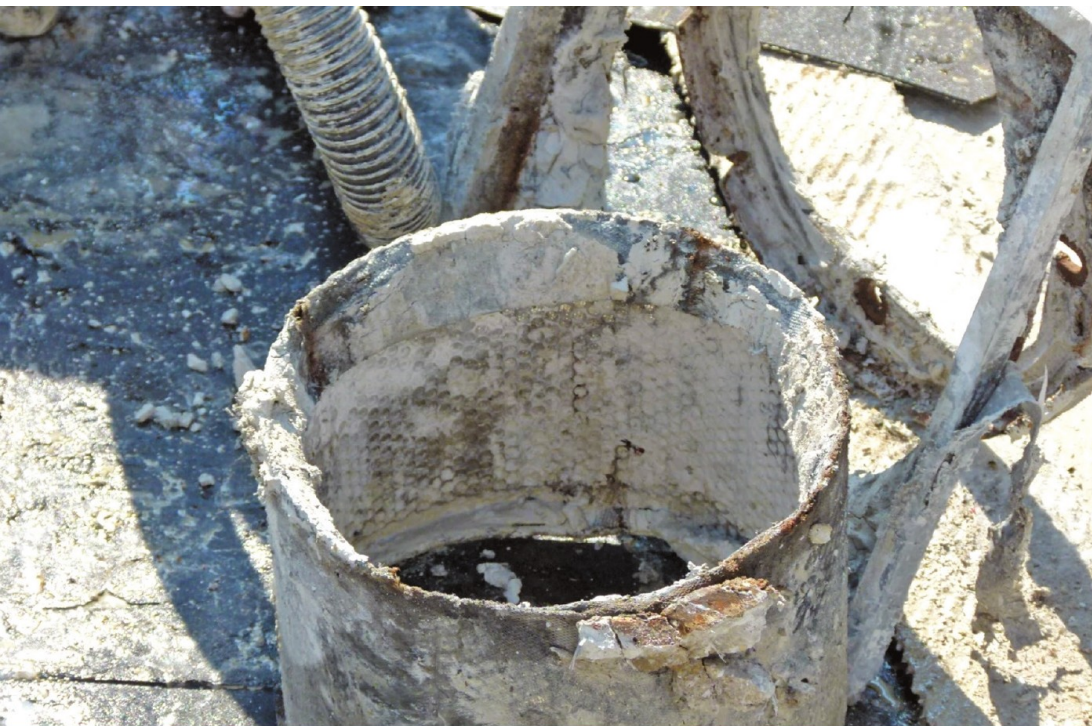
Figure 2. A filter screen around a two-stage drain is clogged due to decalcification of the concrete topping.

age composites and two-stage drains are prone to clogging due to concrete leachate or accumulation of calcium hydroxide. When water flows through cracks, microcracks, and joints, it dissolves free calcium hydroxide, which is subsequently deposited elsewhere within the system when the water evaporates. In many cases, we have observed substantial clogs in two-stage drain screens or the fabric layer of the drainage composite due to this phenomenon (Fig. 2).

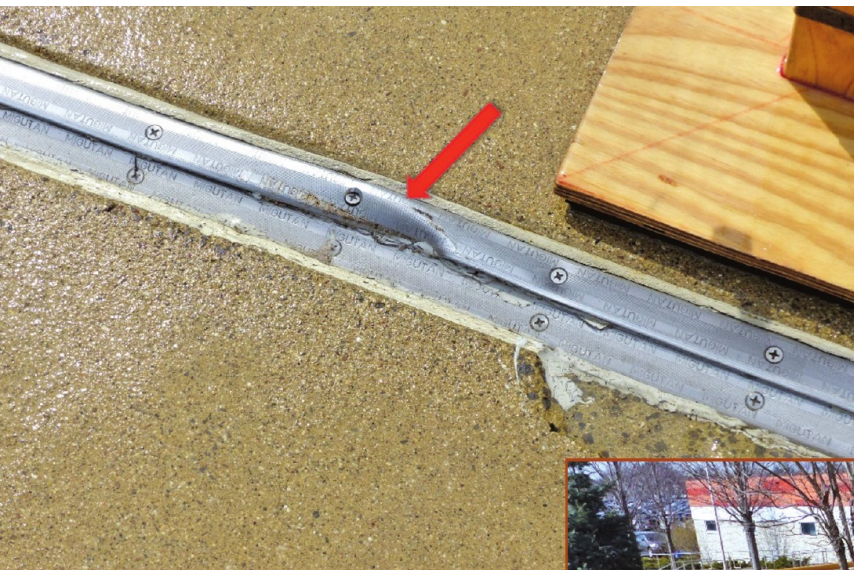
Figure 4. Deformation around a retaining cap.

The visual review of the expansion joints indicated deformations around the retaining caps of the expansion joint gland (**Fig. 4**). Water penetration testing was performed along the expansion joints in 6-ft (2-m) increments using a calibrated spray bar (**Fig. 5**). At most locations, water leakage was observed in the occupied space below within 2 to 5 minutes after the start of testing.

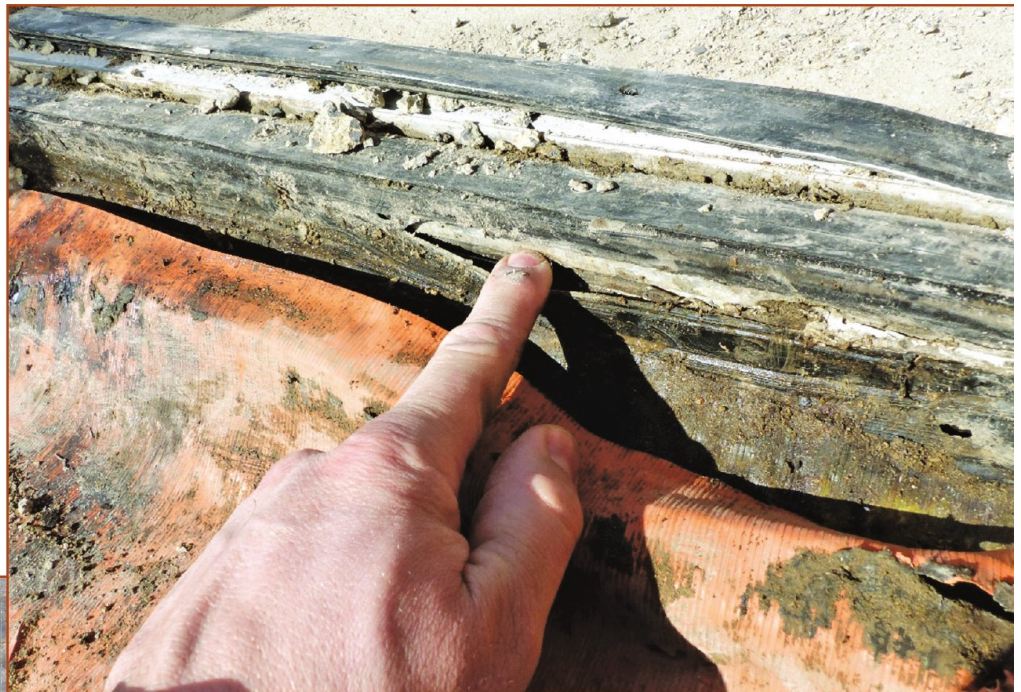
Figure 6. Severed flange of an expansion joint sealing gland.

Exploratory openings were made to identify the path of water leakage through the expansion joints. Upon removal of the expansion joint retaining caps, investigators observed that flanges of the sealing gland were severed from the body of the gland (**Fig. 6**). The investigators also observed a large tear in the vertical leg of the expansion joint flashing sheet at the bottom edge of the expansion joint retaining cap (**Fig. 7**), and they found that an expansion joint anchor bolt used to attach the horizontal leg of the expansion joint flange to the slab had failed in tension.

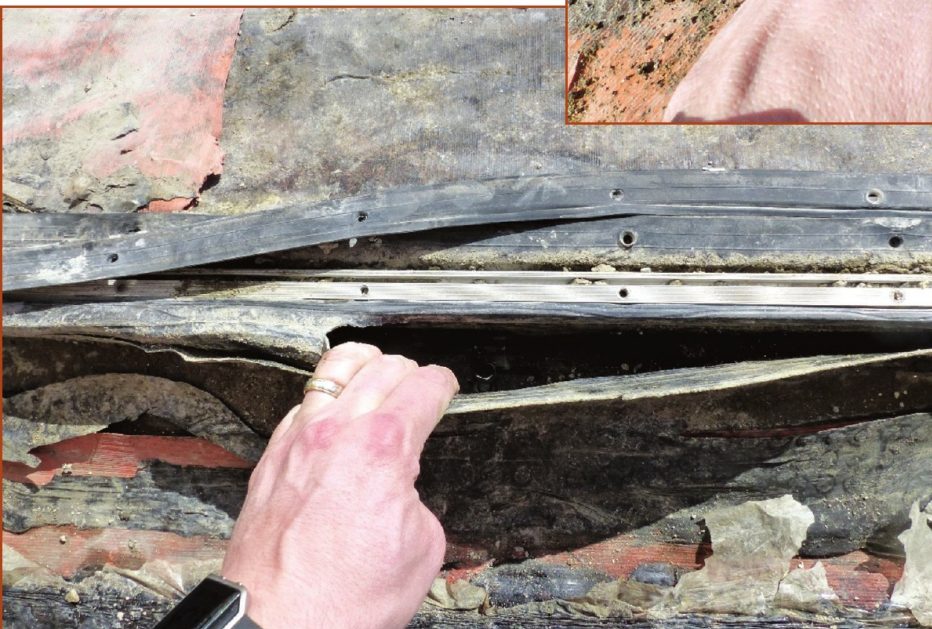
Figure 7. A large tear in an expansion joint flashing sheet.

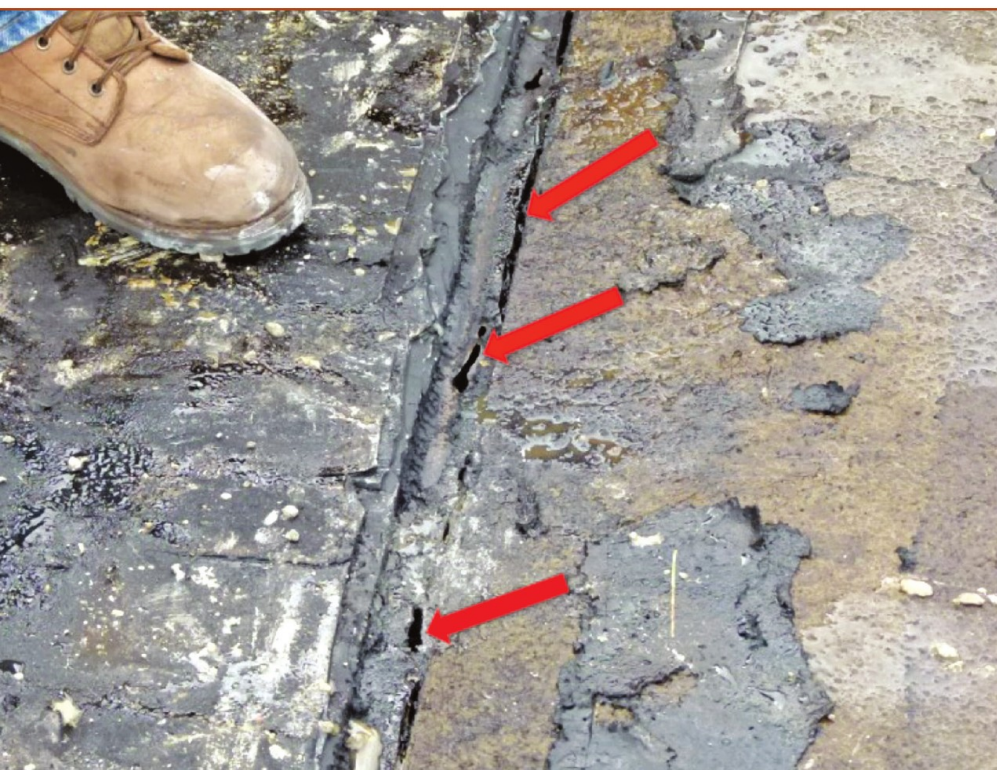
Figure 8. A failed sealant joint.
