Project Name:
Motorola Parts Building, Curtain Wall Rehabilitation

Nature of Services:
Evaluation, Repair, and Restoration of Deteriorated Curtain Wall System

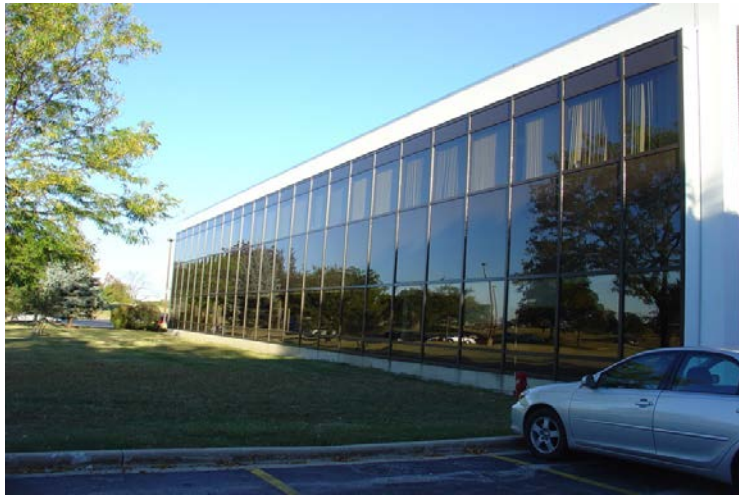
The Motorola Parts Building in Motorola’s Schaumburg, Illinois, campus is a large office/manufacturing facility built in the 1960s. The office wing of the building is a 2-story steel frame building with an aluminum/glass curtain wall system on 3 sides. The curtain wall system consists of insulated vision glass and spandrel panels.

The curtain wall system suffered from many problems including water and air leakage. An investigation of the curtain wall system performed by BTC revealed numerous problems including shrunk and deteriorated gaskets, shifted glass and spandrel panels due to lack of isolation blocks, and cracked spandrel and glass panes.

Another issue with the curtain wall system was ongoing breakage of the spandrel panels along the grade level where they were damaged by airborne debris from lawnmowers. However, the replacement of such panels, and other glass panes with broken seals were difficult and costly because all glass and spandrel panels were originally set from the inside, and were subsequently covered with mechanical equipment and finishes.

The Owner had considered a complete replacement of all system gaskets, necessitating extensive interior work and moving of building occupants. However, BTC developed a unique retrofit system that enabled the future replacement of glass and spandrel panes, and provided for the proper replacement of the dry gasket system with wet sealant. The repairs were successfully implemented at a fraction of the cost for replacement of the gaskets.
