AN UNCONVENTIONAL APPROACH TO CURTAIN WALL REPAIR

BY KAMI FARAHMANDPOUR, PE, FRCI, FNAFE, RRC, RWC, REWC, CCS, CCCA

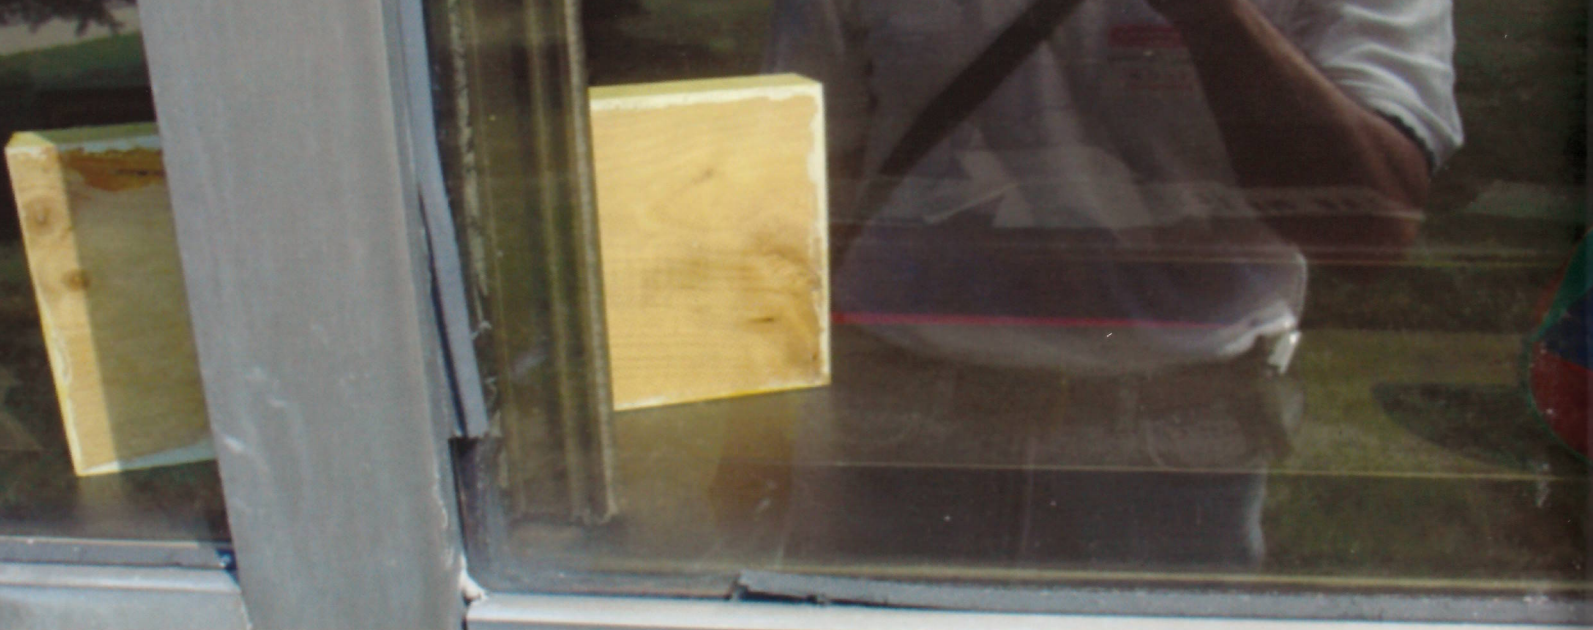
Photo 2: Extensive shrinkage and deterioration of glazing gaskets.

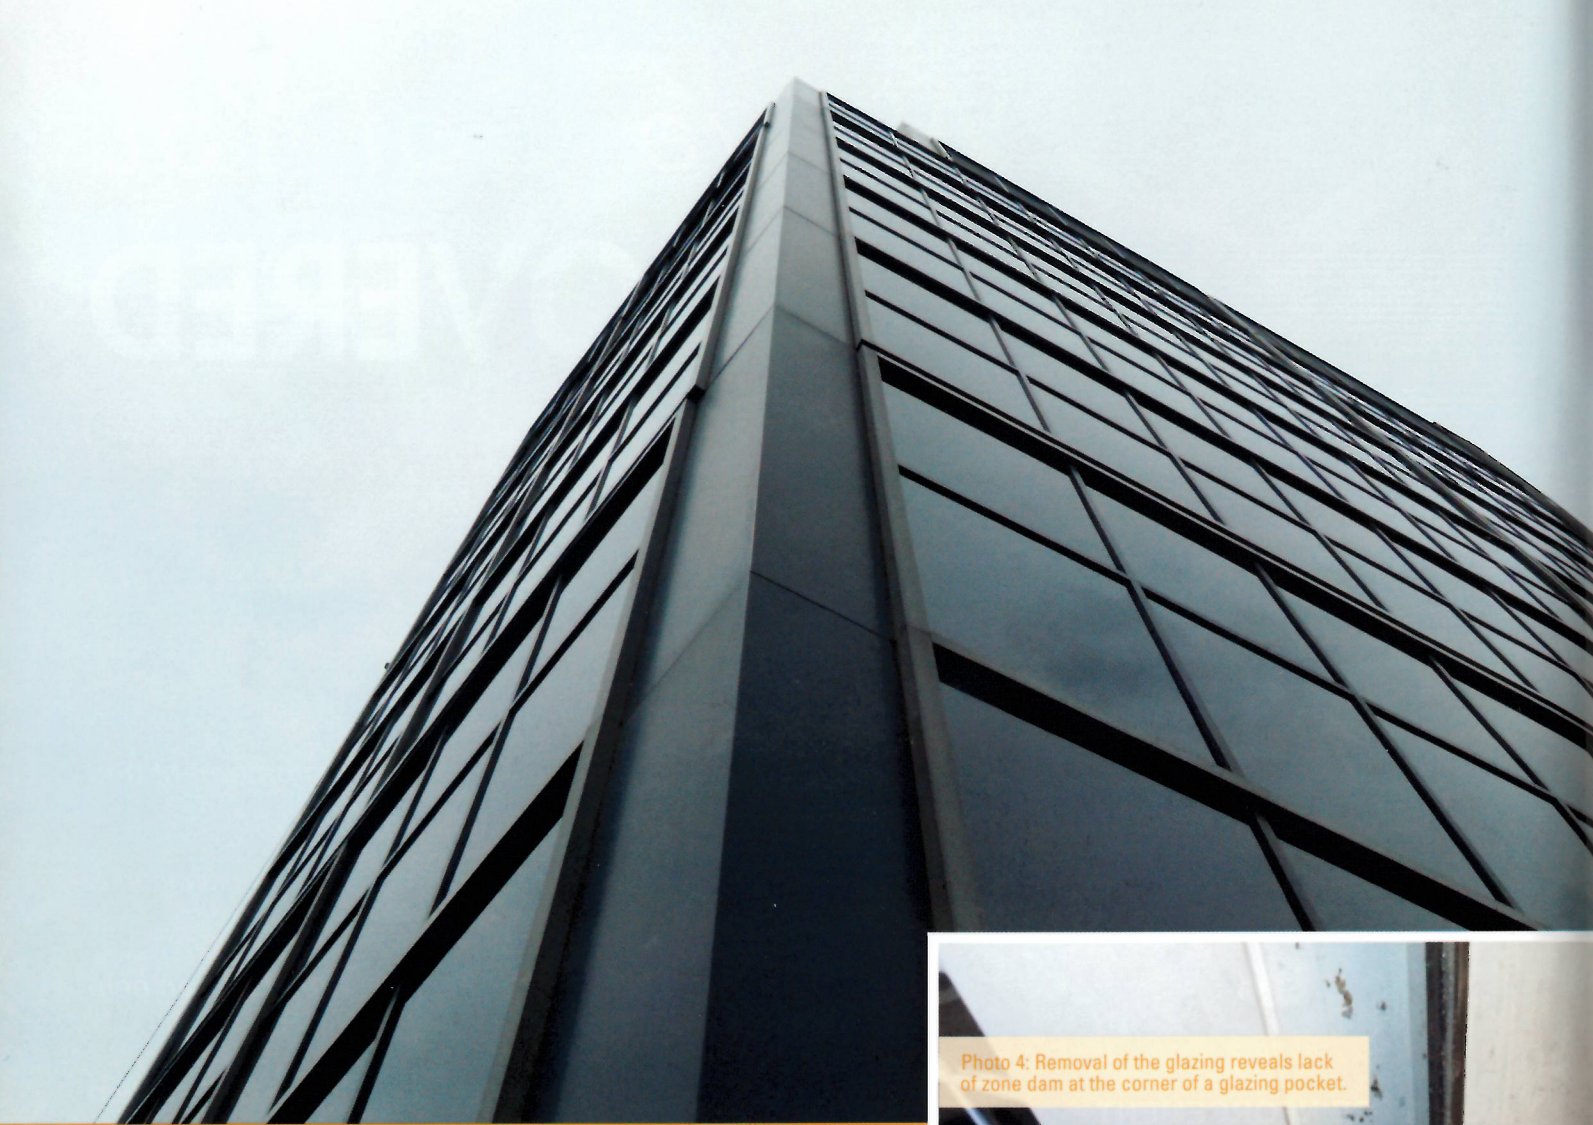
Photo 4: Removal of the glazing reveals lack of zone dam at the corner of a glazing pocket.

(typically referred to as "glazing pocket"), end dams or zone dams to control flow of water in those troughs and sealants to ensure watertight integrity at various joints. (Photo 4) In most cases, original deficiencies in the application of the internal seals may not manifest until the primary seals deteriorate sufficiently to allow a significant amount of water to enter the system. In other cases, material

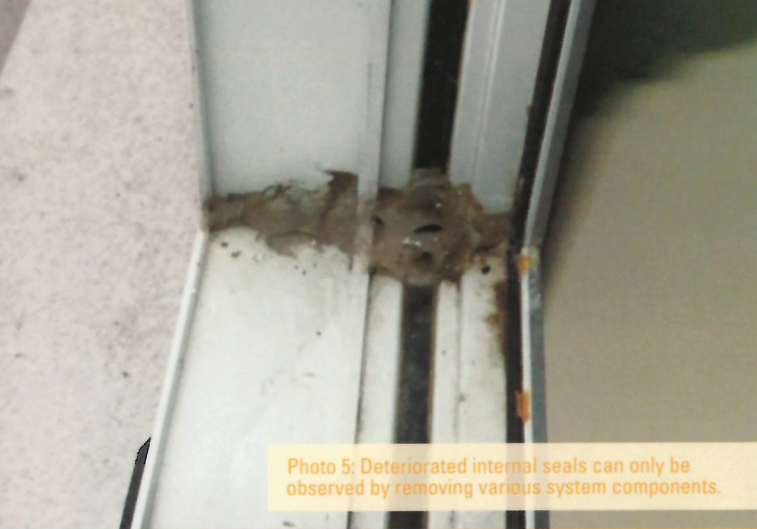
Photo 5: Deteriorated internal seals can only be observed by removing various system components.

deterioration or movement at the connection can cause failure of the internal seals. (Photo 5) Once internal seals fail, the drainage system will not be able to control incidental water, resulting in water infiltration.

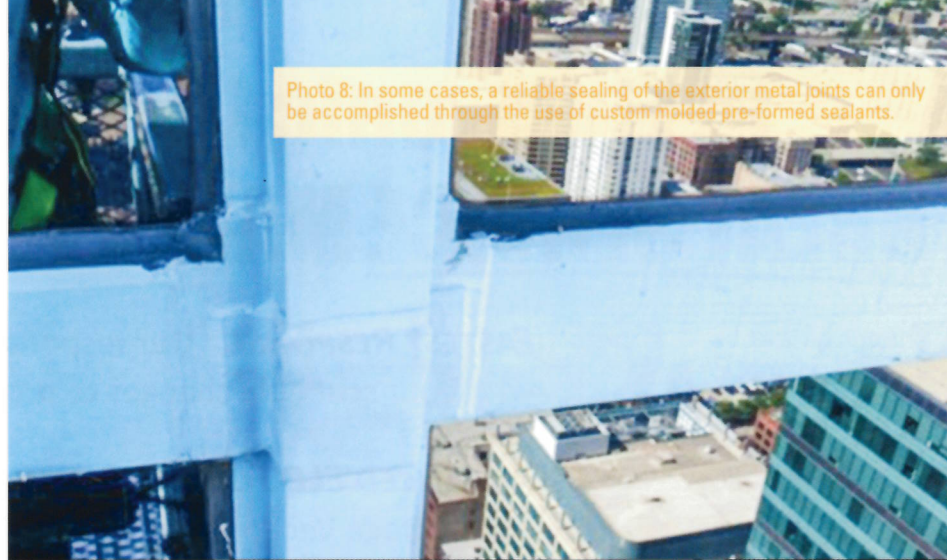
Photo 8: In some cases, a reliable sealing of the exterior metal joints can only be accomplished through the use of custom molded pre-formed sealants.

pre-molded custom silicone boots can help provide for a watertight condition (Photos 8 and 9).

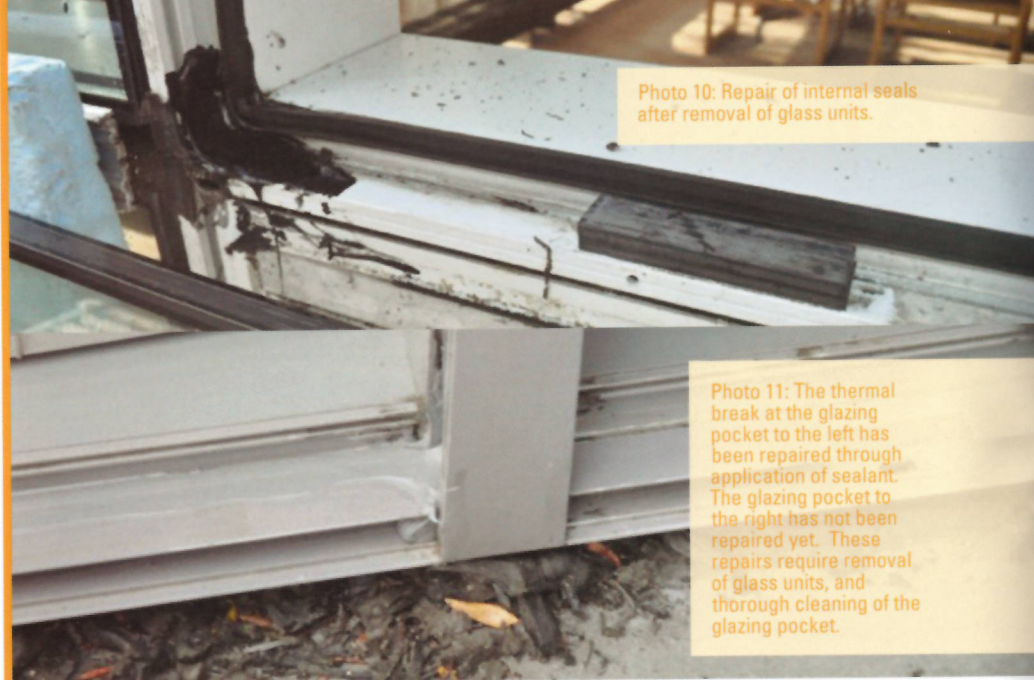
Photo 10: Repair of internal seals after removal of glass units.

Repair of internal seals is not performed on a routine basis. Such replacement will necessarily require de-glazing to expose the internal seals. In some cases, repair of internal seals may be possible by removing exterior pressure bars to expose glazing pockets. (Photo 10) However, such repairs are difficult and not as reliable as those made where glazing is removed from the system.

Addressing thermal break issues will also require deglazing to expose the thermal breaks. Once the thermal breaks are exposed, they can be cleaned and sealed. (Photo 10)
