ROOF DECKS

A to Z

Part V: Precast, Prestressed Concrete Tees

By Lyle D. Hogan, RRC, FRCI, PE; & Kami Farahmandpour, FRCI, RRC, RWC, REWC, RBEC, PE

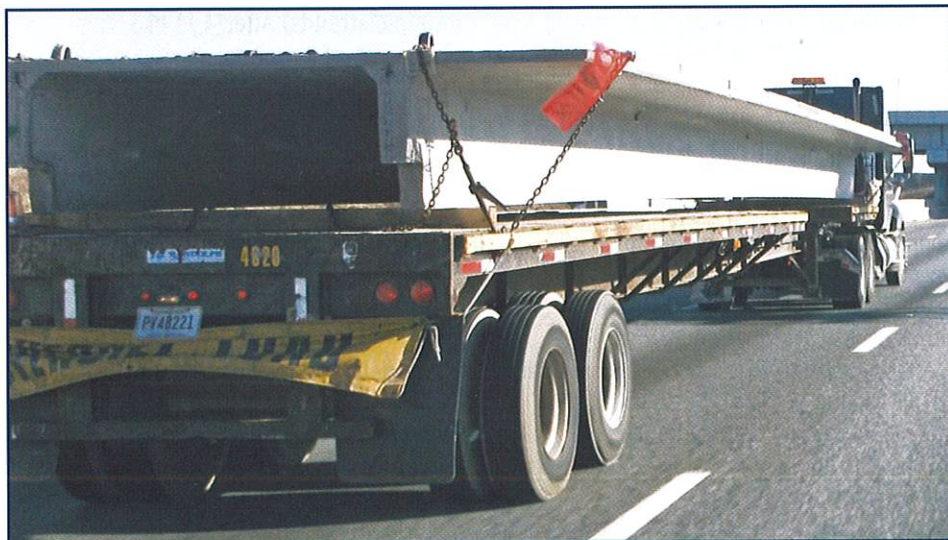
Figure 2 – Spans of 50 to 80 ft. are rather common, with some projects supplied in lengths in excess of this range. Transportation of precast tees may be the limiting factor in determining their maximum practical span.

side of the aisle are 60 ft. or more. Spans of 50 to 80 ft. are rather common, with some projects supplied in lengths well in excess of this range. Transportation of precast tees may be the limiting factor in determining their maximum span (Figure 2).

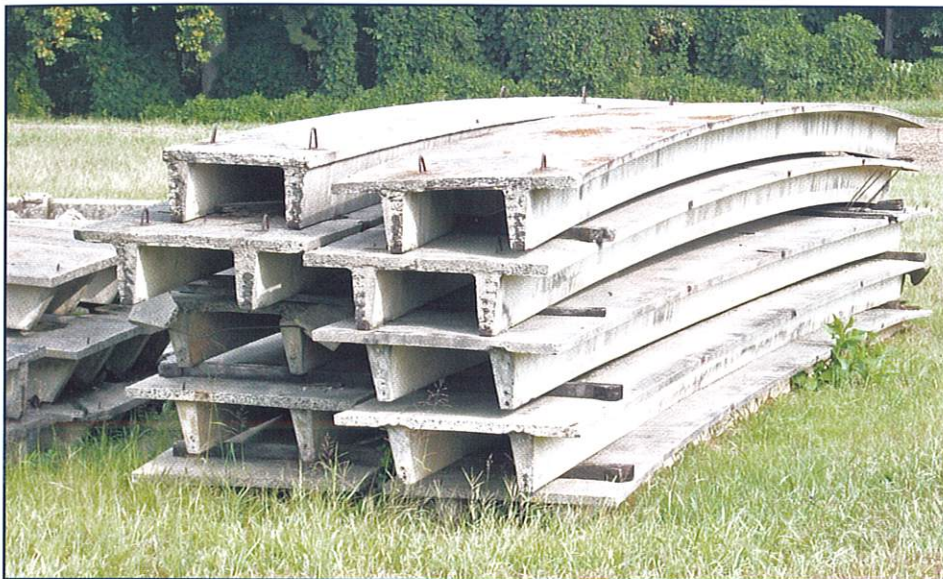
Figure 3 – Camber of tees from compression induced by the embedded prestressing tendons. This is beneficial to counteract the dead-load, live-load, and creep deflection of panels.

in the forms and are stretched (stressed) prior to placement of concrete.¹ Tendons are high-tensile-strength cables, typically of multiple strands. After placement of concrete and development of adequate compressive strength, tendon ends are cut, releasing the tension and imparting compression to the stems. This compression shortens the lower section of panels, resulting in upward curvature known as “camber” (Figure 3); this is beneficial to counteract the dead-load, live-load, and creep deflection of the panels.

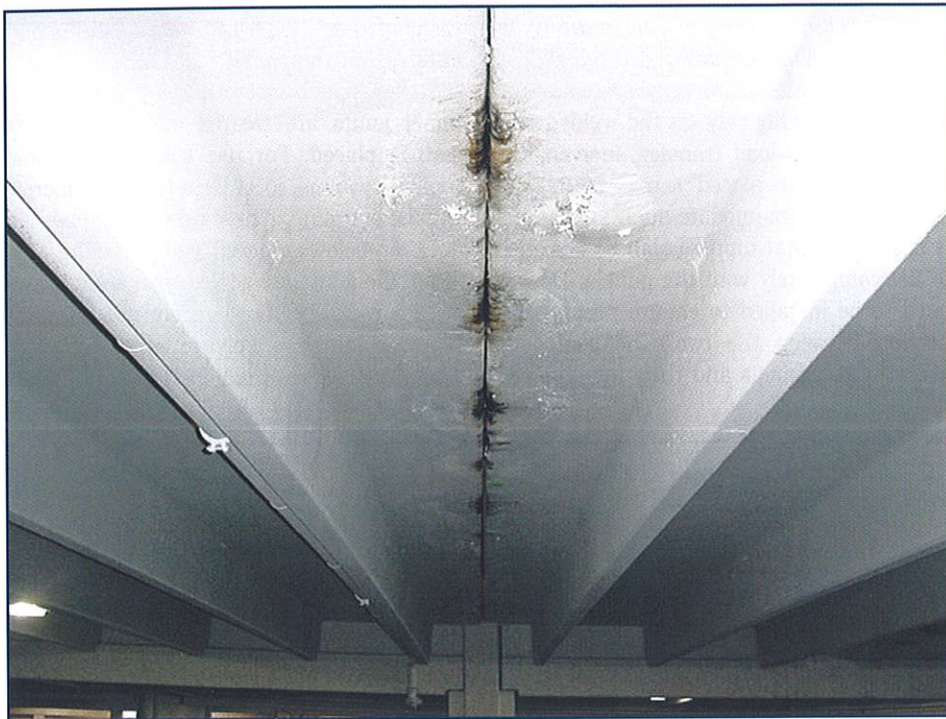
Figure 5 – Parking deck joints are particularly prone to leakage. Backer rods cannot be properly installed at the embedded connection brackets, and the joint geometry makes them susceptible to failure.

A parking deck constructed using tees can have thousands of linear feet of sealant joints. In the absence of a protective membrane such as a traffic-bearing membrane, these joints are a common avenue for water leakage (Figure 5). Joints are particularly prone to leakage due to the following factors:

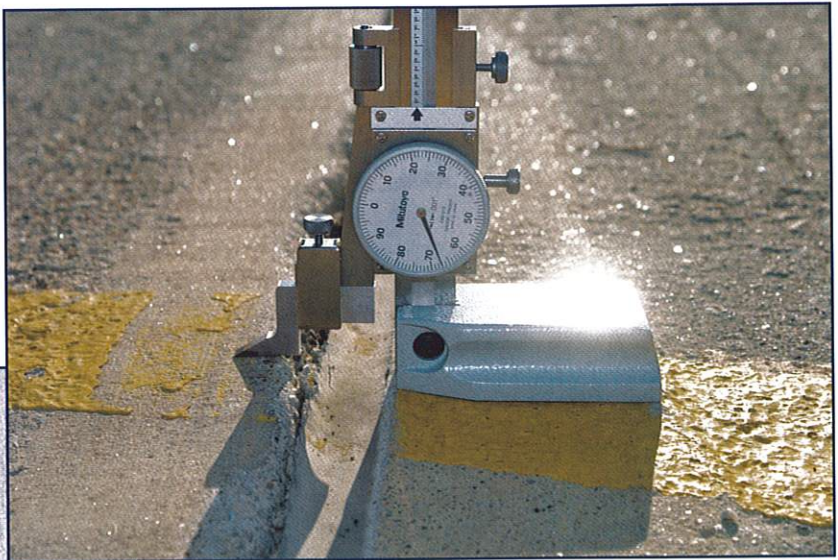
Figure 6 – Differential loading and stresses at connection brackets can result when adjacent panels are not the same height. Here, the difference in top-surface elevation is measured using a dial gauge micrometer.

Differential loading at connection brackets can be exacerbated when the top elevations of adjoining panels are not the same (Figure 6). This causes impact loads from vehicles to induce higher stresses at the connection brackets. These stresses can result in concrete cracking, in turn allowing water and deicing salts to penetrate the concrete and come in contact with the connection brackets. These cracks also allow water to bypass the sealant joints along panel connections and result in water leakage (as discussed above).

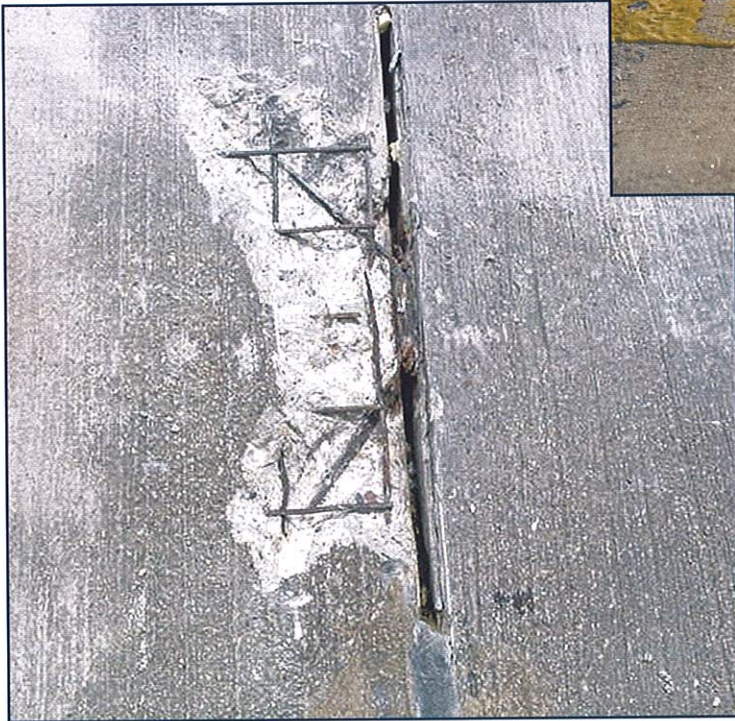
Figure 7 – Whether the cracking or corrosion starts first, the combination makes connection brackets prone to damage. When investigating tees, exploratory openings are crucial to evaluate the condition of brackets.

most cases, corrosion of connection brackets is the first sign of deterioration (Figure 7). When investigating such decks, a thorough visual review of the concrete around the connection brackets and exploratory openings at connection brackets are crucial. Brackets can be found using an R-Meter, and removal of concrete around brackets is necessary for proper evaluation.

If connection brackets are found to be corroded or the cause of concrete cracking, retrofit brackets of various configurations can be designed and installed to transfer loads across the panel side joints. It should be noted that patching of the concrete around brackets should be avoided as a method of restoring the brackets. If the concrete around the brackets is patched, the patch should be carefully designed to accommodate the stresses that the brackets impose on the immediately surrounding concrete. Otherwise, the patched area will simply fail again.

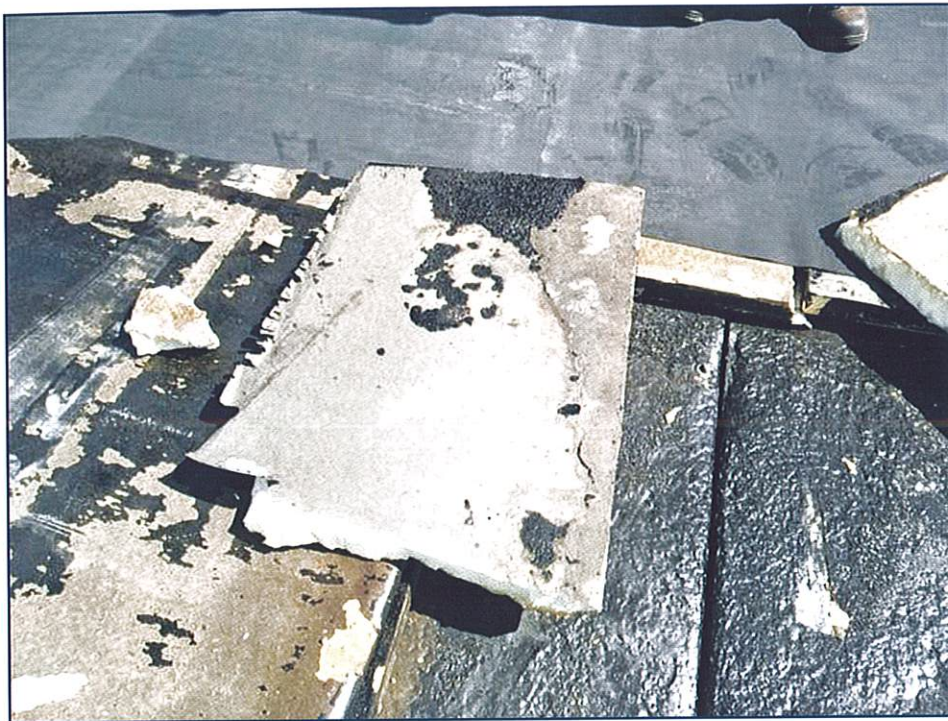
Figure 8 – Substandard adhesion of insulation over tees has been encountered in a number of instances. Concrete is a thermal sink and can become very cold, so direct mopping of hot asphalt should embody long-recognized cold-weather procedures. Note also the lack of taped decking joints.

When board insulation is installed over panels in hot bitumen, a bituminous primer should be first applied, and decking joints should be taped. Tees are a thermal sink and can become very cold, so direct mopping of hot asphalt should embody long-recognized cold-weather procedures. The authors have encountered substandard adhesion of insulation in a number of instances (Figure 8). Alternatively, if a topping course of LWIC is applied, a base ply will need to be used, along with fasteners appropriate for that material.
