# EIFS Come and EIFS Go; A Case Study on EIFS Cladding Rehabilitation

**Project Title:** Exterior Facade Rehabilitation, Fisher Corporate Center

**Location:** 1707 North Randall Road, Elgin, Illinois

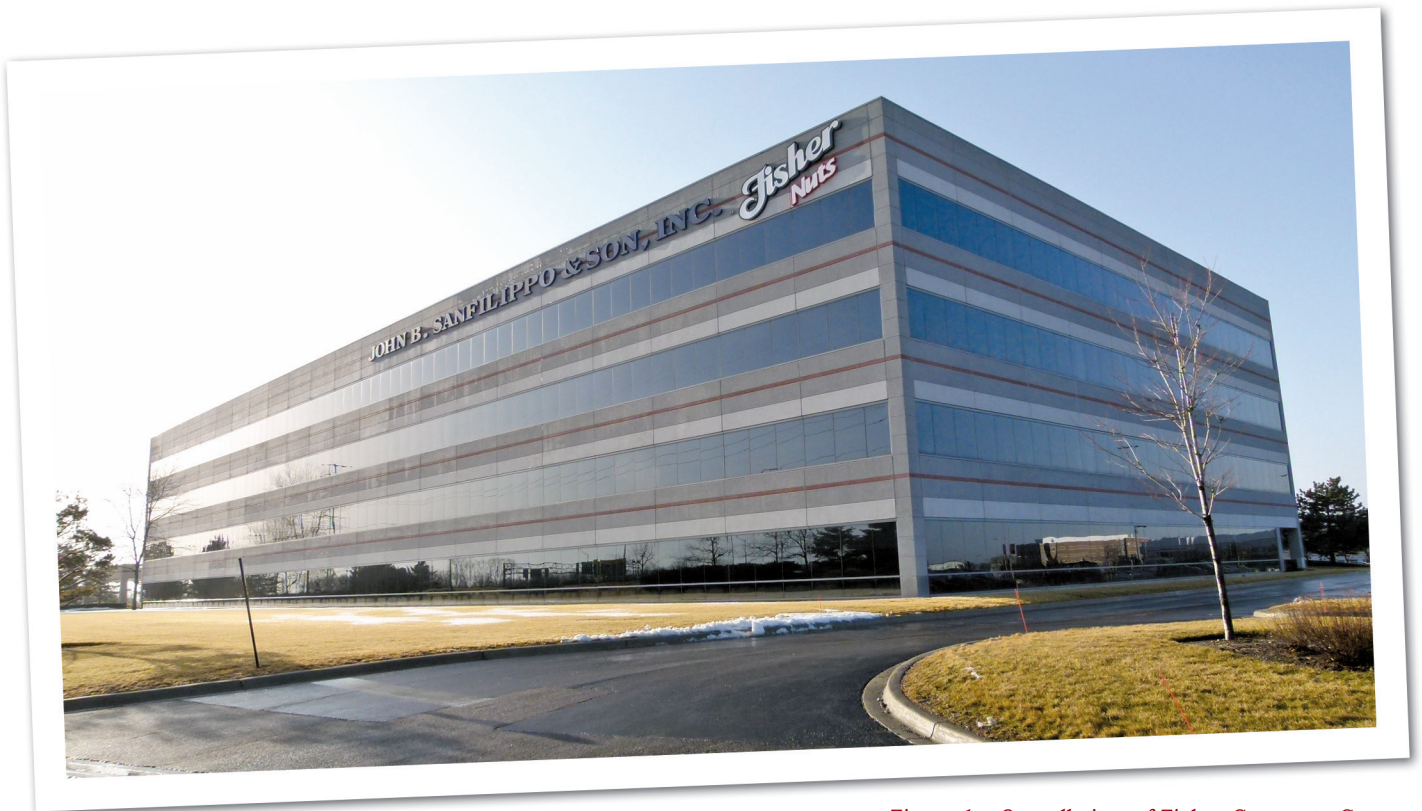
*Figure 1 – Overall view of Fisher Corporate Center.*

Fisher Corporate Center is a four-story office building located in the Chicago suburb of Elgin, Illinois. The building was primarily clad in 6400 linear feet of prefabricated EIFS panels and aluminum-framed strip windows (*Figure 1*). The joints between EIFS panels
