AN UNCONDITIONAL APPROACH TO CURTAIN WALL REPAIR

BY KAMI FARAHMANDPOUR, PE, FRCI, FNAFE, RRC, RWC, REWC, CCS, CCCA

This is the second installment of this article. The first installment summarized the typical failure mechanisms in curtain wall systems, the conventional repair approaches and a discussion of advantages and disadvantages of each repair approach. This installment is a case history on using the repair approaches outlined in the first installment.

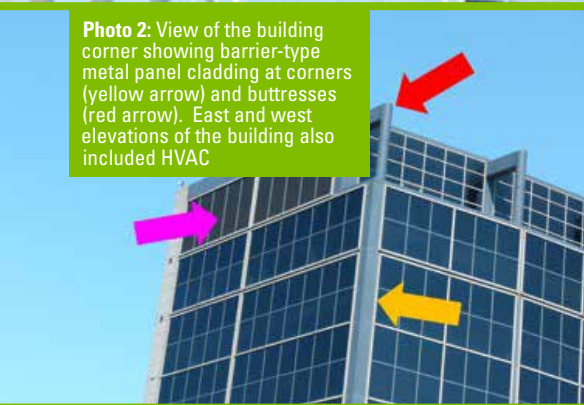
metal cladding system separating the curtain wall panels (Photo 1). The joints in the barrier metal cladding are sealed with field-applied liquid sealant. On the

been integrated into the curtain wall system (Photo 2).

On the south elevation, the building columns extended above a setback terrace area forming decorative buttresses (Also Photo 2). These buttresses had been clad with a barrier type prefinished aluminum cladding system.

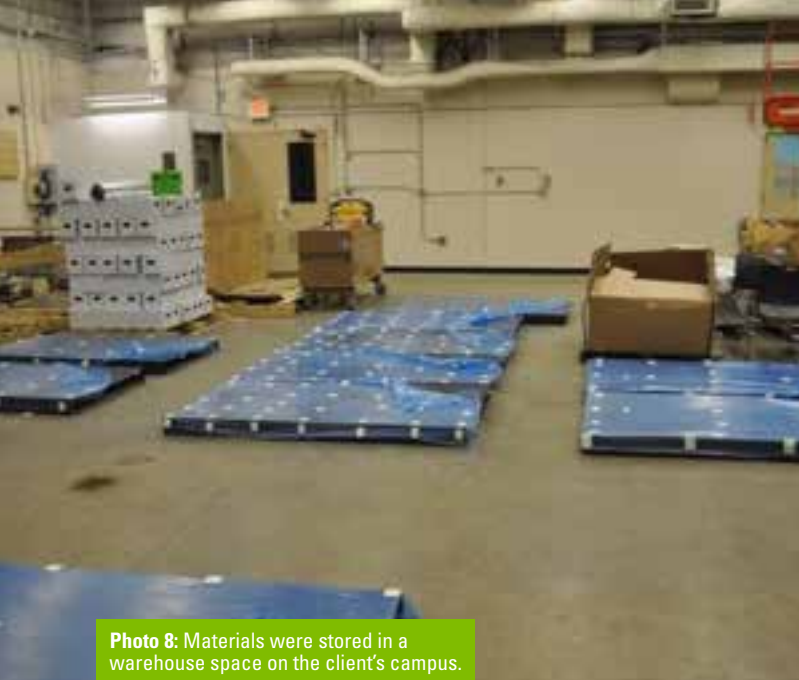
Photo 8: Materials were stored in a warehouse space on the client's campus.

After the mock-ups were evaluated, materials were ordered by the contractor. The lead time for some of the components included fabrication and finishing by two separate subcontractors, requiring shipment of components between multiple subcontractors. In some cases, the process took several months to complete. The materials were delivered to the site and stored in an indoor warehouse provided by the owners (Photo 8).

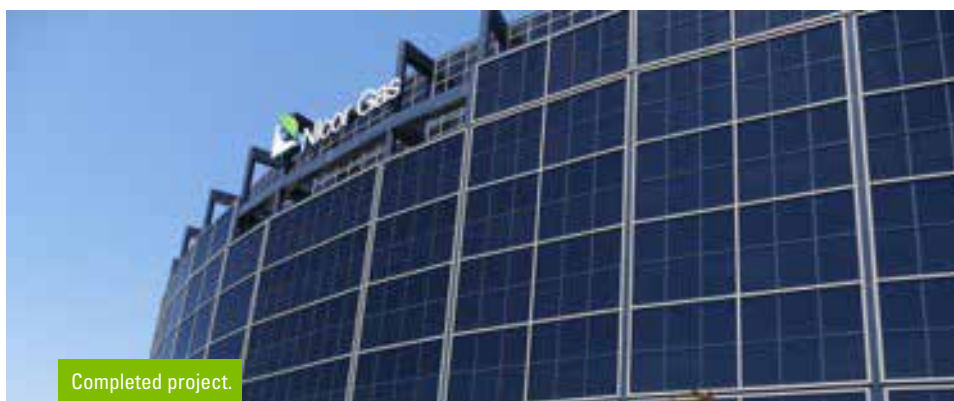
Completed project.
