Project Profile

Project Name:
20 East Cedar
Exterior Facade Repairs

Project Location:
Chicago, Illinois

Year Completed:
2006

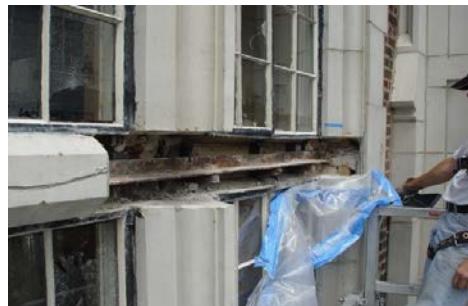
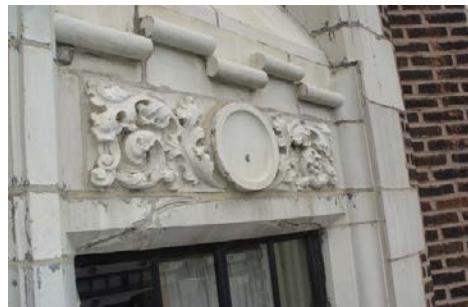
BTC's evaluation of the exterior facade indicated significant corrosion of the 14th floor parapet wall steel support angle, cracking and displacement of the 18th floor parapet walls, significant cracking of terra cotta units, many loose terra cotta units, failed crack repairs from previous repair projects, and deteriorated brick mortar joints.

Repair of the exterior walls required removal and replacement of the corroded parapet wall support steel, rebuilding portions of the 18th floor parapet walls, removal and replacement of 130 terra cotta units, removal and resetting of 115 loose terra cotta units, removal and replacement of failed sealant at previous crack repairs, installation of retrofit facade stabilization pins, epoxy repair of selected cracked terra cotta units, and repointing of deteriorated mortar joints.
