**Project Name:**  
*Fire Damage Investigation  
Busse Building*

**Project Location:**  
*Mount Prospect, Illinois*

**Nature of Services:**  
*Forensic Investigation*

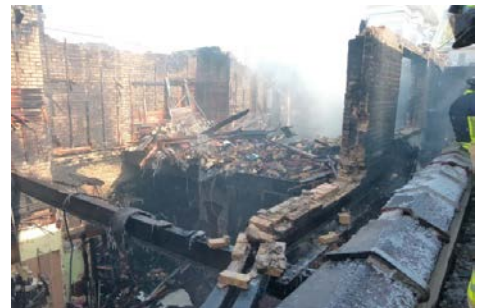
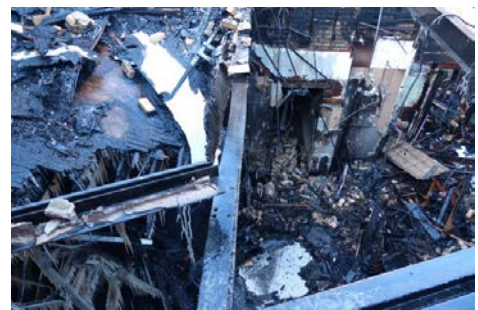
The evaluation indicated that the northernmost portion of the building that contained the restaurant was a complete loss. The timber floor and roof framing had been almost completely consumed in the fire. Steel floor support beams had significantly warped in the heat of the fire. In addition, portions of the masonry walls had collapsed. As such, the cost to repair this portion of the building would have been greater than demolishing and rebuilding it.

Although the remaining portion of the building exhibited only minor damage, it was judged to be more costly to salvage this portion of the building than to rebuild it with the northern portion. Therefore, this portion of the building was also demolished.
