Project Name:
*Roof Collapse Investigation
Wildbrook Commercial Building*

Project Location:
Prospect Heights, Illinois

Nature of Services:
Forensic Investigation

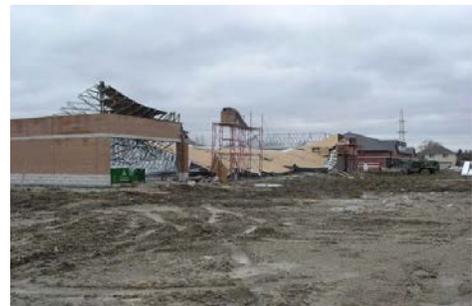
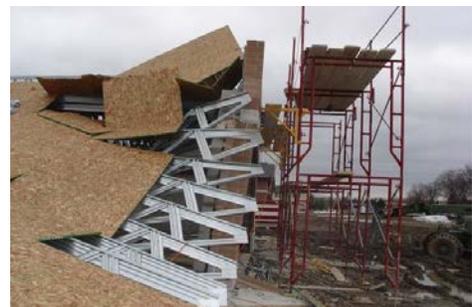
While the south building was under construction, the roof structure collapsed during a high wind event. This also resulted in collapse and/or damage to most of the masonry walls. Wind gusts on the day of the collapse varied from 30 to 35 miles per hour.

At the time of the collapse, all of the roof trusses were in place and only the east half of the roof had been sheathed. In addition, no temporary masonry wall braces had been installed. As such, the unbraced masonry walls were inadequate to support the wind loads imposed on them from the incomplete roof diaphragm.

During installation of replacement roof trusses, another partial roof collapse occurred. However, masonry wall braces were in place at the time and only minor damage to the walls occurred. The partial collapse of the roof trusses was attributed to lack of temporary construction bracing.

BTC reviewed the remaining masonry walls and provided recommendations for repair and replacement based on the extent of the damage.
