CONVENTIONAL AND NONCONVENTIONAL REPAIR OF CURTAIN WALL SYSTEMS

KAMRAN FARAHMANDPOUR,
FCI, RRC, RWC, REWC, RBEC, PE, CCS, CCCA, FNAFE

BUILDING TECHNOLOGY CONSULTANTS, PC

Building
Envelope
Technology
Symposium

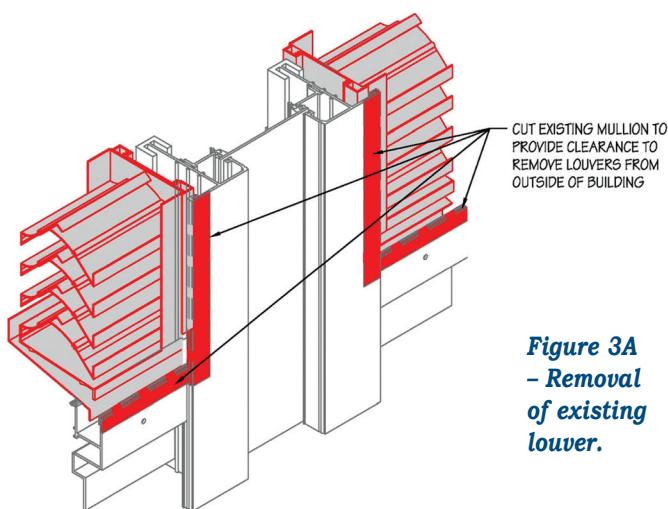
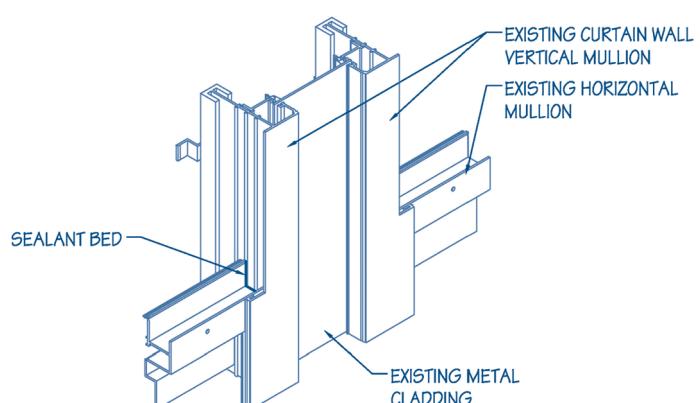
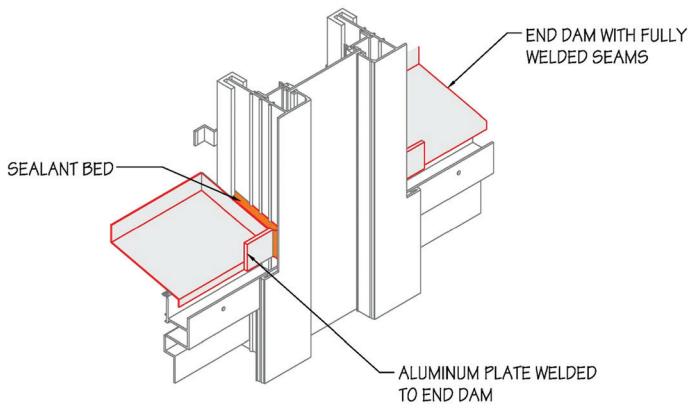
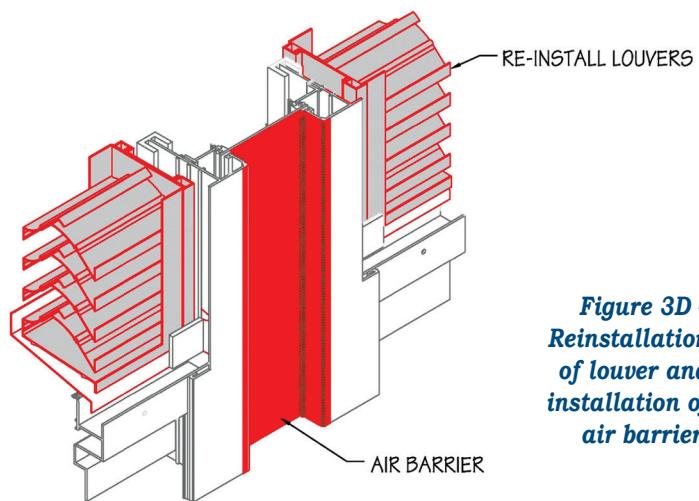
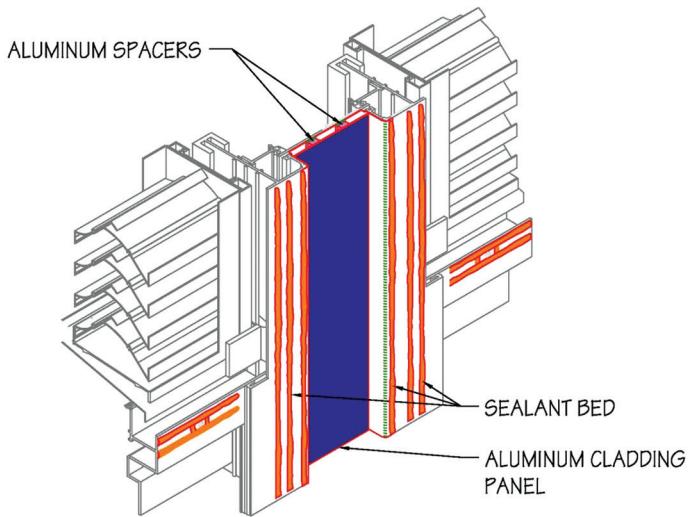
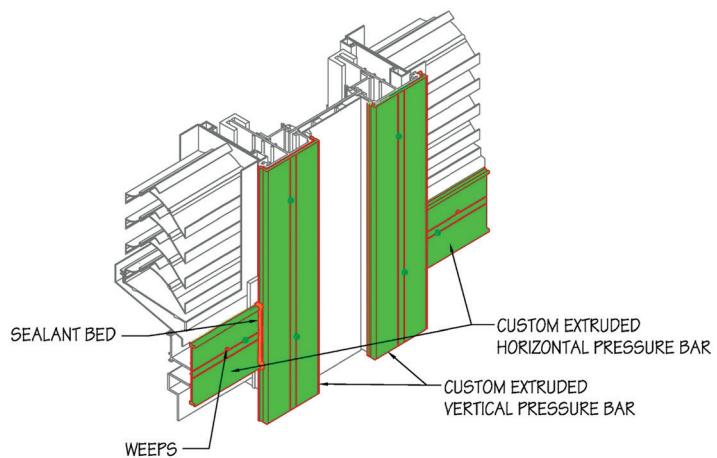
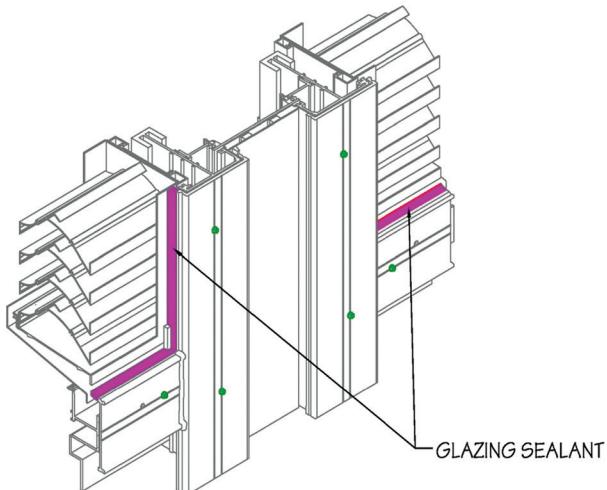
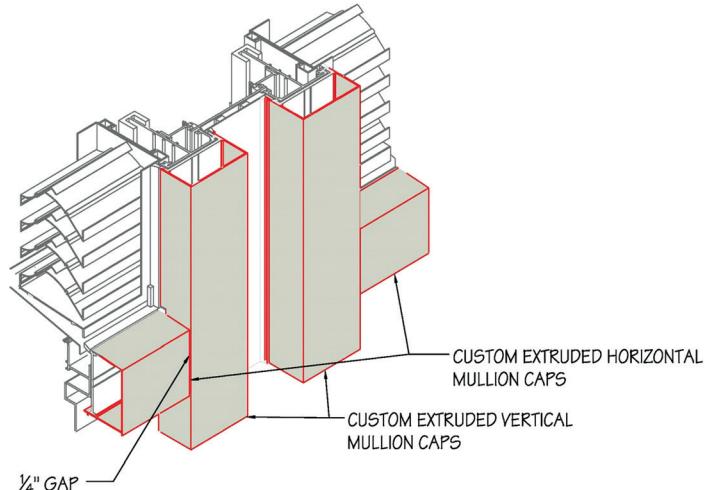
Figure 3A
- Removal
of existing
louver.

Figure 3B – Sealing end of existing mullion.

Figure 3C – Installation of pan flashing.

Figure 3D – Reinstallation of louver and installation of air barrier.

Figure 3E – Installation of sealant for new pressure bars.

Figure 3F – Installation of new pressure bars.

Figure 3G – Installation of glazing sealant.

Another challenge for the design team was the configuration of the HVAC louvers. Field-testing has indicated extensive water leakage below the louvers. The interiors of the louvers were either blanked off or directly connected to large ductwork. In order to

Figure 3H – Installation of new mullion caps.

ensure water management below the louvers, the louvers would have to be removed so that a pan flashing could be installed below them. The louvers had originally been installed from the interior. However, removal of the louvers would require removal of the interior ductwork that was deemed

impractical. As such, the design team opted to trim the exterior flanges of the vertical mullions to allow removal of the louvers from the exterior of the building. Once the flanges were trimmed, the louvers could be disconnected from the interior duct-work and removed. The design documents included an alternate to replace the louvers with new high-performance louvers.

Figures 3A through 3H depict the sequence of work related to the louvers. Once the louvers were removed, a stainless steel pan flashing was designed to be installed below the louvers. Due to the complex geometry of the new pressure bars, the louvers, and their new pan flashing end dams, the louver assemblies and their surrounding curtain wall framing were modeled using 3-D solid modeling software. This modeling allowed the design team to evaluate the sequence of work during con-

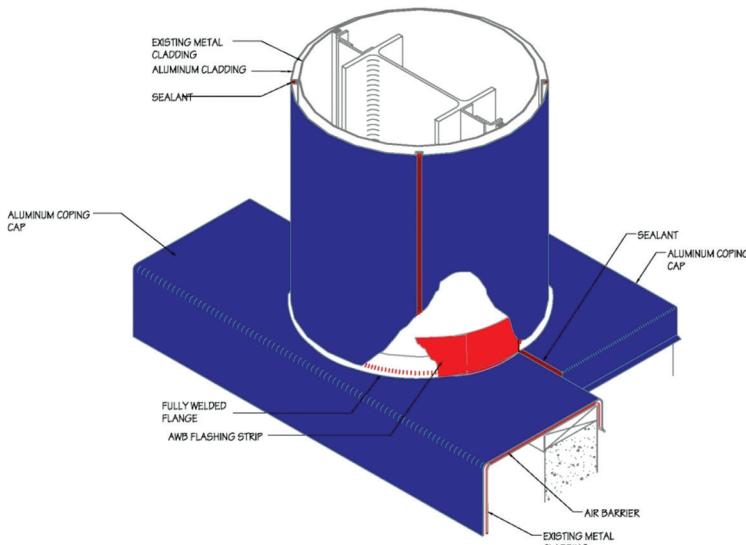
Figure 4 – Buttress base detail.

Figure 4 depicts the configuration of new metal cladding at the seventh-floor terrace buttresses. The buttresses were treated similarly to other metal-clad areas by installing an air barrier over the existing cladding, installing spacer bars, and installing new metal cladding over the spacer bars. Care was taken to ensure the gap between the new and existing metal cladding was drained to the exterior.

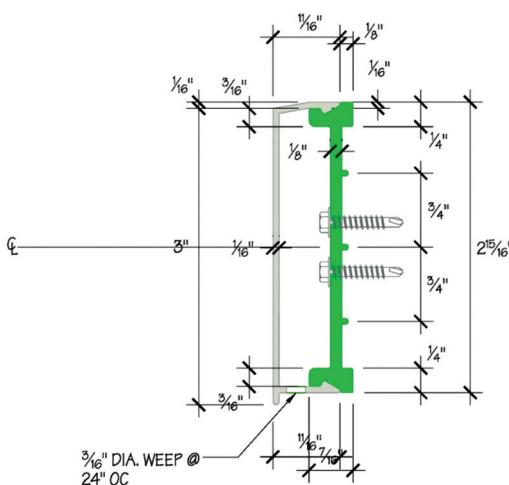
Figure 5 – Typical extrusion profile.

All in all, the design required 19 custom-extruded profiles. *Figure 5* depicts the design details for a pressure bar and its companion cap. Those profiles were carefully designed to provide for sealant geometry and grooves in the components to allow field technicians to properly locate fasteners. In addition to the custom-extruded profiles, many of

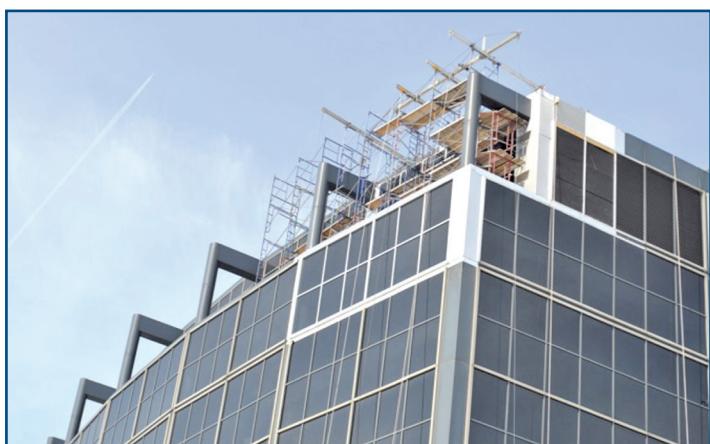
Photo 10 – Pipe scaffolding on setback terraces.

This allowed the use of the building davit system to erect swing-stage scaffolding over most of the facade. However, at the terrace areas, pipe scaffolding was installed to gain access to the building exterior (*Photo 10*). As is typically done with facade-repair projects, building entrances and entrance canopies were protected with temporary canopies.

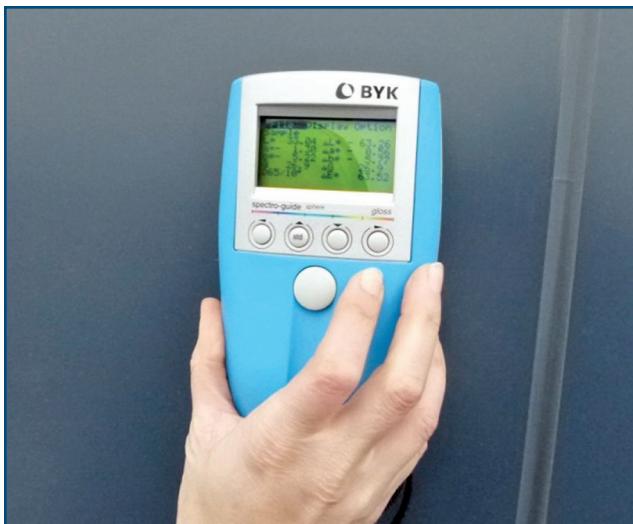
Photo 11 – Measurements of finish gloss using a color spectrophotometer.
