# **Failure Mechanisms in Liquid-Applied Waterproofing Systems**

Kami Farahmandpour, PE, RRC, CCA, CCCA

### **Case History: Cincinnati Museum Center Plaza Fountain**

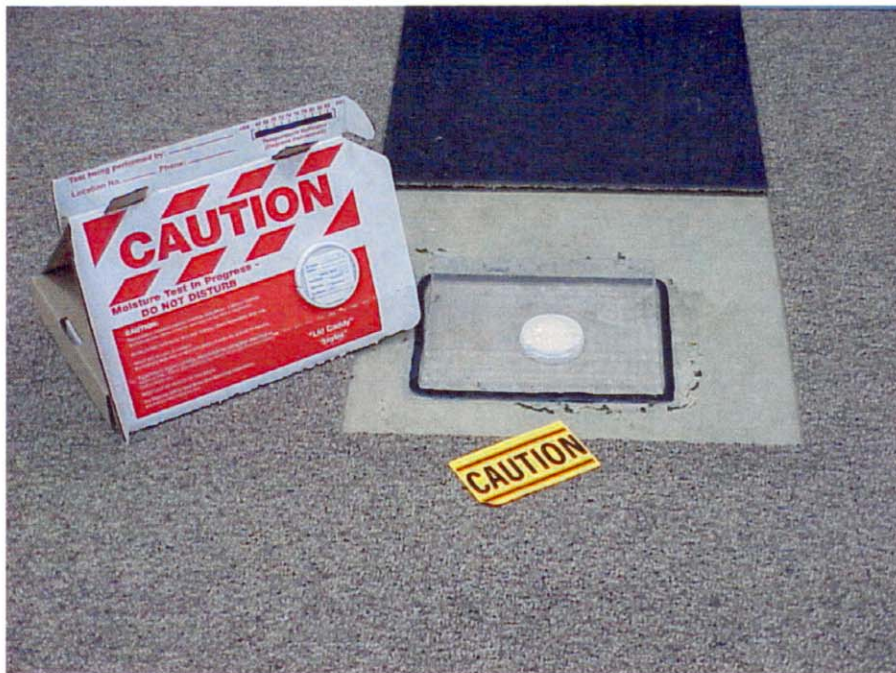
Before application of bonded flooring systems, the flooring industry typically specifies ASTM F 1869 <sup>4</sup> to measure the amount of moisture vapor emitted from concrete. This test takes approximately 72 hours to complete, and results are expressed in pounds [kilograms (kg)] of moisture vapor emitted through the surface in 24 hours for 1000 square feet (92.90 square meters) of concrete surface (Figure 4). The results obtained reflect only the condition of the concrete at the time of the test. In the author's opinion, this test method is a good tool for evaluating the MVER of concrete surfaces despite its drawbacks. However, because of the time it takes to perform the test, it poses practical difficulties in scheduling work.

Figure 4 – ASTM F 1869 test being performed for evaluation of carpeting installation on a concrete floor.

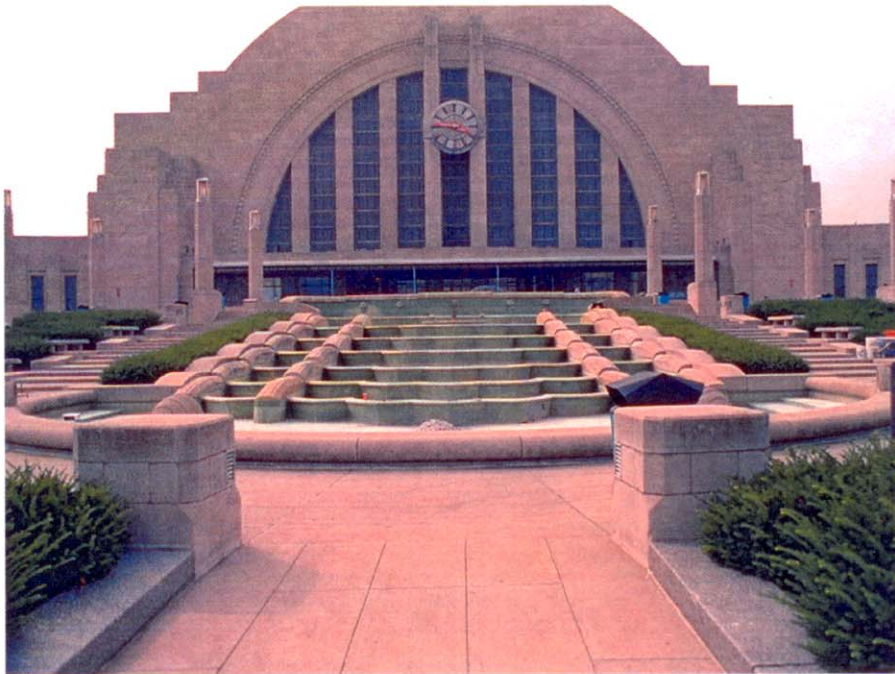
Constructed in 1933, the plaza fountain at the Cincinnati Museum Center is a tiered fountain built on a sloping structural deck over occupied space (Figure 5). The lower portion of the fountain and structural deck beneath the fountain's lower pool extend over a vehicular underpass. The structural deck consists of a reinforced concrete slab and is supported by a grid of steel beams and girders. The fountain's original primary waterproofing system was placed on top of the structural deck and consisted of a five-ply coal tar pitch waterproofing membrane covered with a lead sheet (lead pan). The fountain was cast with concrete to rough elevations on top of the lead pan. A trowel-applied mortar was then used to form the curved surfaces of the cascades before finishing the entire fountain with a green terrazzo surface. No topside waterproofing was specified originally.

Figure 5 – Front view of the Cincinnati Museum Center with the fountain.
