“L”-evating Concrete Façade Restoration to a New Level: A Case Study with Access Challenges

by Christopher Kottra

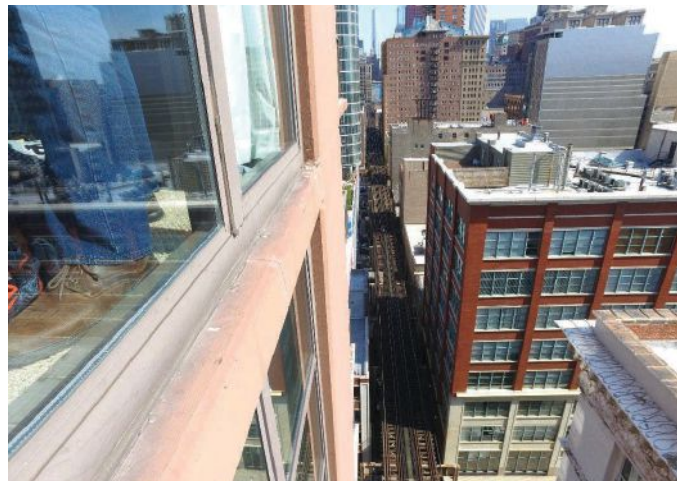
Chicago Transit Authority’s (CTA) elevated train tracks (“L”) run alongside the east elevation of the property (Fig. 2).

Use of a UAS was not permitted over the “L” tracks. Initial discussions with the CTA revealed that there would be significant costs involved and a great deal of red tape to have swing-stages on the east elevation. As such, it was not considered practical to pursue the up-close review of the east elevation. However, given the number of units reporting leaks on the east elevation, it was assumed that similar deterioration could be expected on this elevation. It was clear that time and cost considerations would have to be planned for well in advance of any façade repairs on the east elevation.

Fig. 2: View of “L” tracks along east elevation

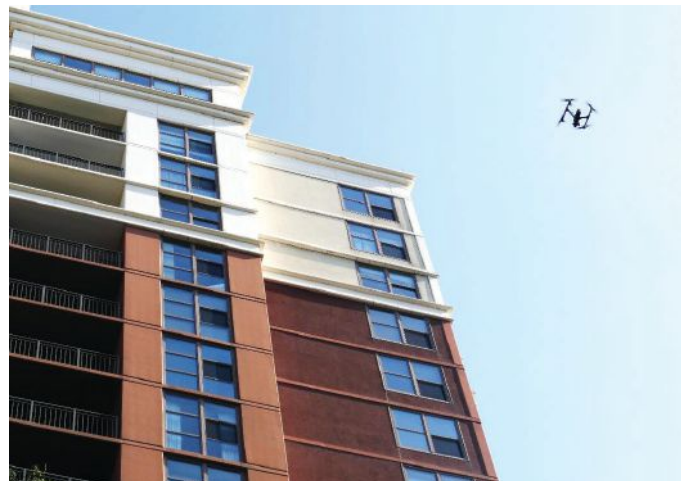
Water leakage had been reported in several Tower units, including several units on the east elevation over the “L” tracks. A building envelope evaluation was performed in 2016 to identify potential sources for the water leakage. An up-close review of the façade was performed from swing-stage scaffolding on the center section of the north and south elevations. An up-close visual review was also performed at the eastern- and western-most tiers of the south elevation using an unmanned aerial system (UAS or drone) (Fig. 3 and 4). Advanced deterioration of concrete slab edges and sealant components were identified during the up-close reviews.

Fig. 3: Drone survey
