Project Name:
East Elevation Louver Repairs

Project Location:
*474 North Lake Shore Drive
Chicago, Illinois*

Nature of Services:
*Precast Concrete Louver Repair Design,
Bidding Assistance, and Construction
Phase Services*

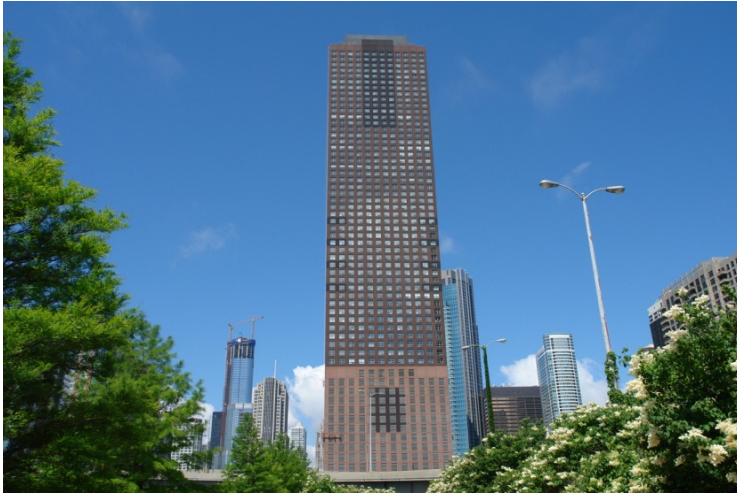
Significant deterioration of the east elevation concrete louvers was noted during a critical examination performed by BTC in 2008. Much of the observed deterioration was attributed to direct exposure to salt spray from heavily traveled Lake Shore Drive within 20 feet from the east elevation of the building. BTC was retained to design repairs for the deteriorated concrete.

A typical louver repair included removal of loose material down to sound concrete, cleaning and painting existing reinforcing steel, installing supplemental reinforcing steel where needed, installation of a new concrete patch material, and application of an acrylic waterproofing sealer. Other repairs included routing and sealing cracks, patch repairs of the exposed aggregate precast panels, and application of a clear water repellent at the first 15 floors of precast panels.
