Project Name:
*Facade Glazing Repairs
The Moorings of Arlington Heights*

Project Location:
Arlington Heights, Illinois

Client:
*Presbyterian Homes
Evanston, Illinois*

Nature of Services:
*Evaluation, Repair Design, and
Construction Phase Services*

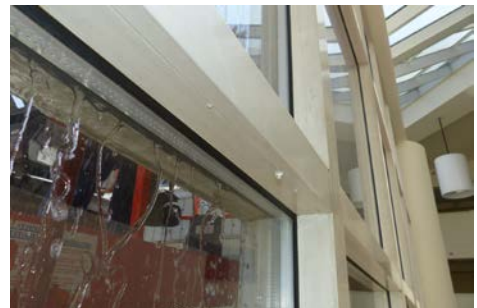
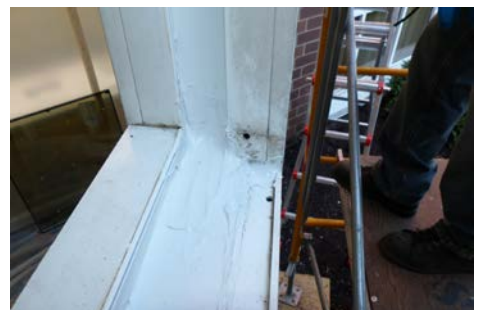
Evaluation of the water leakage included a visual review, water testing, and partial dismantling of the glazing systems. This evaluation indicated that the cause of water leakage was due to the lack of a suitable water management system within the vertical glazing system; primarily lack of end dams, weep holes, and water diverters within the glazing pockets, and lack of through-wall flashing at the base of the glazing system. Long-term deterioration of exterior gaskets exacerbated the water leakage problems by allowing significant water penetration into the glazing pockets.

A comprehensive long-term rehabilitation option was selected to address the water leakage. This option included installation of end dams and weep holes within the glazing pocket of each lite within the system, replacing insulated glass units, replacing interior and exterior gaskets, and installing a back dam and liquid-applied through-wall flashing at the base of the glazing system.
