*Evaluation of Plaza, Elevated Walkways and, Parking Garage
Gatlinburg Town Square*

*414 Historic Nature Trail
Gatlinburg, Tennessee*

*Condition Evaluation of Plaza, Elevated Walkways, and Parking Garage,
Assessment of Leakage Sources,
Conceptual Repair Recommendations*

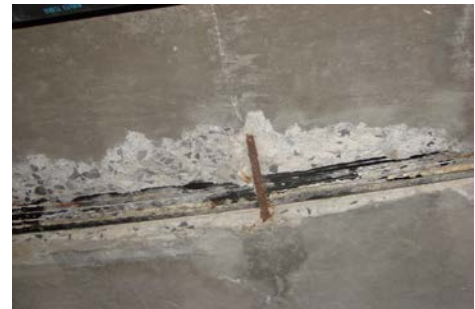
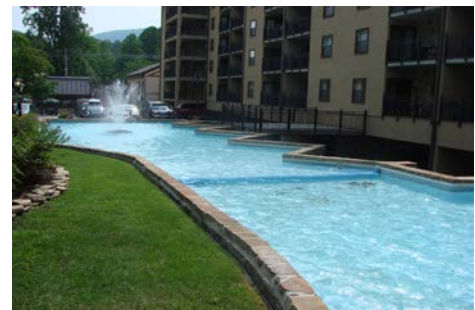
Our evaluation revealed significant deterioration in the concrete components of the garage and elevated walkways. The deterioration of garage components were primarily due to water leakage through the plaza waterproofing system. Lack of concrete protection had resulted in localized deterioration of the elevated walkways.
