The Reroofing of an Iconic Structure in Memphis

Employing Technology to Develop a Suitable Solution

By Charles Sietmann, RRO, REWO, CCCA, CIT, and Kami Farahmandpour, F-IIBEC, REWC, RRC, RWC, RBEC, PE, CCS, CCCA

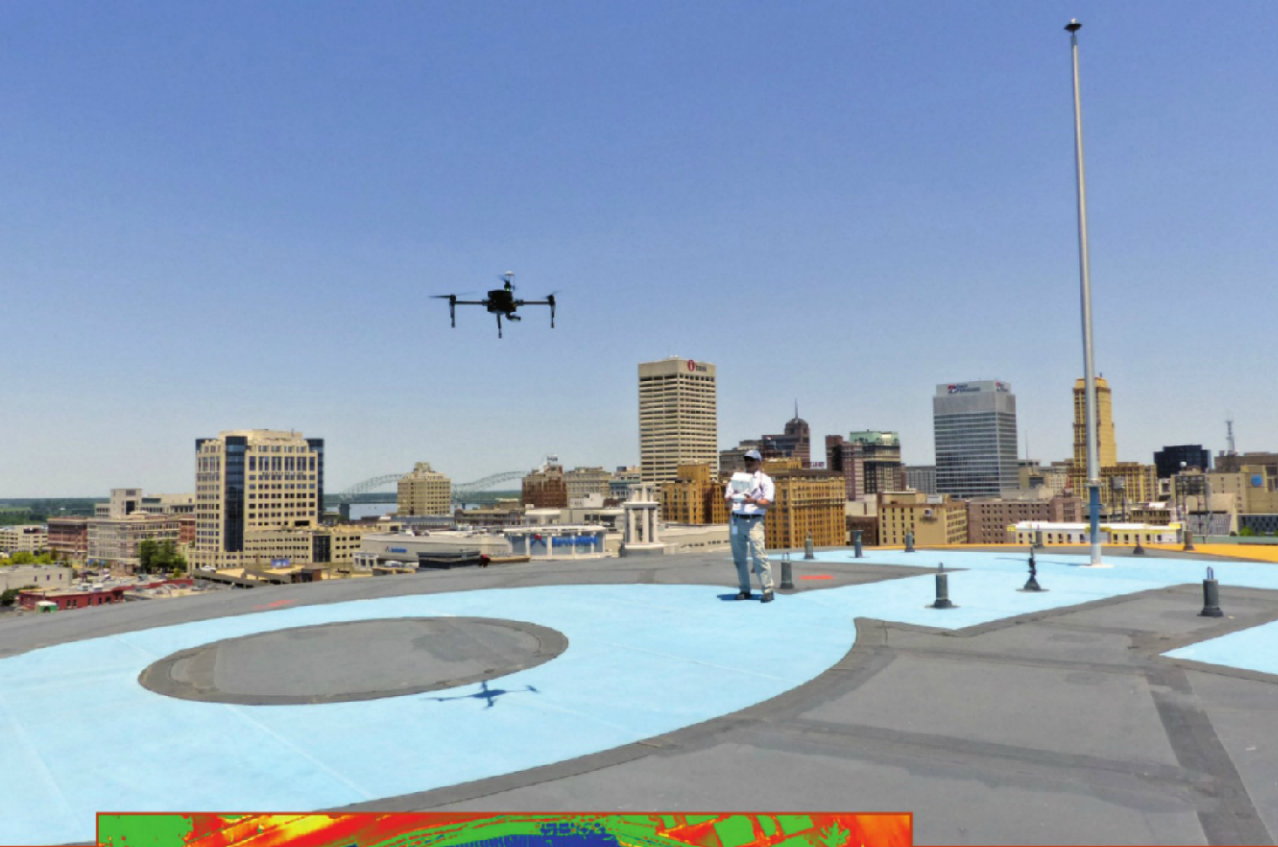
Figure 3. Unmanned aerial system in use.

The visual review was supplemented with an aerial review and infrared thermographic survey performed using a UAS equipped with a gimbal-mounted remote thermal imager (Fig. 3). Several areas of the dome roof along the perimeter exhibited thermal anomalies (Fig. 4 and 5). Some of the thermal anomaly locations coincided with areas that had been previously repaired. Other thermographic anomalies correlated with the extent of craze cracking of the roof membrane. These observations of thermal anomalies indicated that moisture intrusion through craze cracking, and through the resulting tears, had saturated the lower areas of the roof. Similar craze

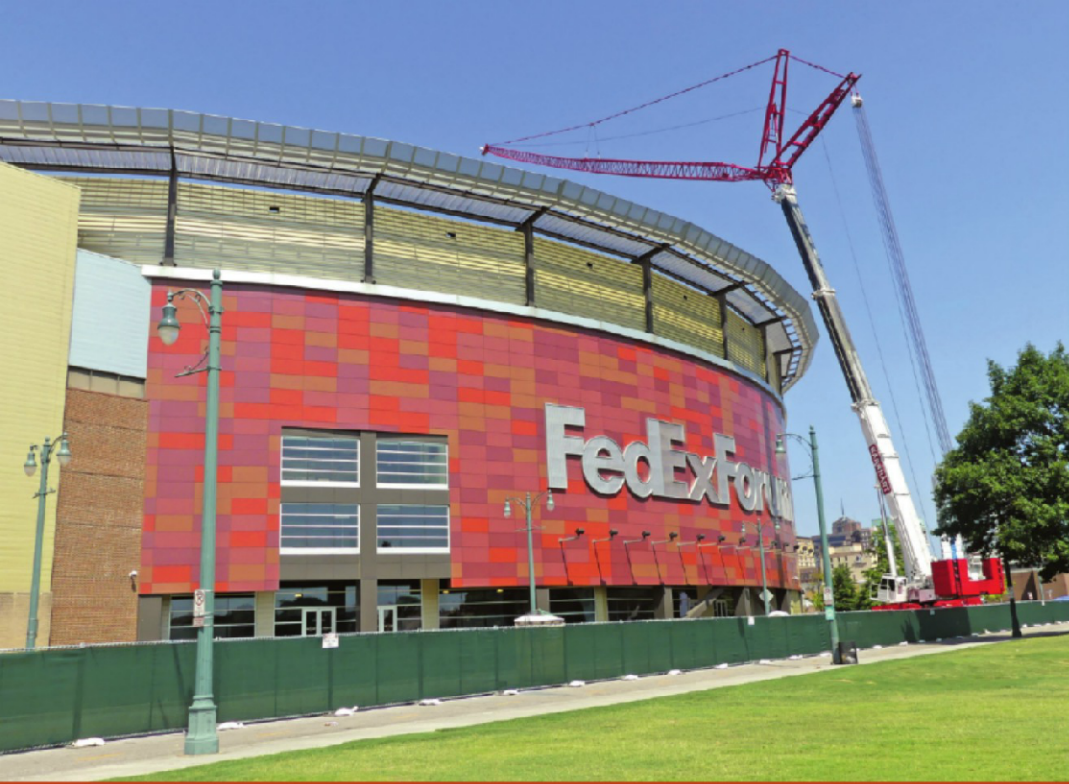
Figure 8. Staging area and crane in use.

Transportation of materials to the top of the dome roof posed the biggest logistical challenge. The use of a large crane (a mobile crane with 100-ft [30-m] tower, luffer boom, and large outriggers) was required to reach the central area near the top of the dome (Fig. 8). Use of a smaller crane with less reach and capacity was also required during tear-off of the lower dome areas.

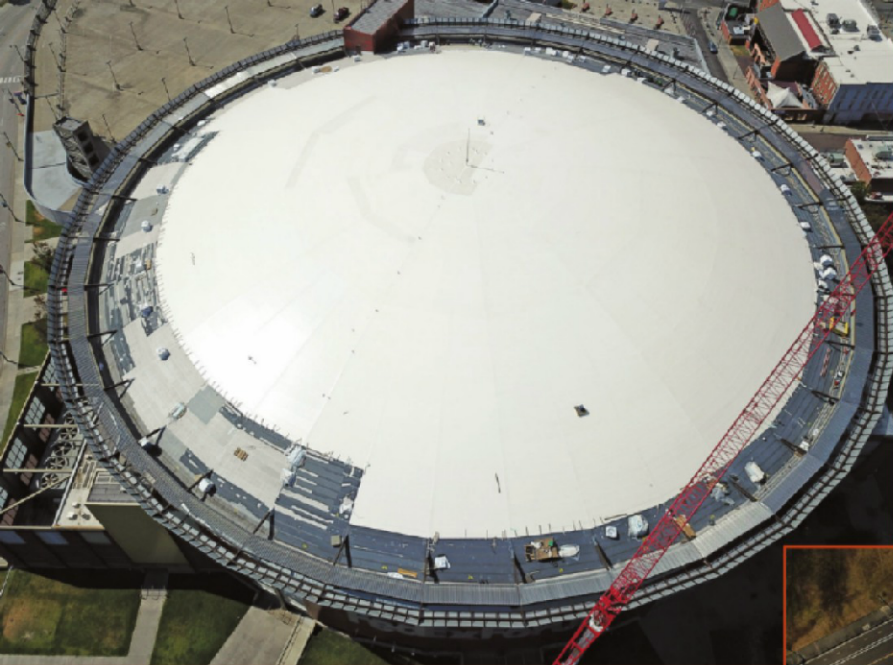
Figure 12. Work progress around the dome.

The project was successfully completed on time and within budget, with minimal change orders (Fig. 12–15). Although basketball games and other events under this beautiful new roof have been impacted due to the ongoing COVID-19 pandemic, we know this venue will be home to many significant events for years to come.
