Project Name:
*Evaluation of Moisture Intrusion,
Glenside Public Library*

Nature of Services:
*Evaluation of Moisture Intrusion, Infrared
Thermography, and Hygrothermal
Analysis*

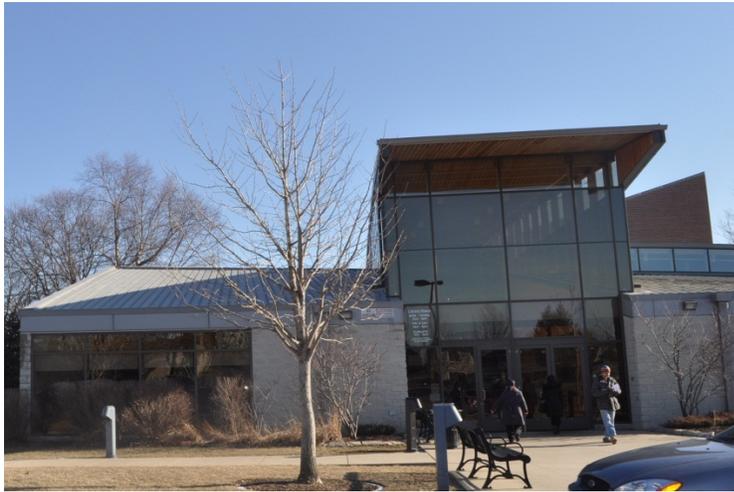
Glenside Public Library is a 2-story structure originally constructed in 1982. The library underwent major renovations in 2002 which included the construction of an addition. The meeting room at the building was constructed as part of the 2002 addition. Condensation and moisture related issues had been a concern within the meeting room interior space for many years. Therefore, the Library retained BTC to assess the sources of the moisture, and to provide recommendations for repairs.

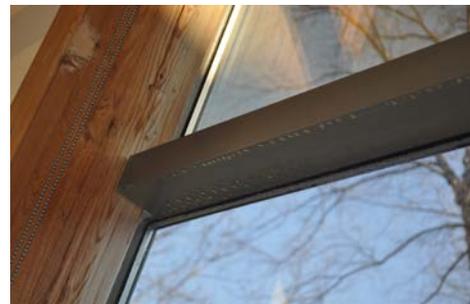
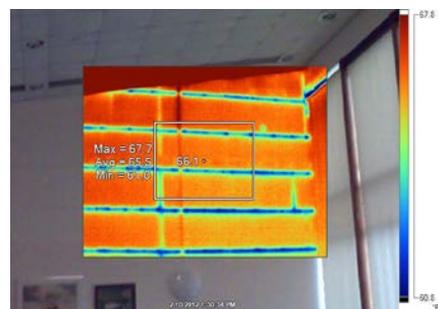
During the visual review, evidence of condensation such as water droplets on aluminum curtain wall framing members and water staining on interior finishes was observed. BTC also observed potential paths of bulk water infiltration. Temperature and relative humidity dataloggers were installed at several interior locations. Analysis of the data indicated high relative humidity within the space. Infrared thermography confirmed surface temperatures lower than interior dew point temperature on several occasions. BTC's WUFI analysis also suggested the potential for condensation within the meeting room. Based on BTC's findings, it was concluded that the moisture issues were primarily related to condensation; however, bulk water infiltration could also occur.

A multifaceted evaluation protocol was recommended by BTC. The evaluation consisted of review of available drawings, meetings with Library staff to establish the pattern of previous moisture-related events, visual review of interior and exterior building components, infrared thermography, analysis of interior temperature and humidity data over a 2-week period, and hygrothermal analysis using WUFI commercial software.
