Project Profile

210 East Pearson
Exterior Facade Repairs

Repair Design, Bidding Assistance, and
Construction Phase Services

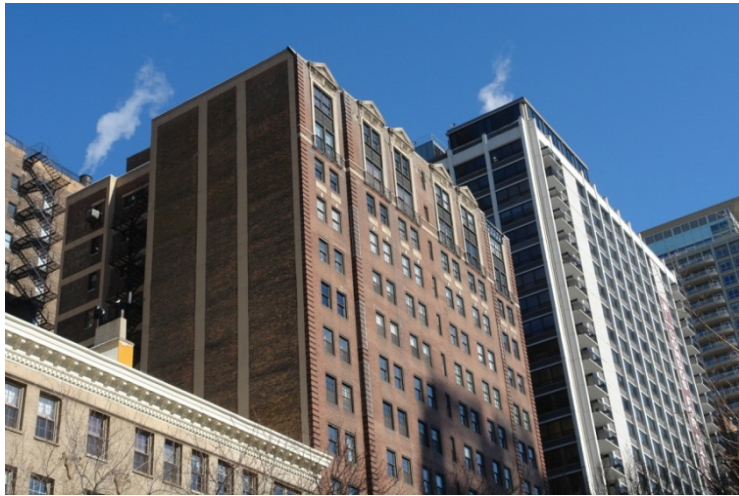
The 210 East Pearson Building is a 16-story concrete framed structure built in 1926. The south elevation of the building is clad in brick and limestone masonry. Projecting brick masonry quoins accent the southeast and southwest corners of the building, as well as intermediate offset corners. Six limestone pediments cap the top of the south elevation with a copper mansard roof between them. The remaining elevations of the building are clad with brick masonry between exposed concrete beams and columns.
