Wrigley Building Architectural Terra Cotta Facade Repair and Restoration

Evaluation, Repair, and Restoration of Deteriorated Architectural Terra Cotta Facade

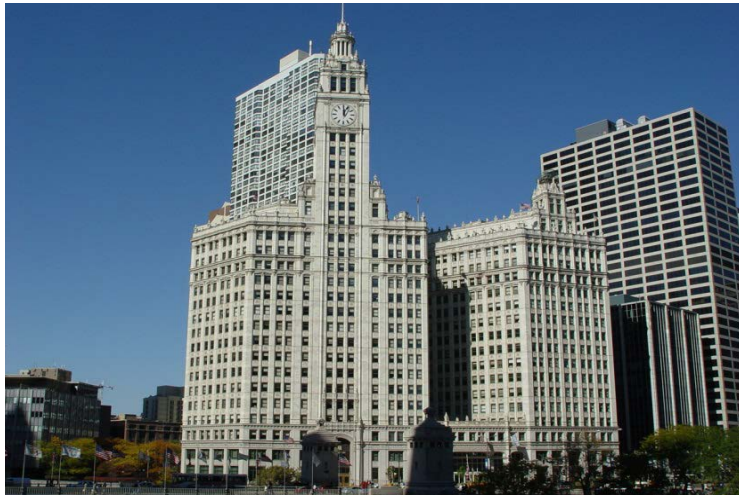
The Wrigley Building consists of 2 towers, a breezeway connecting the 2 towers at grade, and a sky bridge between the 2 towers at the 14<sup>th</sup> floor. The South tower rises 28 stories above Upper Michigan Avenue and was completed in 1921. The North Tower was completed in 1924.

With nearly 300,000 square feet of facade surface, the Wrigley Building is clad in approximately 250,000 pieces of architectural terra cotta, glazed in several shades of white. The lower 2 floors of the building, between Rush Street and Upper Michigan Avenue, are clad in limestone.
