*Buttress and Exterior Facade Repairs at Alice S. Millar Chapel, Northwestern University*

*Evanston, Illinois*

*Evaluation, Repair Design, Bidding Assistance, and Construction Phase Services*

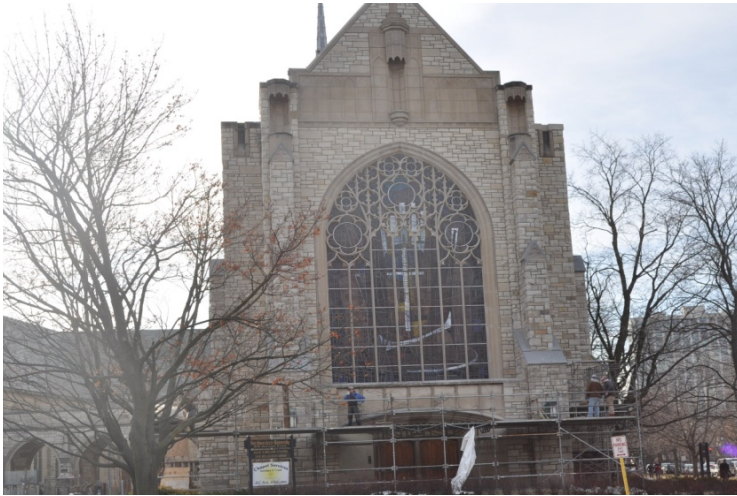
Alice S. Millar Chapel is a steel frame structure built in 1962. The exterior facade at this religious facility is clad in lannon stone, buff limestone, and bluestone. Large stained glass windows are located at each elevation. Full-height 60-foot tall buttresses are located at each corner of the building and along the east and west elevations.

Due to significant cracking of mortar joints and displacement of lannon stone at the corner buttresses, BTC was requested to perform an evaluation of the exterior facade. This evaluation indicated that the observed deterioration was due to severe freeze-thaw damage of the back-up brick masonry within the buttresses.

BTC prepared repair details and specifications for rebuilding the deteriorated buttresses with freeze-thaw resistant back-up masonry, stainless steel ties and anchors, and properly configured through-wall flashing. Additional repairs included comprehensive repointing, localized lannon stone replacement, replacement and reconfiguration of bluestone buttress caps, sealant replacement, new roofing at top of buttresses, and application of a penetrating water repellent to all lannon stone and limestone.
