ESSENTIAL ELEMENTS OF DURABLE EXTERIOR MASONRY WALLS

By Joshua J. Summers, SE, PE, and Kami Farahmandpour, PE, RRC, RWC, CCS, CCA

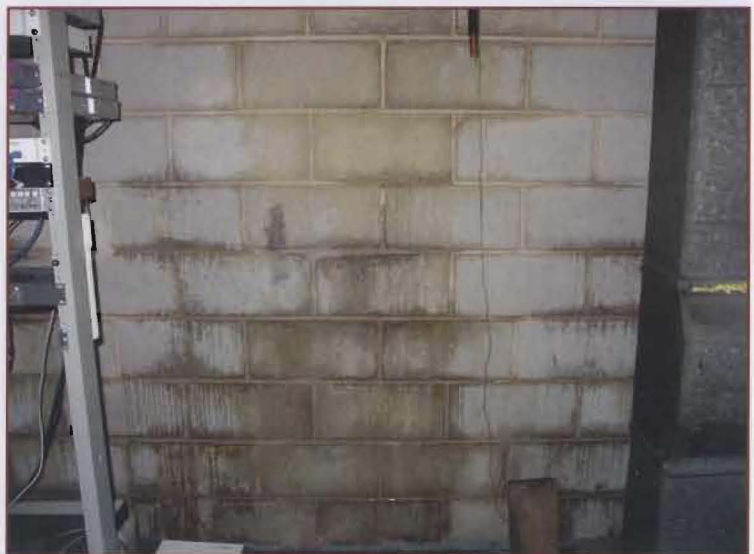
Photo 1: Water penetrating to interior surface of CMU wythe of solid masonry wall.

of hollow masonry units) increased the need for more freeze/thaw-resistant materials. The higher quality masonry units and mortar used today are far more impervious than the materials used in early solid masonry walls and absorb far less moisture. Therefore, water penetrating the surface of an exterior wall through cracks

or other defects is forced to continue through the wall instead of being absorbed in the wall materials and will reach the interior surface much quicker (Photo 1).

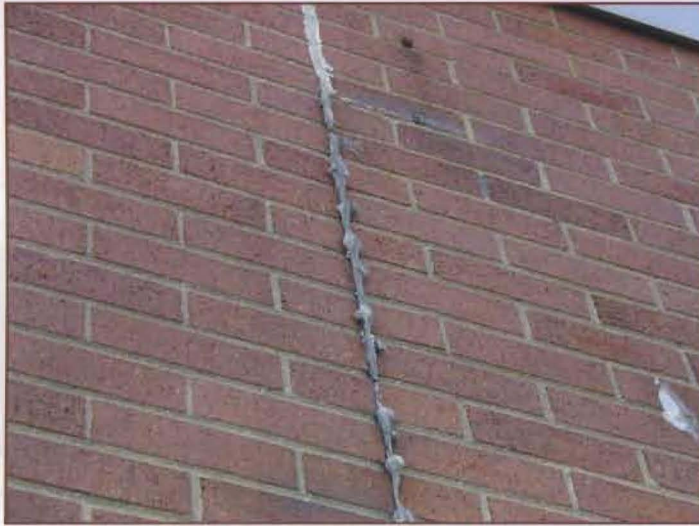
Photo 2: Sealant compressed out of improperly sized vertical expansion joint.

Location of control and expansion joints and sizing of expansion joints are critical to minimize cracking and displacement of masonry. Expansion joints that are too narrow will close and begin to cause cracking and displacement as if the joints were never present (Photo 2). Improperly spaced or located control and expansion joints will do the same.

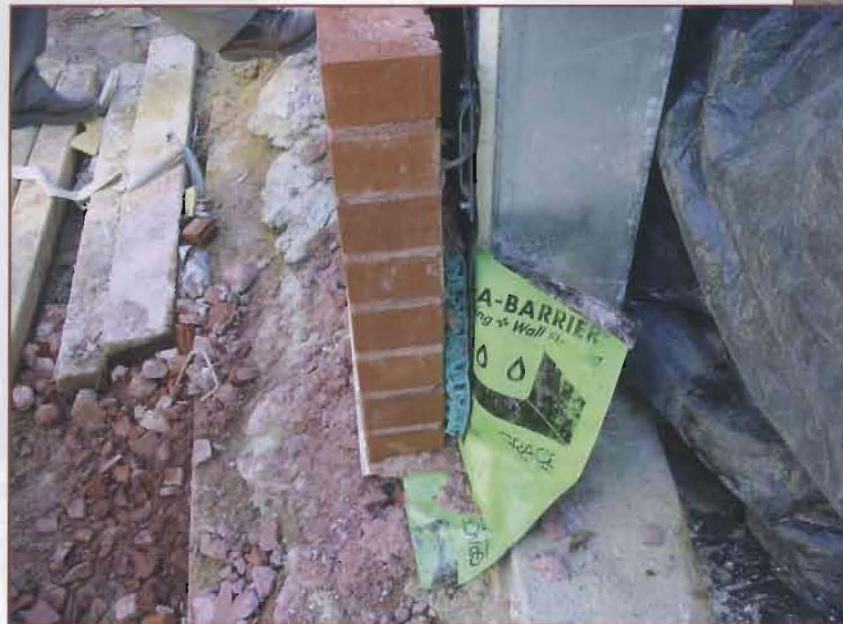
Photo 3: Narrow wall cavity difficult to keep clean during construction.

sion is considered the minimum width necessary, as recommended by the Brick Industry Association (BIA), to prevent the cavity from being bridged by mortar or other materials and allow water to cross over to the interior wythe. Narrower cavities are typically more difficult to keep clear during construction (*Photo 3*). However, it should be noted that mortar bridging can still occur with a wider cavity if the masons do not exercise care to keep the cavity clear during construction.

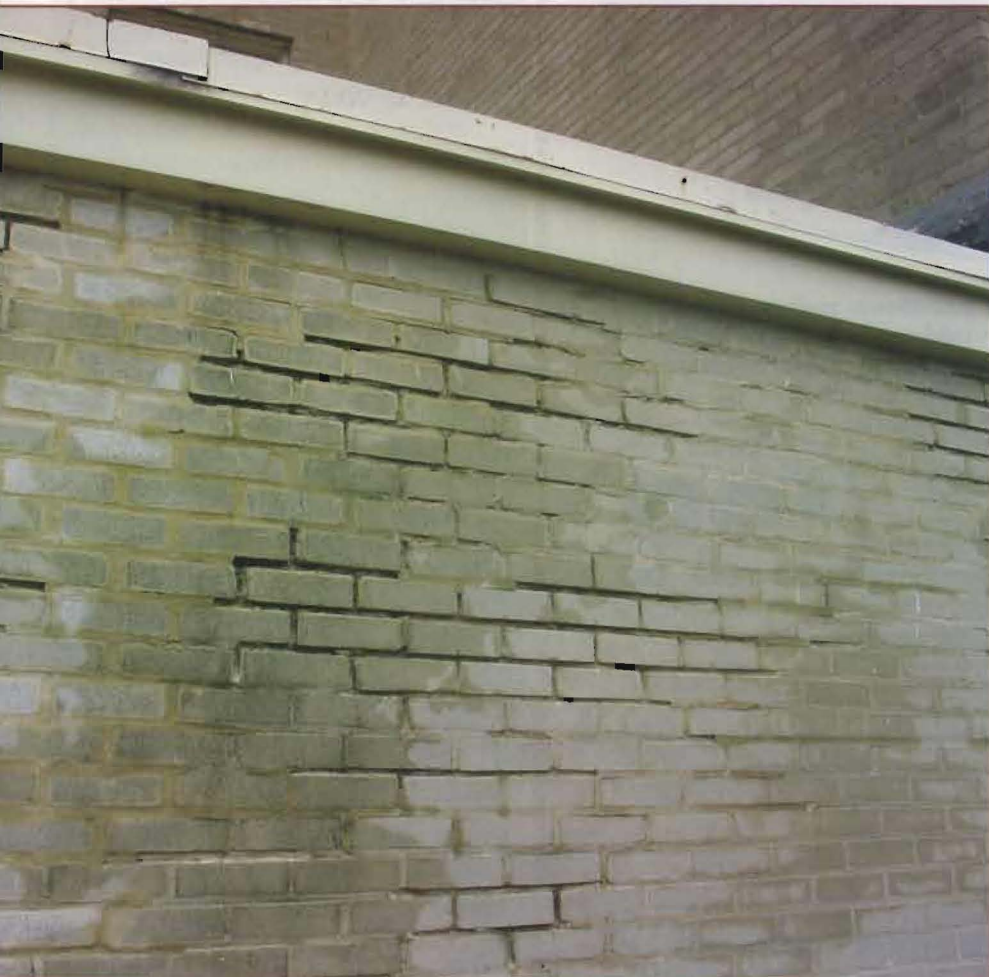
Photo 4: Freeze-thaw deteriorated mortar joints.

Similarly, mortar must have appropriate physical properties for the intended service conditions. Strength, workability, and freeze/thaw resistance are all important properties to consider when specifying mortar (*Photo 4*). The mortar must also be compatible with the masonry units to ensure proper bond.

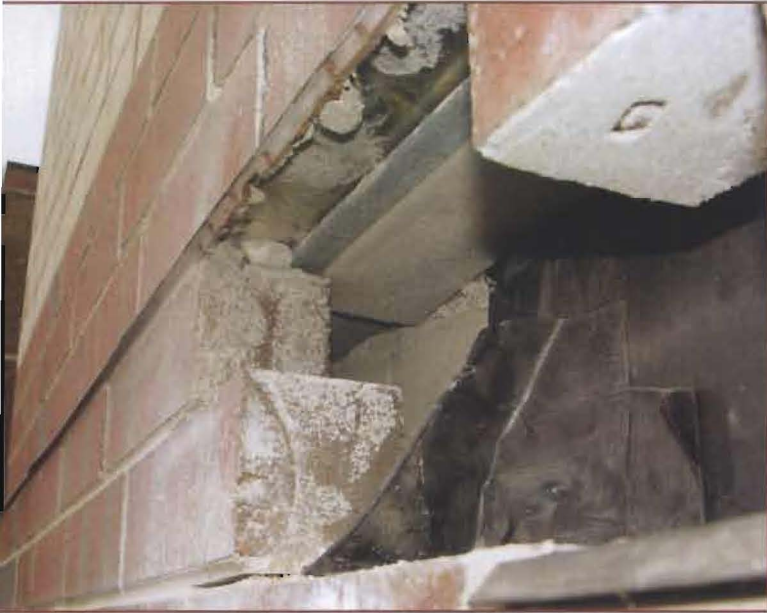
Photo 5: Mortar improperly placed in horizontal mortar joint and brick not properly supported on shelf angle.

- Vertical and horizontal expansion joints must be kept clean to allow them to function as intended (*Photo 5*). Obstructions over only a portion of these joints can still cause cracking and displacement of adjacent masonry.
- Flashing must be carefully installed to ensure that it will be watertight. Open seams, punctures, and other damage to the flashing must be avoided, end dams must be installed, and flashing must not be trimmed back too close to the face of the wall (*Photo 6*). Since most through-wall flashing materials degrade rapidly when exposed to UV, stainless steel drip edges are typically incorporated into the flashing system to extend beyond the face

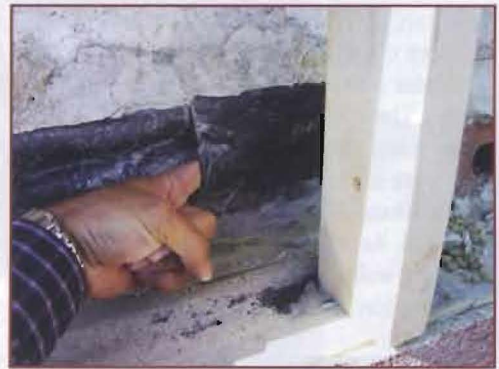
Photo 6: Improperly sealed flashing seam.
