Roof Rehabilitation at Park Edge Water Condominiums

Chicago, Illinois

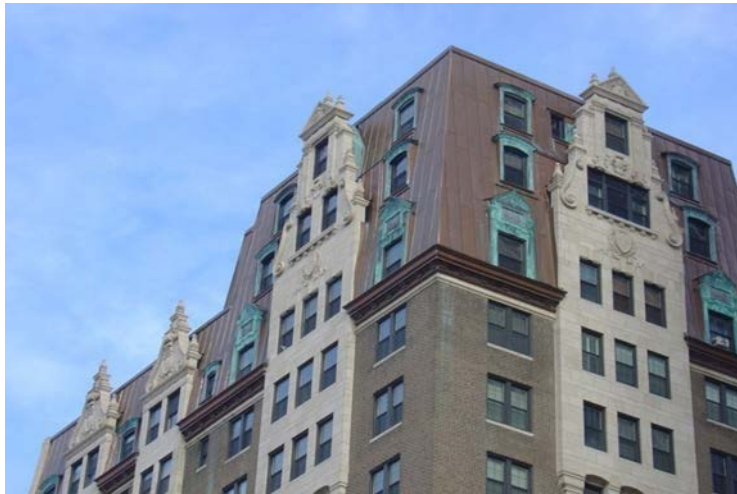
Park Edge Water Condominiums is a 16-story tall building. On the top 3 levels of the building, there are several mansard roofs that incorporate ornate built-in gutters and terra cotta features.

The original roofing system consisted of an asbestos fiber cement tile roofing system attached directly to precast planks. Over the years, several of the tiles had dislodged and cracked. In addition, extensive water leakage below the gutters and at interior downspout locations was persistently reported.

BTC was originally retained to evaluate the condition of the roofing system and to present recommendations for repair/replacement. Based on its investigation, BTC determined that the existing roof tiles had exceeded their anticipated service life and required replacement. Subsequently, BTC was retained to design a new roofing system for the building. After considering several replacement options, the Owners selected a standing seam copper roofing for its architectural advantages as well as long anticipated service life.

The design of the new roof posed several challenges. The ornate perimeter gutter system had to be designed with a redundant waterproofing system and with new structural support members. BTC also designed a new ventilation system to reduce the potential for ice damming along the gutters. In order to save costs, BTC specified the existing copper dormers to be saved and repaired.
